RESIDUAL STRENGTH OF FULL- DEPTH RECLAMATION

**APPLIED RESEARCH &
INNOVATION BRANCH**

1. Report CDOT-2020-09		2. Government Accession No.		3. Recipient's Catalog No.	
4. Title and Subtitle Residual Strength of Full-Depth Reclamation				5. Report Date July 2020

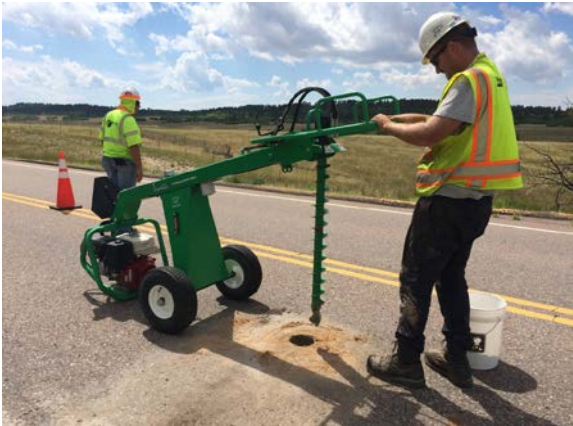
Figure 5. Granular material sampling

Coring was performed in 2018, with the first section being cored in July 16, 2018 and the last section cored in August 8, 2018. Figure 4 and Figure 5 show pictures of this sample collection.

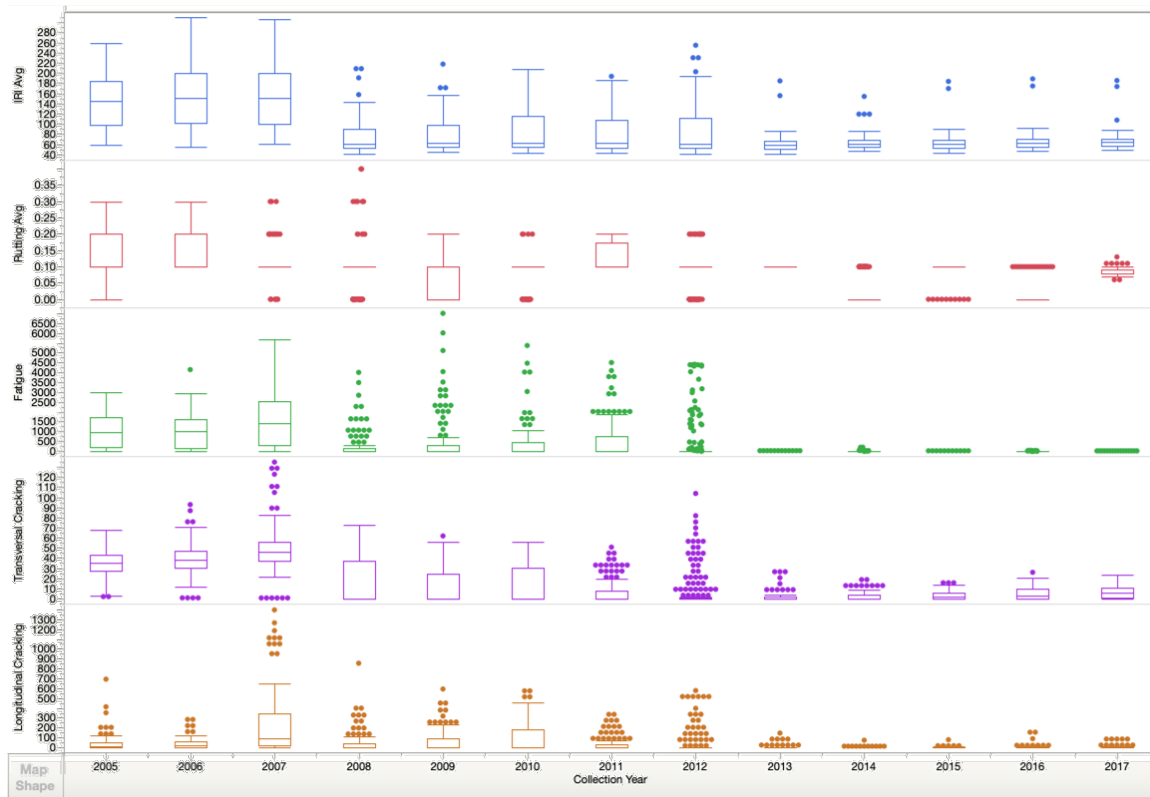
Figure 8. Outlier box plot of distresses in site 1

From the analysis of outliers box plots, the research team found that mean values were very sensitive to outliers and therefore recommended the use of median values as a reliable measure to characterize the deterioration of sites over time.

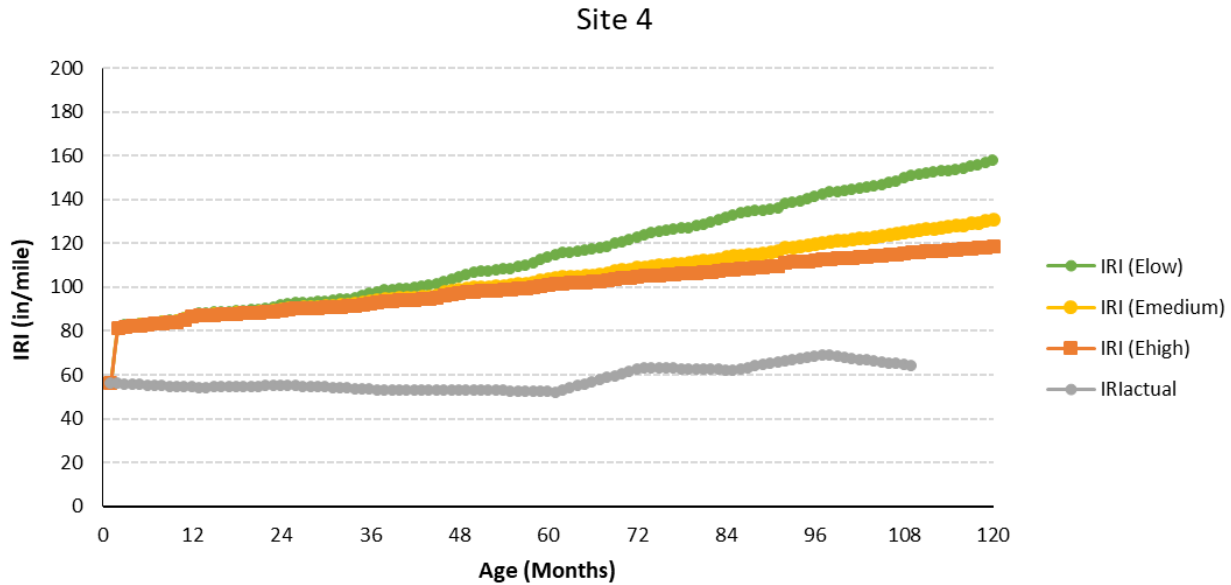
Figure 17. Sensitivity analysis of IRI predictions to changes in FDR modulus - Site 4

To analyze the sensitivity of IRI predictions to strength modulus values, the research team run three models for each site, each of them considering low, medium, and high values of the strength modulus as summarized in Table 13 and keeping initial IRI to the actual value at the beginning of the analysis period.

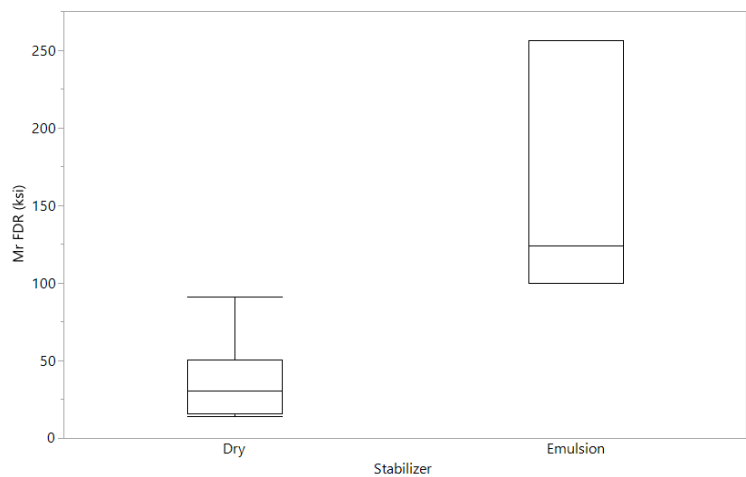
Figure 19: Resilient modulus of FDR layers with different stabilizers

Figure 20 shows that stabilizers have a significant impact on the resilient modulus values of FDR layers. Emulsion-stabilized FDR result on stiffer layers than non-stabilized projects (also known as dry projects). From these results it can be concluded that the recommended resilient modulus values should be different for non-stabilized and emulsion-stabilized FDR.

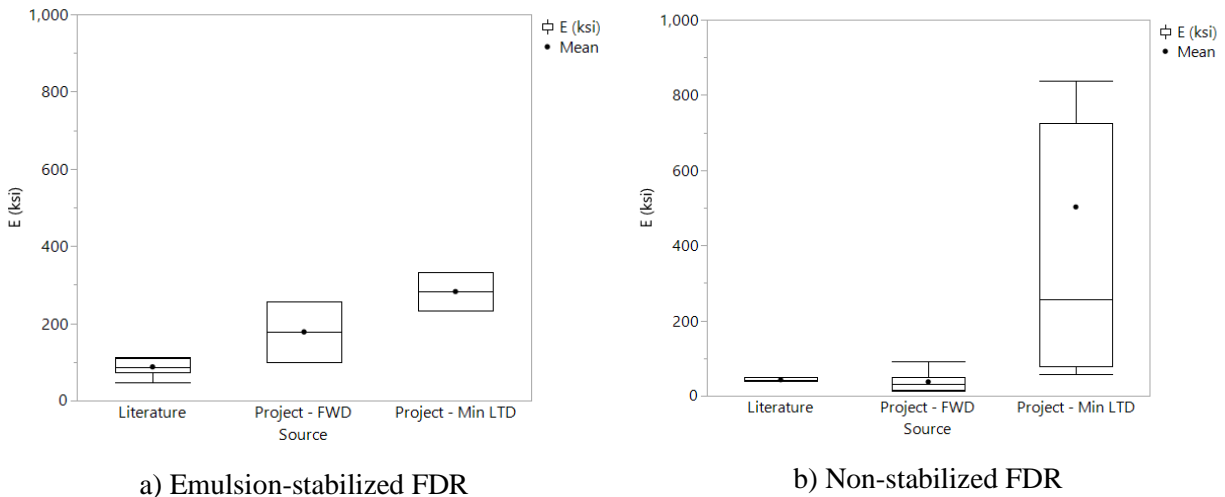
Figure 22. Comparative analysis of modulus values in literature and this project

The proposed values of strength modulus were compared with values found in the literature (Amarh et al. 2017; Johanneck and Dai 2013; Kroge et al. 2009; Mallick et al. 2002) and the calibrated values that minimized the long-term difference of predicted and actual IRI (summarized in Table 15). This comparison is plotted in Figure 20. It is worth mentioning that the strength values included in Figure 20 correspond to values for ME input. Therefore, the back-calculated modulus values (E_{FWD}) obtained from deflection data are adjusted to laboratory conditions of resilient modulus by applying a coefficient of 0.62, as recommended by AASHTO (2015). The values obtained from the literature were also weighted by the same coefficient in those cases in which the modulus was obtained from deflection measures. The comparative analysis (Figure 20) shows that the recommended values (depicted by the mean value in the “Project-FWD” box plot in Figure 20) are slightly higher than the ones found in the literature but seem more reasonable than the values obtained through the minimization of the long-term deterioration (Project - Min LTD in Figure 20).

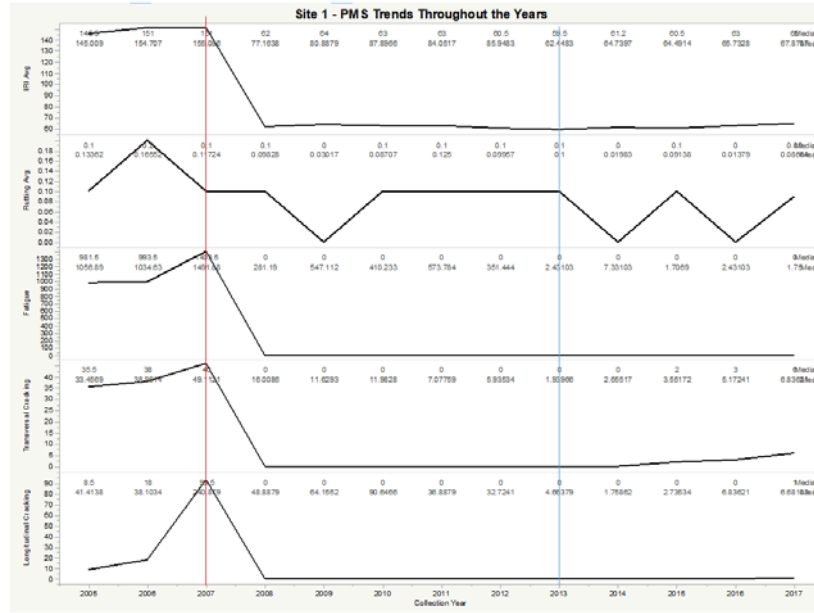
The research team's interpretation from this unexplained pavement behavior is that FDR was actually constructed on the "Ad Date"—as referred to in the DCP records—and not on the year when the earliest PMS data was made available. For example, referring to Figure 3, 2007 would be the year of FDR construction, not 2005. Nonetheless, considering data starting with the "Ad Date" still shows high unexpected distresses. The assumption for this is that PMS data may have been collected before FDR construction actually occurred on the same year. This would explain that such high distresses should not be accounted for in the data analysis.

Figure A-12. Issue #1 described. Red line represents “Ad Date” from CDOT’s DCP records. Blue line indicates “Maintenance Date” from CDOT’s DCP records.

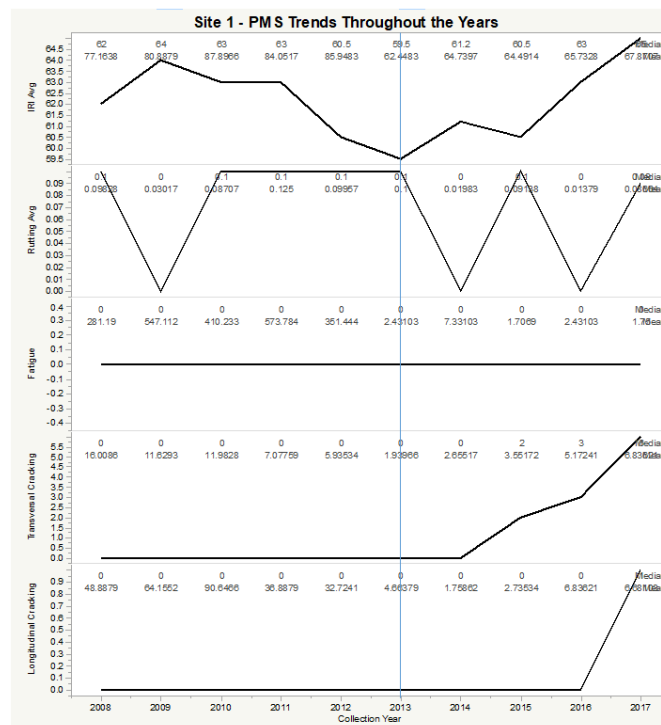
The recommendation to address this issue is to analyze distress data starting from “Ad Date” plus one year, effectively ignoring distress data from previous years, which always display random variability for all sites. Figure A-13 shows a visual representation of the proposed resolution.

Figure A-13. Issue #1 resolved. PMS distresses throughout the years excluding data before “Ad Date” plus one year. Blue line indicates “Maintenance Date” from CDOT’s DCP records.

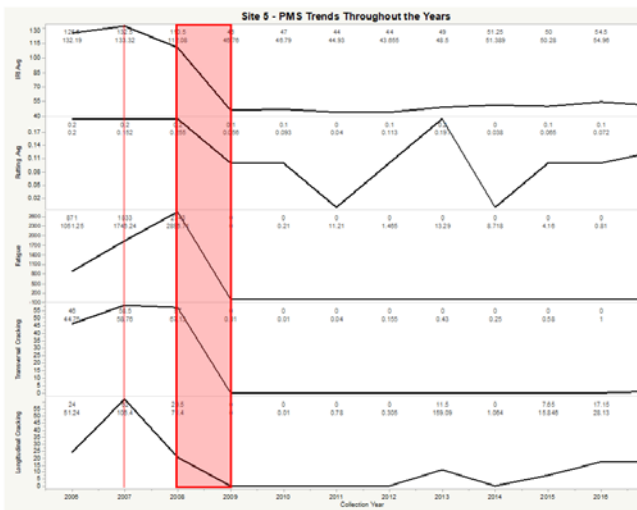
The ensuing recommendation is to analyze distress data from the year that all distresses start increasing from the lowest values. Figure A-15 shows a visual representation of the proposed resolution applied to the same site for ease of understanding.

Figure A-14. Issue #2 visually described. Red-colored area includes distress data with unexpected high values after Ad Date + 1 year. Red line shows actual “Ad Date”.

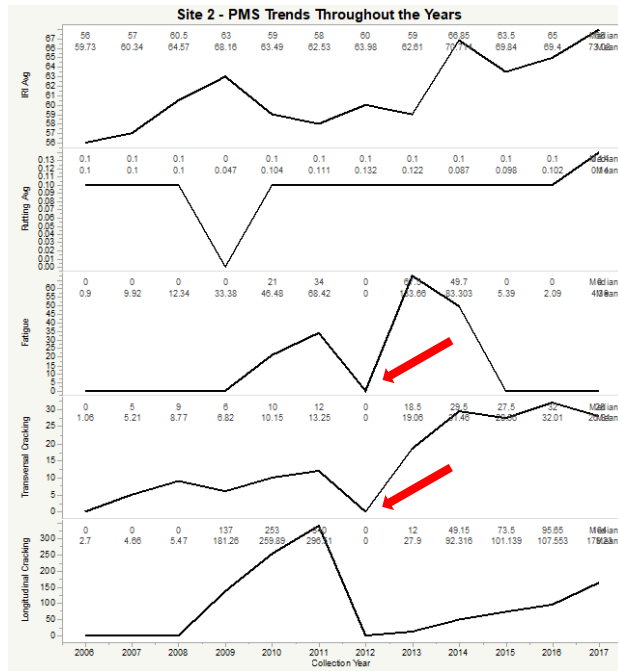
to site 2. However, as it can be observed, this recommendation does not resolve the inconsistencies associated with fatigue in 2015 and longitudinal cracking in 2012. The research team reckons that resolving this inconsistency may require foregoing analysis of both fatigue and longitudinal cracking for site 2, as their associated behaviors are not coherent in the absence of additional, contextual information.

Figure A-18. Issue #4 visually described.

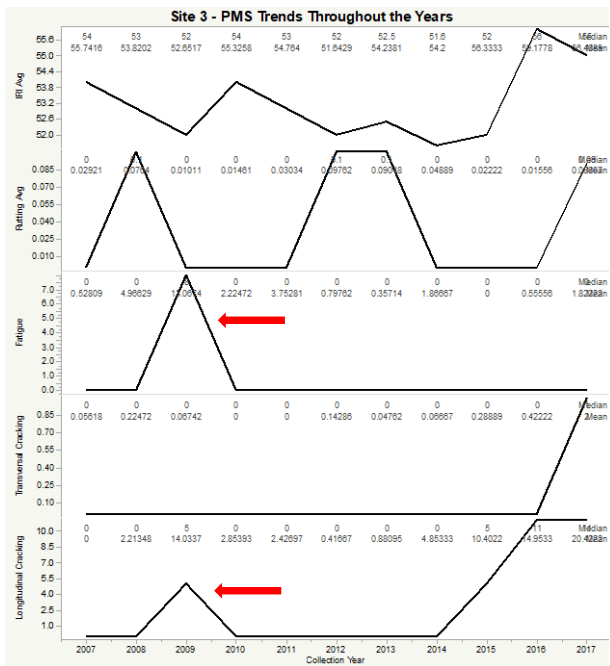
The associated interpretation is that instrument error affected the collection of fatigue and longitudinal cracking in 2009. Correspondingly, ignoring this isolated data and extrapolating the trend as it would be expected is recommended. Figure A-21 shows a visual representation of the proposed resolution applied to the same site.

Figure A-20. Issue #5 visually described.

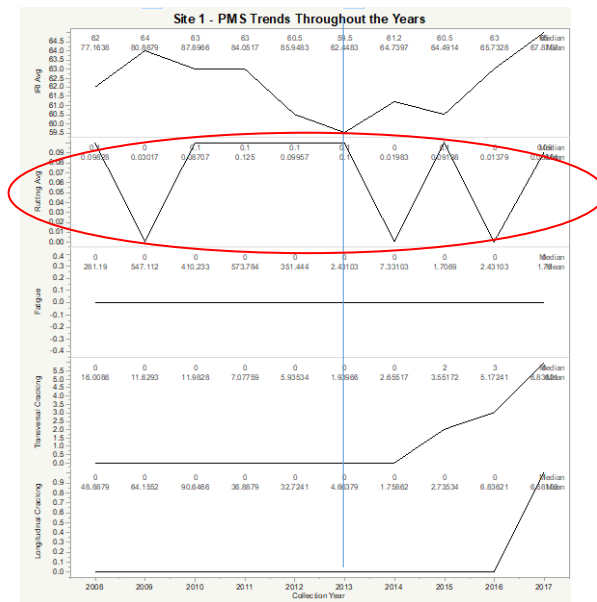
Some sites display inconsistent rutting trends over the years. Referring to Figure A-22, using site 1 as an example, it can be observed that rutting values vary randomly without any correlation to maintenance performed. Instances such as this were observed not only for site 1, but also for every site except sites 7 and 11.

Figure A-22. Issue #6 visually described. Rutting shows inconsistent trends throughout the years. Blue line indicates “Maintenance Date” from CDOT’s DCP records.

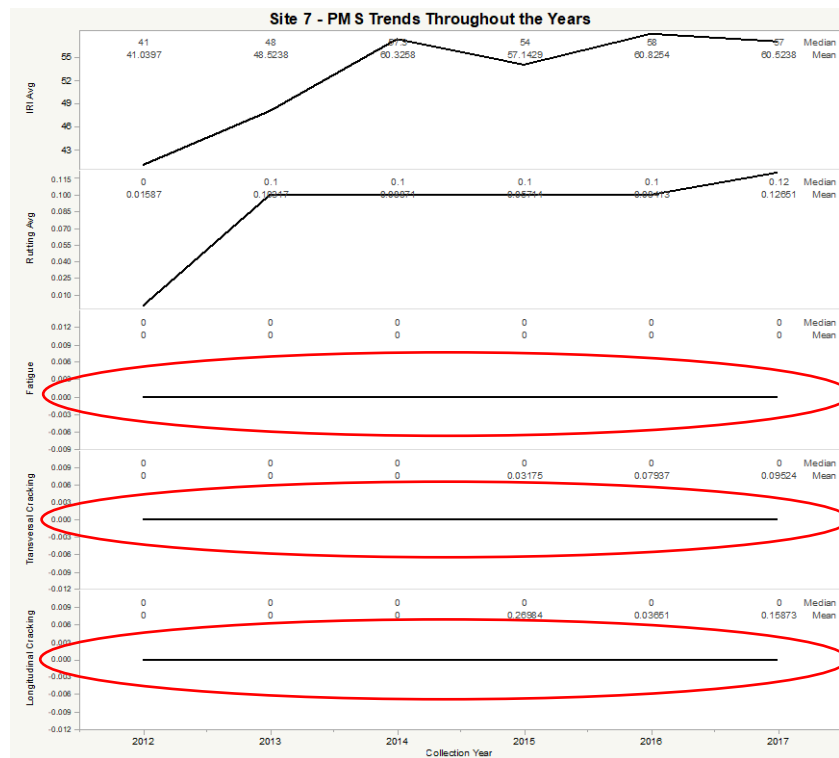
Some sites display null distress median values for all years since FDR construction to until 2017 (after excluding data before “Ad Date” plus one year). This issue is observed only on three distresses: fatigue, transversal and longitudinal cracking. Figure A-23 shows site 7 as an illustrative example where this pattern is evident for all three aforementioned distresses; however, some sites may display null values only for one of the three. Specifically, null fatigue values were observed only on sites 1, 2, 3 and 10. In turn, null transversal cracking values were observed on sites 7, 5, 6, 8 and 9. Lastly, null longitudinal cracking values were observed only on sites 7, 4 and 9. It is worth noting that some outliers did not affect the median computation; that is, values other than zero were collected over the years, but these values did not seem to have driven a change in the median trend.

Figure A-23. Issue #7 visually described. Null median values for fatigue, transversal and longitudinal cracking over the years.
