Review of Structural Materials & Methods for Home Building

3.0 PDH / 3 CE Hours / 3 AIA LU/

PDH Academy

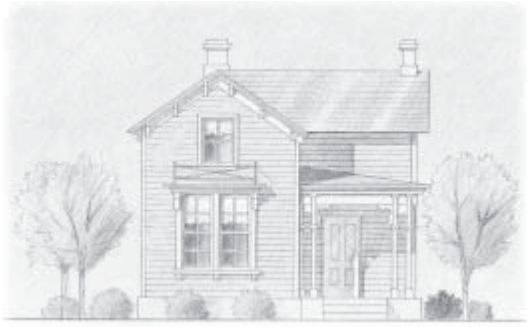
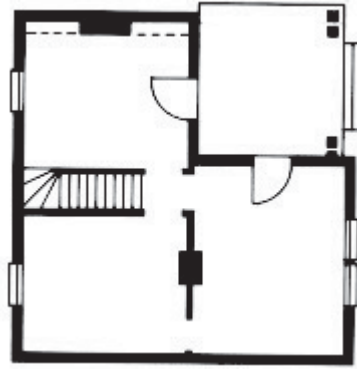
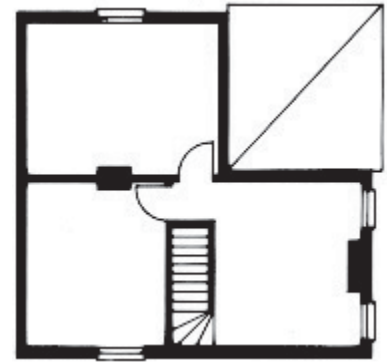
Figure 1. Profile home in 1900 (2 story).²

The front elevation and floor plan of a typical home produced in 1900 is shown in Figure 1. Good examples of traditional housing styles and architectural plans in the early 1900s are found in catalogues produced by Sears, Roebuck and Co., a major producer of traditional American kit homes from about 1910 into the early 1930s (see Bibliography). Likewise, it should be recognized that a large portion of the public lived in rural areas that were not subject to municipal building codes, and housing needs were likely fulfilled in a variety of ways that may not be well documented in the popular literature on housing construction. For example, in Cotton Field's *No More* it is stated that "more than half of the farmers lived in one-and two-room shacks that had not been whitewashed or painted for many years, if ever. Many of these houses had holes in the roof, wall, and floor." Further, U.S. Census data for 1900 reports that the value of land and buildings per farm in eleven Southern states ranged from \$600 to \$2,000. By contrast, the values for Indiana and Kansas were \$6,550 and \$3,718, respectively. Thus, living conditions and housing varied widely in the early 1900s.

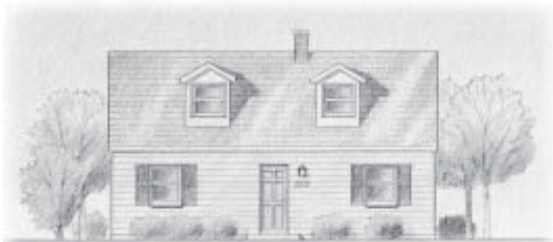
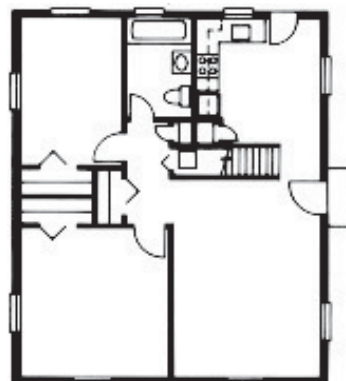
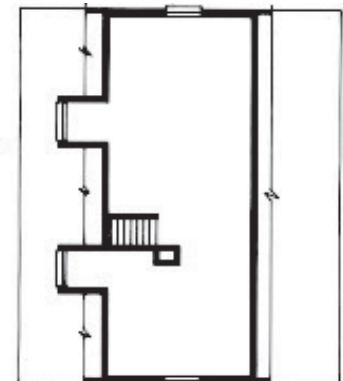
Figure 2. Profile home in 1950 (upper 1/2 story optional)

The front elevation and floor plan of a typical home produced in 1950 is shown in Figure 2.

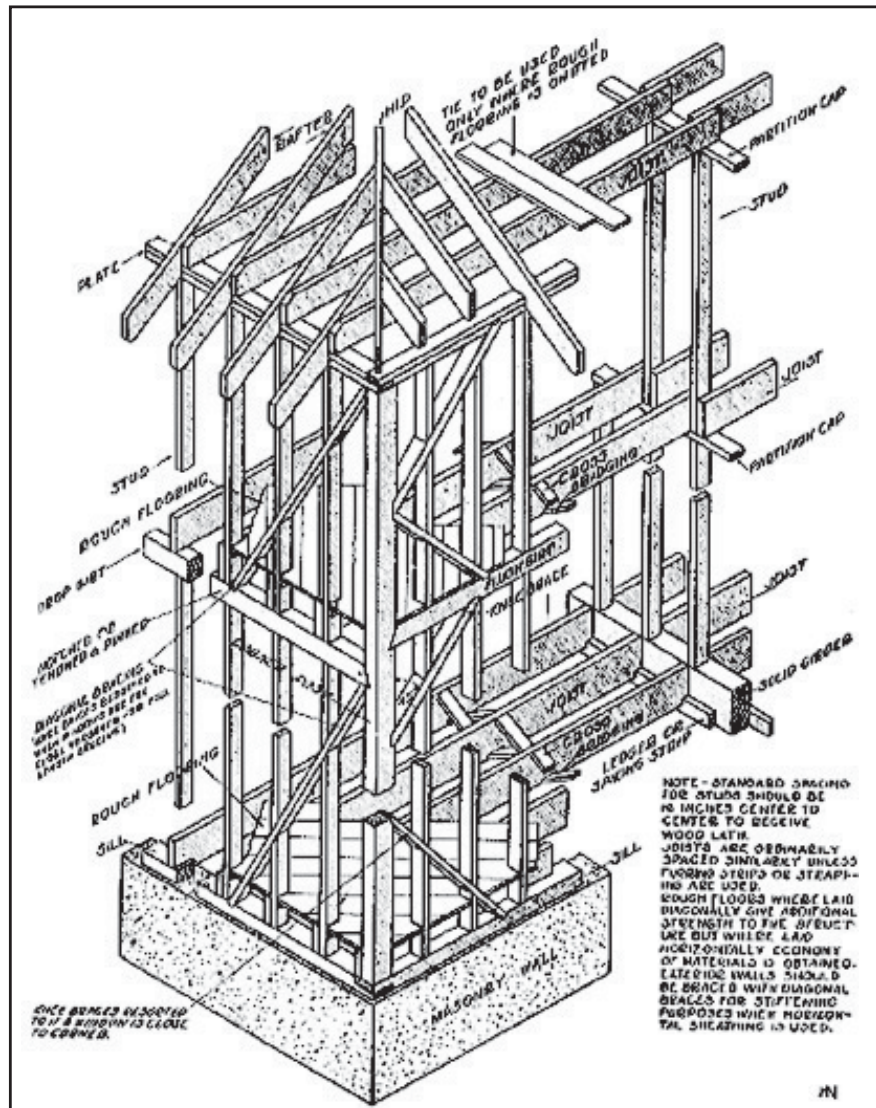
Figure 4. Braced Framing pre-1900.

Prior to the 1900s some significant changes in basic framing practices in the United States were set in motion. Up through most of the 19th century, homes were built following traditional timber construction known as *braced framing* adopted from England (see Figure 4). In this manner, homes used heavy squared timber frames and beams with diagonal bracing of 4x or larger timbers. Wood joinery methods were used for heavy connections rather than steel fasteners. Intermediate framing members of smaller dimension were used within the structural frame to provide for attachment of finish materials.

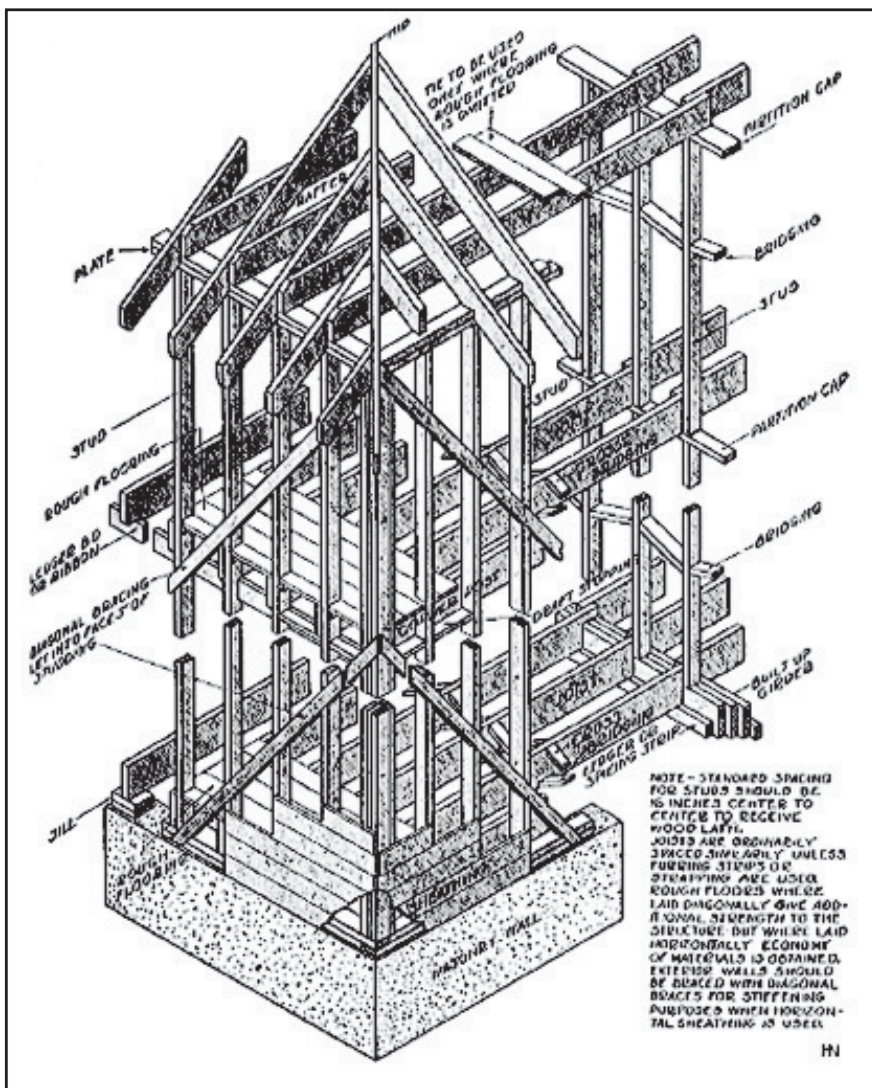
Figure 5. Balloon Framing Technique in Early 1900s.

In the mid-1800s a new construction method, known as *balloon framing*, began to be used in the United States. This method used repetitive light framing members, generally 2x4s, made available by the proliferation of sawmills. By the start of the 20th century, balloon framing had practically replaced the traditional heavy braced framing technique. The balloon framing technique is illustrated in Figure 5. In some cases, vestiges of early practices such as the use of

4x corner posts, beams, and sill framing members existed well into the 20th century in combination with balloon framing. Balloon framing persisted until after World War II in some parts of the country.

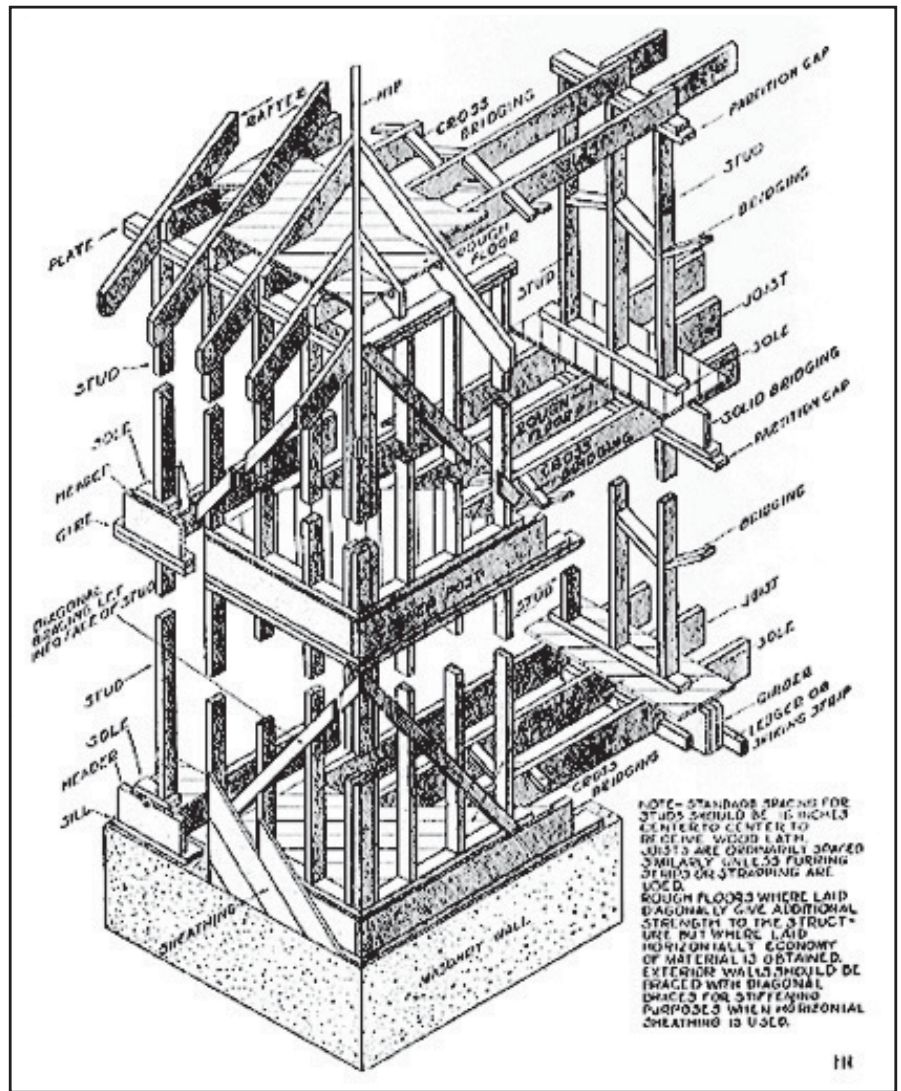
Figure 6. Platform Framing.

Note: Platform framing in Figure 6 is representative of early platform framing. Platform framing in the mid-to late-1900s used panel products in lieu of board sheathing and bridging in floors and walls was eliminated.
