SCC Crack Growth Rate Response for Alloy 152/52/52M Welds and Influence of Additional Strain

***Steve Bruemmer, Matt Olszta,
Nicole Overman and Mychailo Toloczko***
Pacific Northwest National Laboratory

Alloy 690/52/152 PWSCC Research Collaboration Meeting
November 30, 2016 Tampa, FL

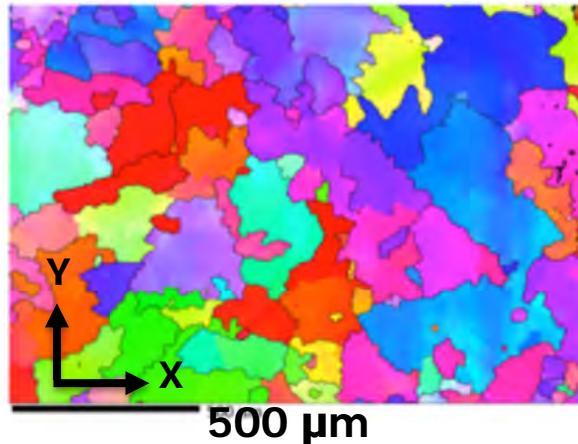
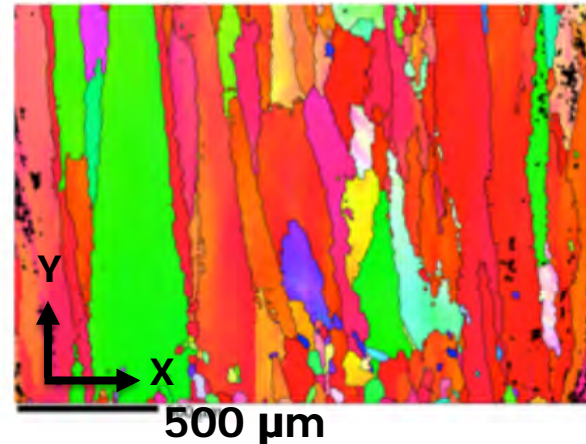
EBSD Characterizations of Weld Microstructures

CT specimen in
TS orientation

- ▶ *Elongated grains in side-view projection.*
- ▶ *Equiaxed grain shape in bottom-view projection.*
- ▶ *Overall shape is needle-like. Aspect ratio is as high as 15:1.*
- ▶ *Large, irregular shape sometimes interlocking with neighboring grains produces a challenging crack path.*

- ▶ *Hardness and tensile yield strength measurements both reveal a significant increase after cold forging, however hardness maps continued to show a strong variation across the weld (e.g., ~230-330 HV versus ~200-250 HV as welded). Hardness variations are consistent with limited EBSD strain measurements.*

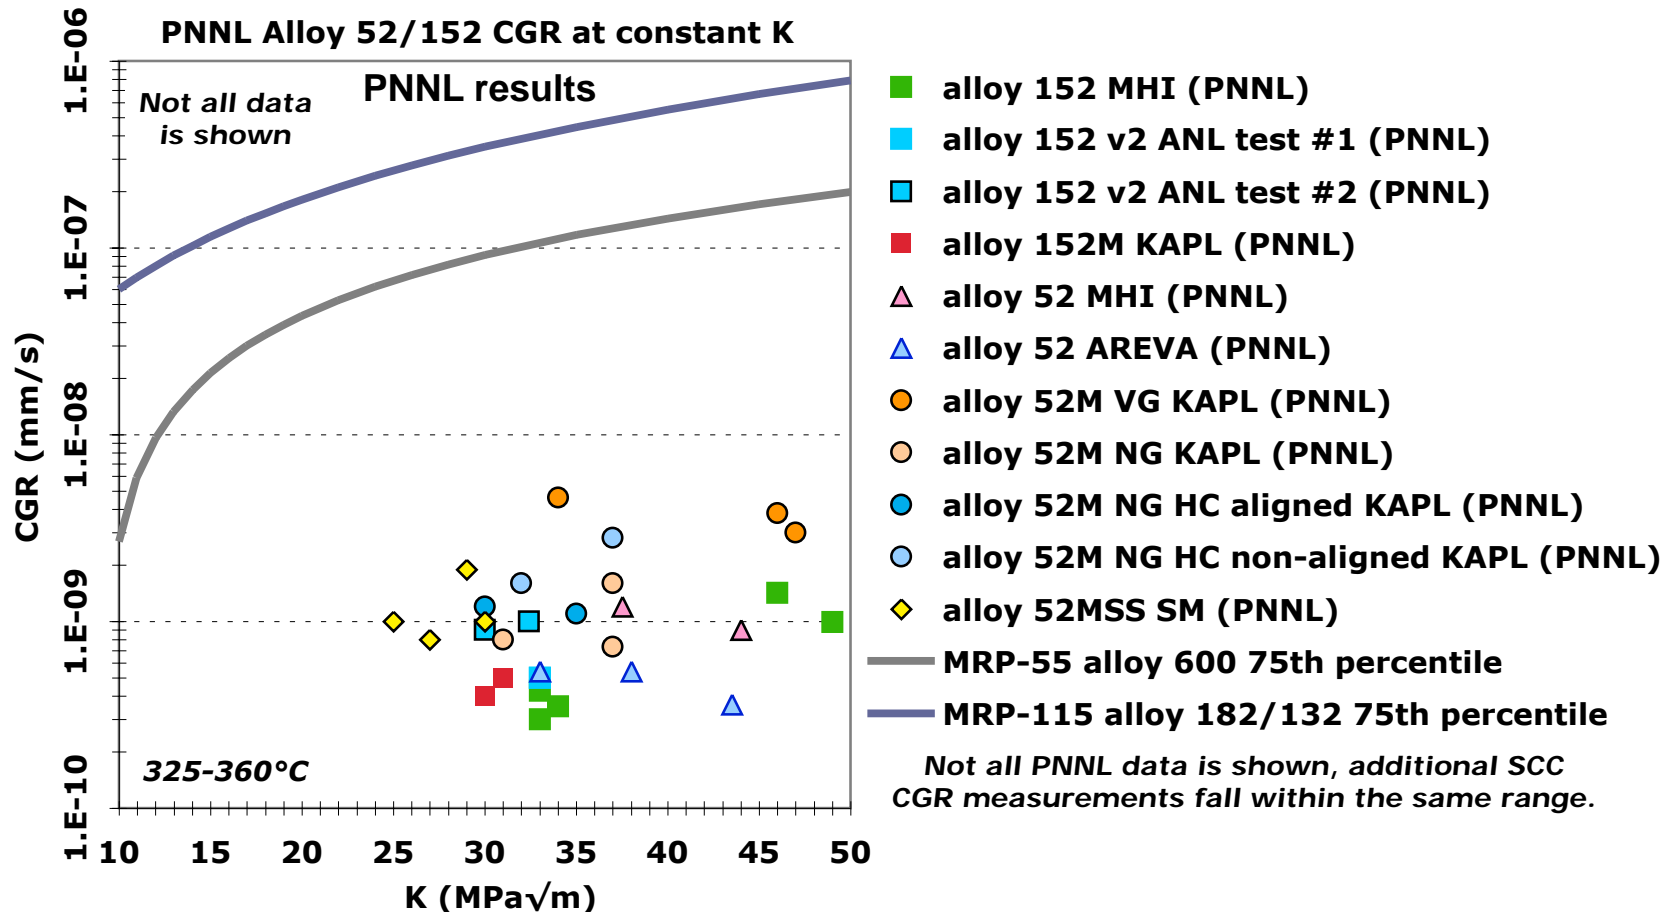
SCC Measurements on Alloy 152, 152M, 52, 52M and 52MSS Welds at PNNL

- ▶ Have completed 31 tests on 17 unique weld mockups, additional tests ongoing including cold-forged weld metal specimens.
- ▶ Sustained constant K crack growth rates (CGRs) range from $<5 \times 10^{-10}$ mm/s to $\sim 5 \times 10^{-9}$ mm/s. Range of CGRs is low (≤ 0.16 mm/year).

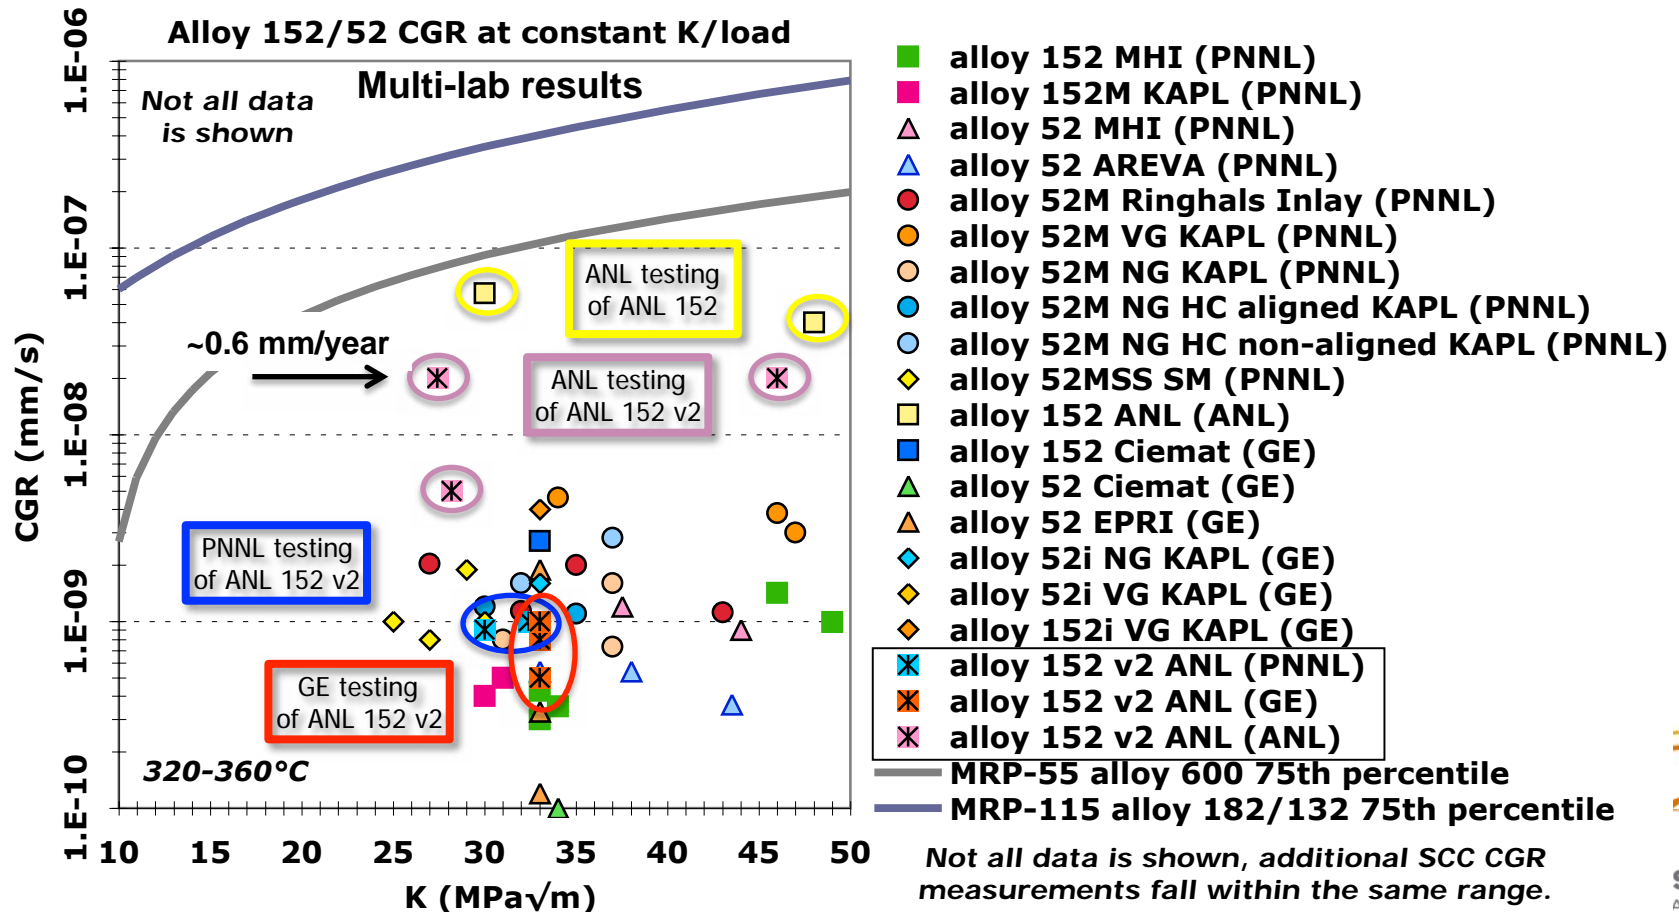
Overview of SCC Growth Measurements on Alloy 152/152M/52/52M Welds

- ▶ PNNL has observed sustained constant K crack growth rates (CGRs) ranging from $<5 \times 10^{-10}$ mm/s to $\sim 5 \times 10^{-9}$ mm/s, most $< 2 \times 10^{-9}$ mm/s.
- ▶ PNNL, ANL and GE have all tested and reported on the ANL 152v2 weldment.
- ▶ Tests by GE on this weldment match PNNL, but ANL reported higher CGRs on this weld and on their original ANL 152 weldment.

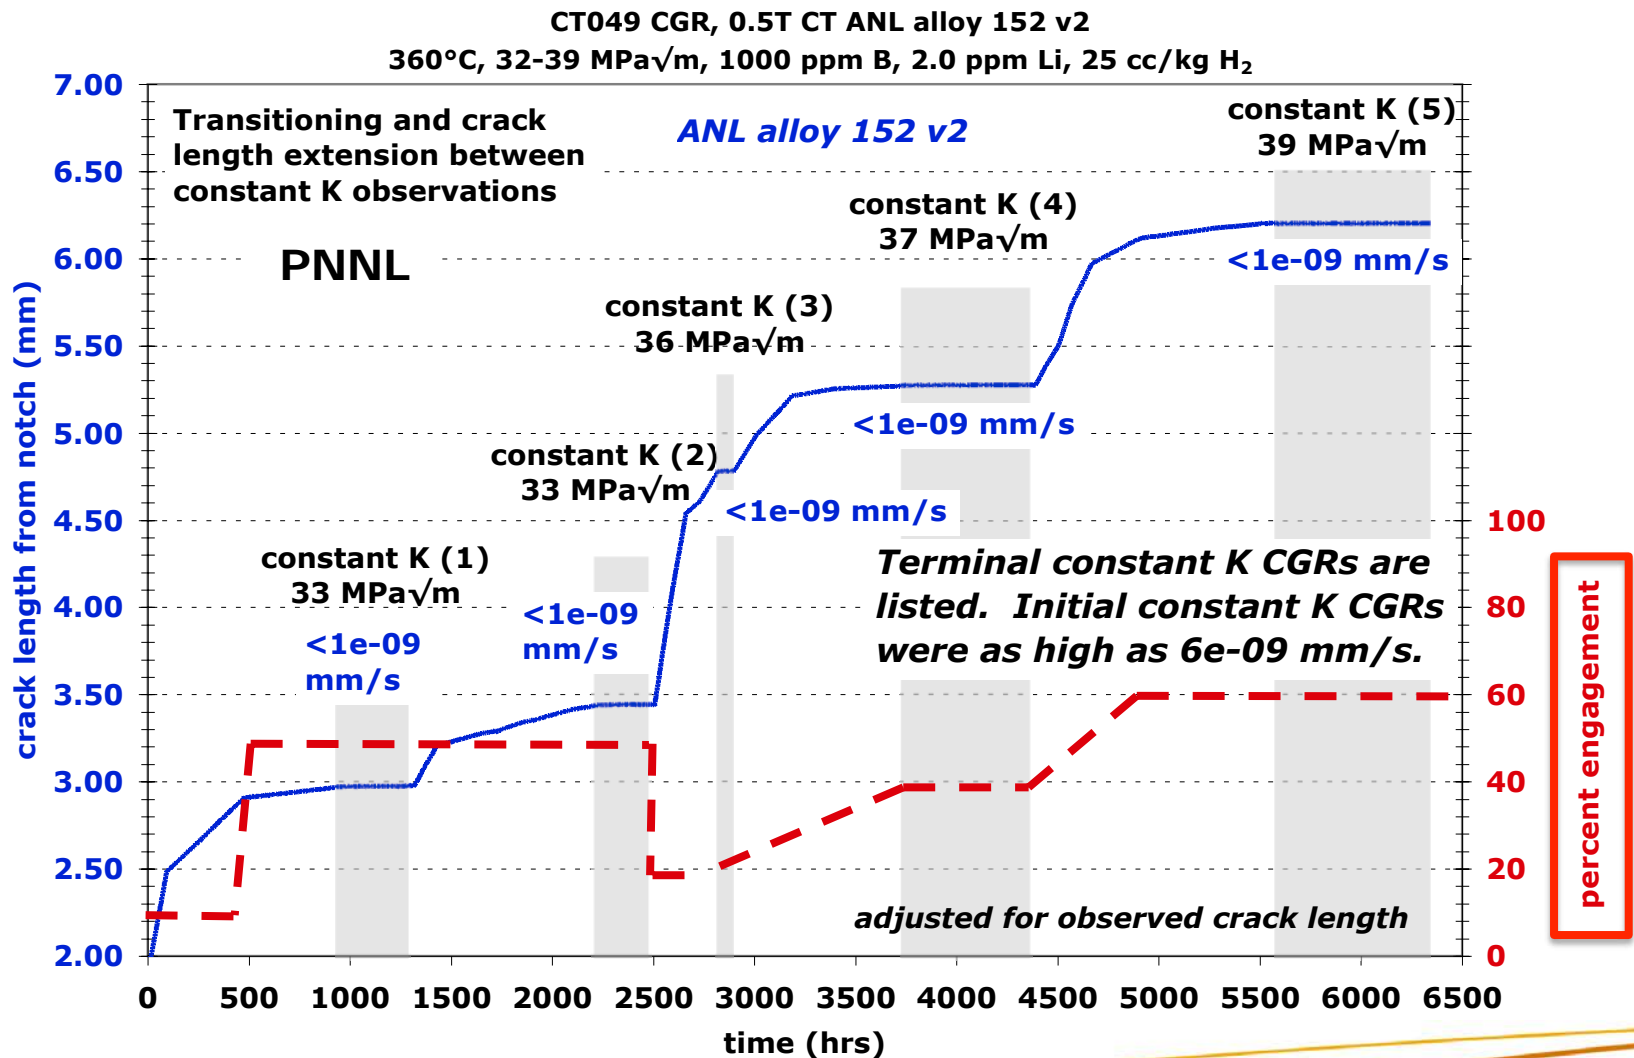
Alloy 152v2 Weldment: Tested by ANL, GEG and PNNL

High degree of IG engagement and growth during transitioning steps indicating IG crack path is favorable, but low constant K CGRs.

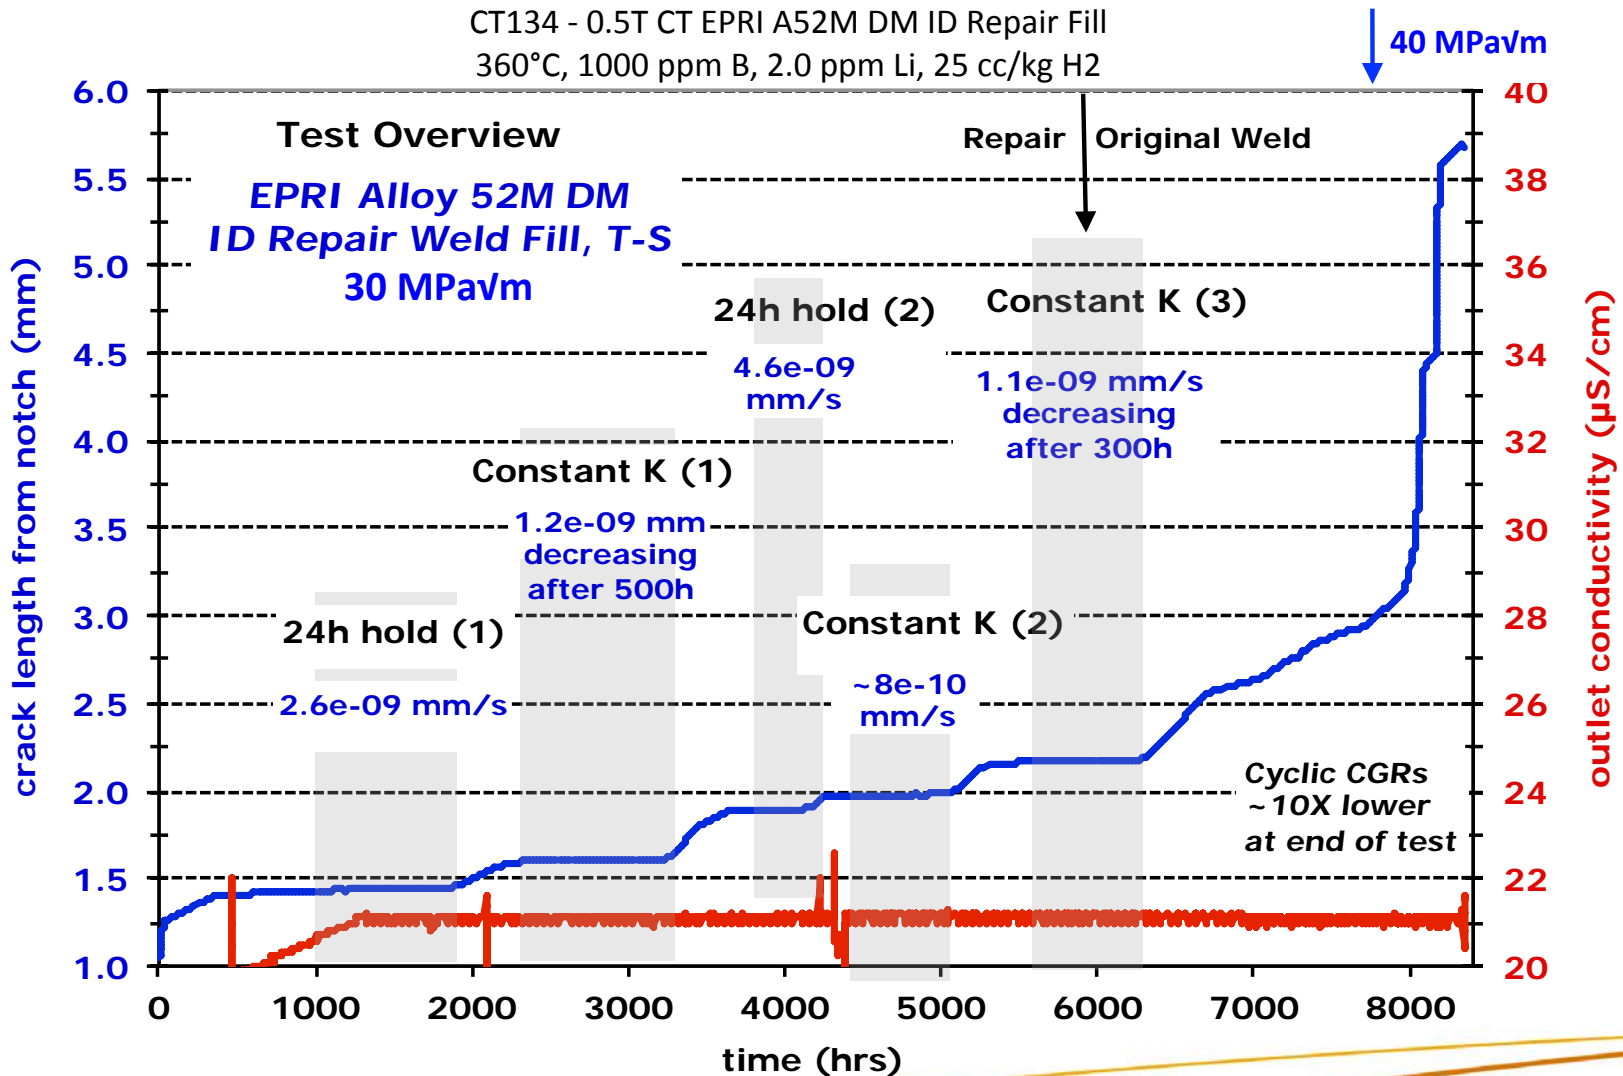
Overview of Crack-Growth Test for EPRI Repair Weld Specimen

Low crack growth rates measured at constant K (~1x10⁻⁹ mm/s) and 24h hold (~4x10⁻⁹ mm/s) in repair weld

- ▶ *Our first test has been completed on an alloy 52M weld with a 20%ID repair in a high hardness (~260 HV) weld region. Very low SCC growth rates were measured with no IG cracking suggesting no enhancement of SCC susceptibility.*

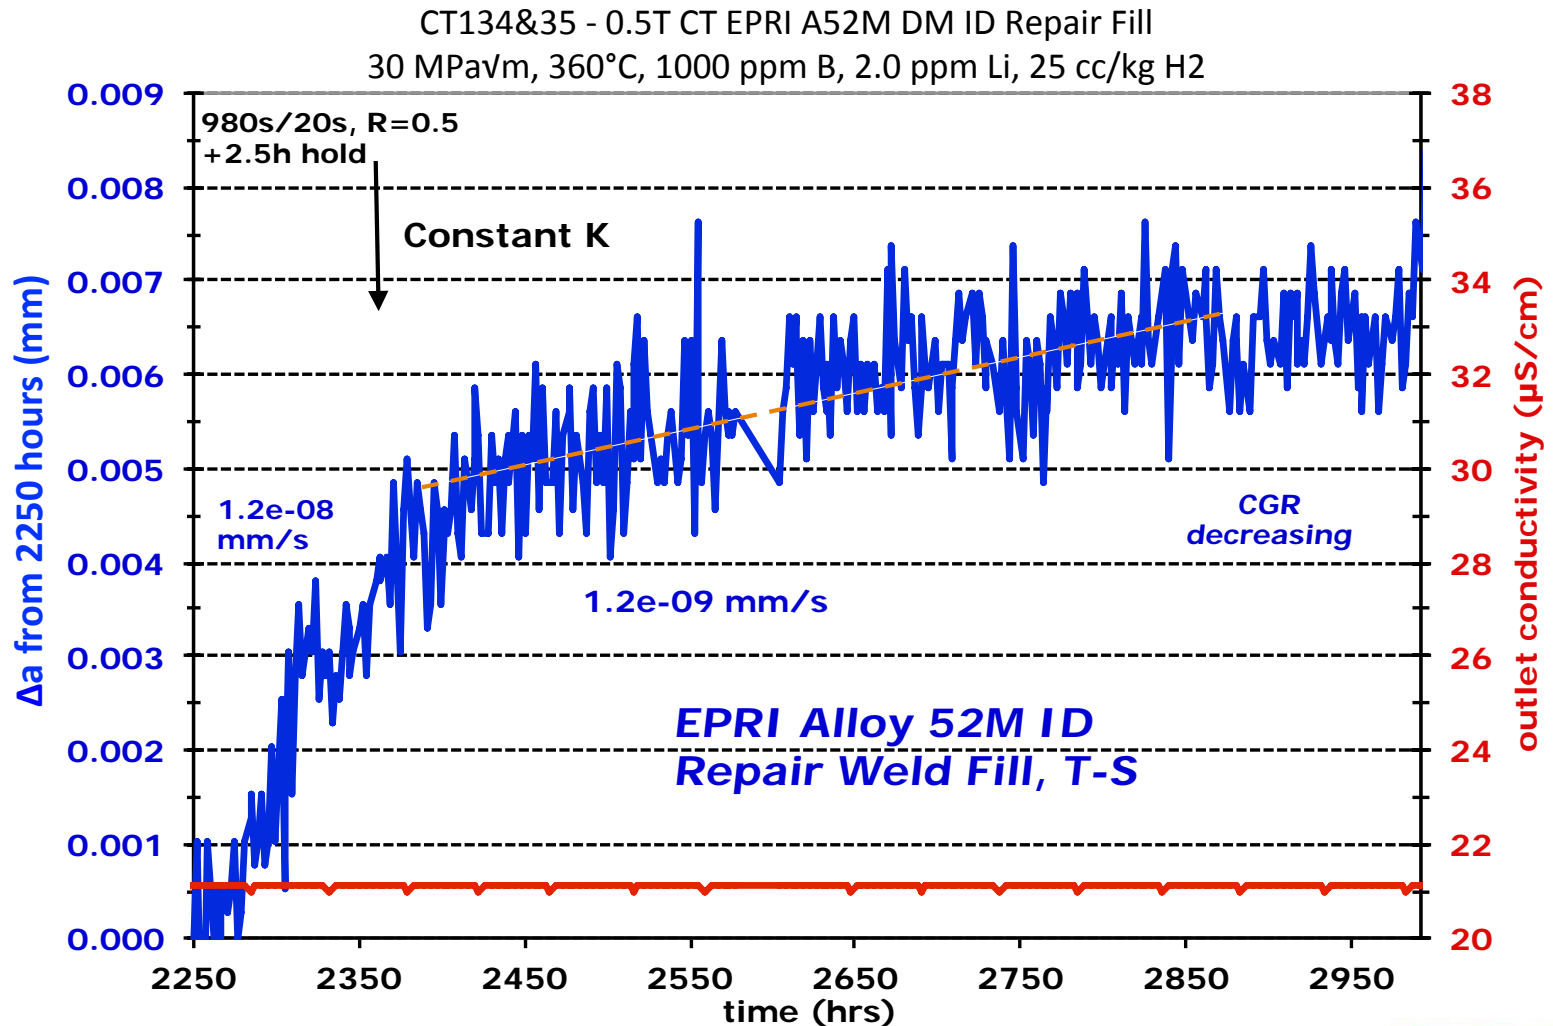
Typical SCC Growth Response for EPRI Repair Weld Specimen at Constant K

Low SCC growth rates ($\sim 1 \times 10^{-9}$ mm/s) measured that decrease after ~ 500 hours at constant K

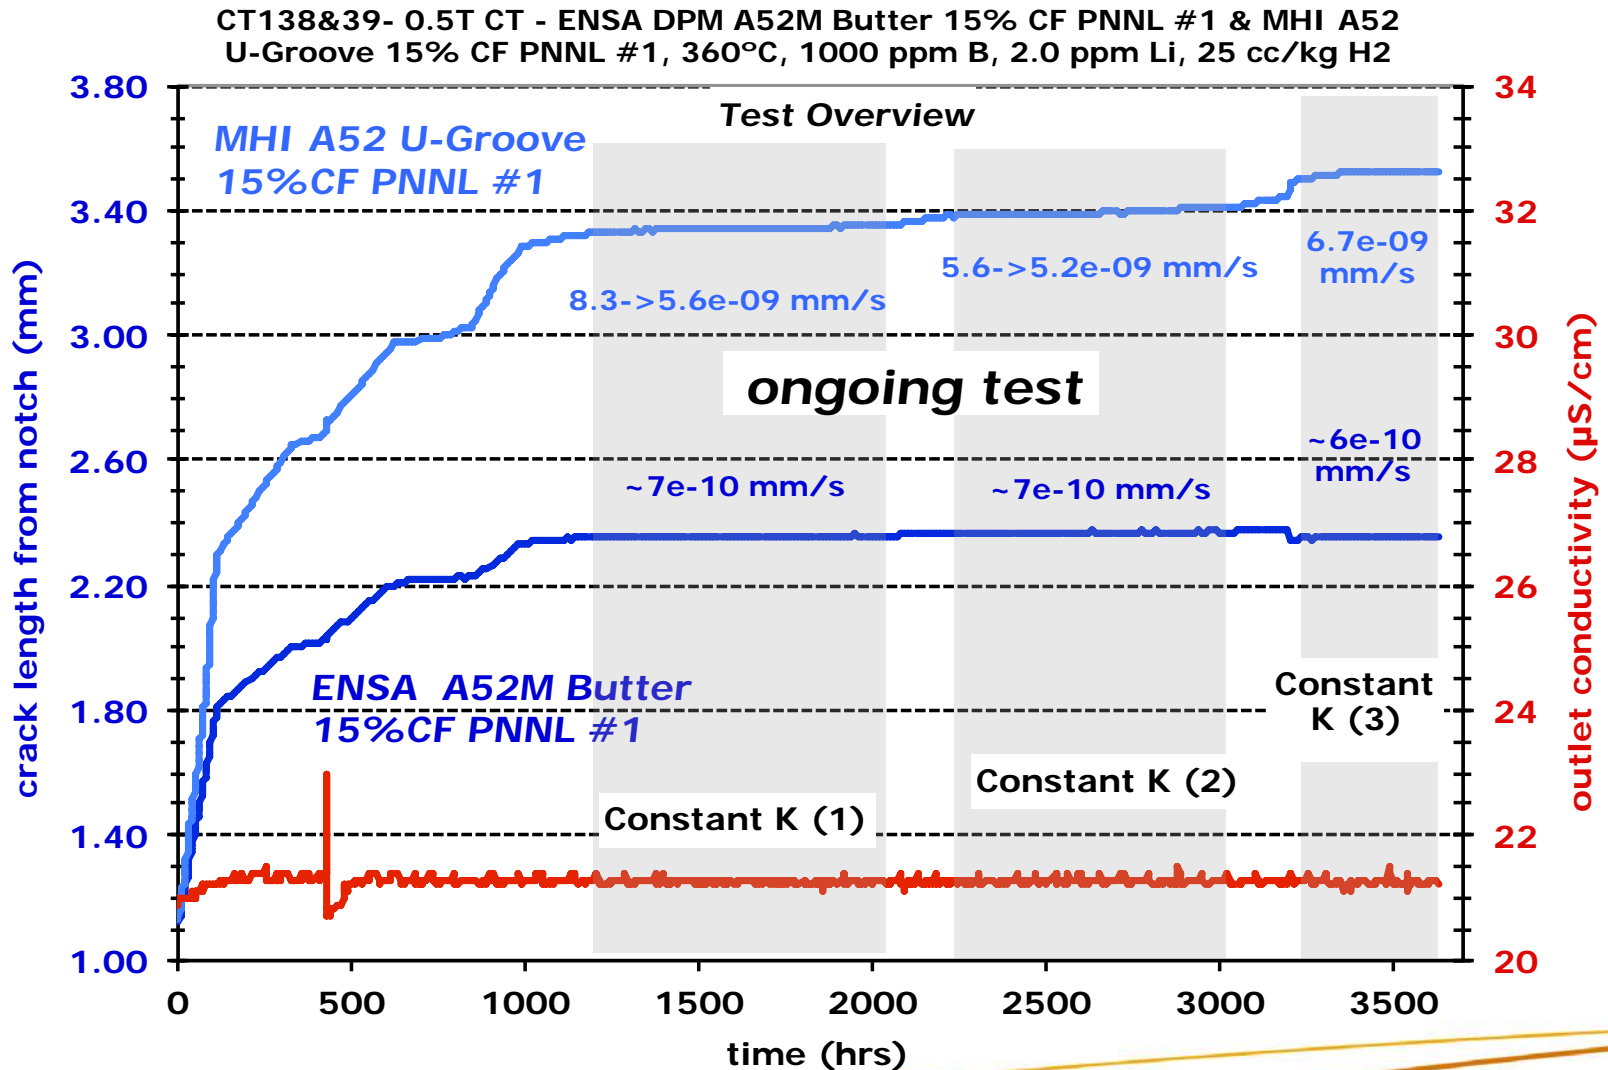
Overview of Crack-Growth Test for 15%CF Alloy 52/52M Specimens

Low-to-moderate SCC growth rates measured for 15%CF MHI ($\sim 6 \times 10^{-9}$ mm/s) and very low for 15%CF ENSA ($\sim 7 \times 10^{-10}$ mm/s)

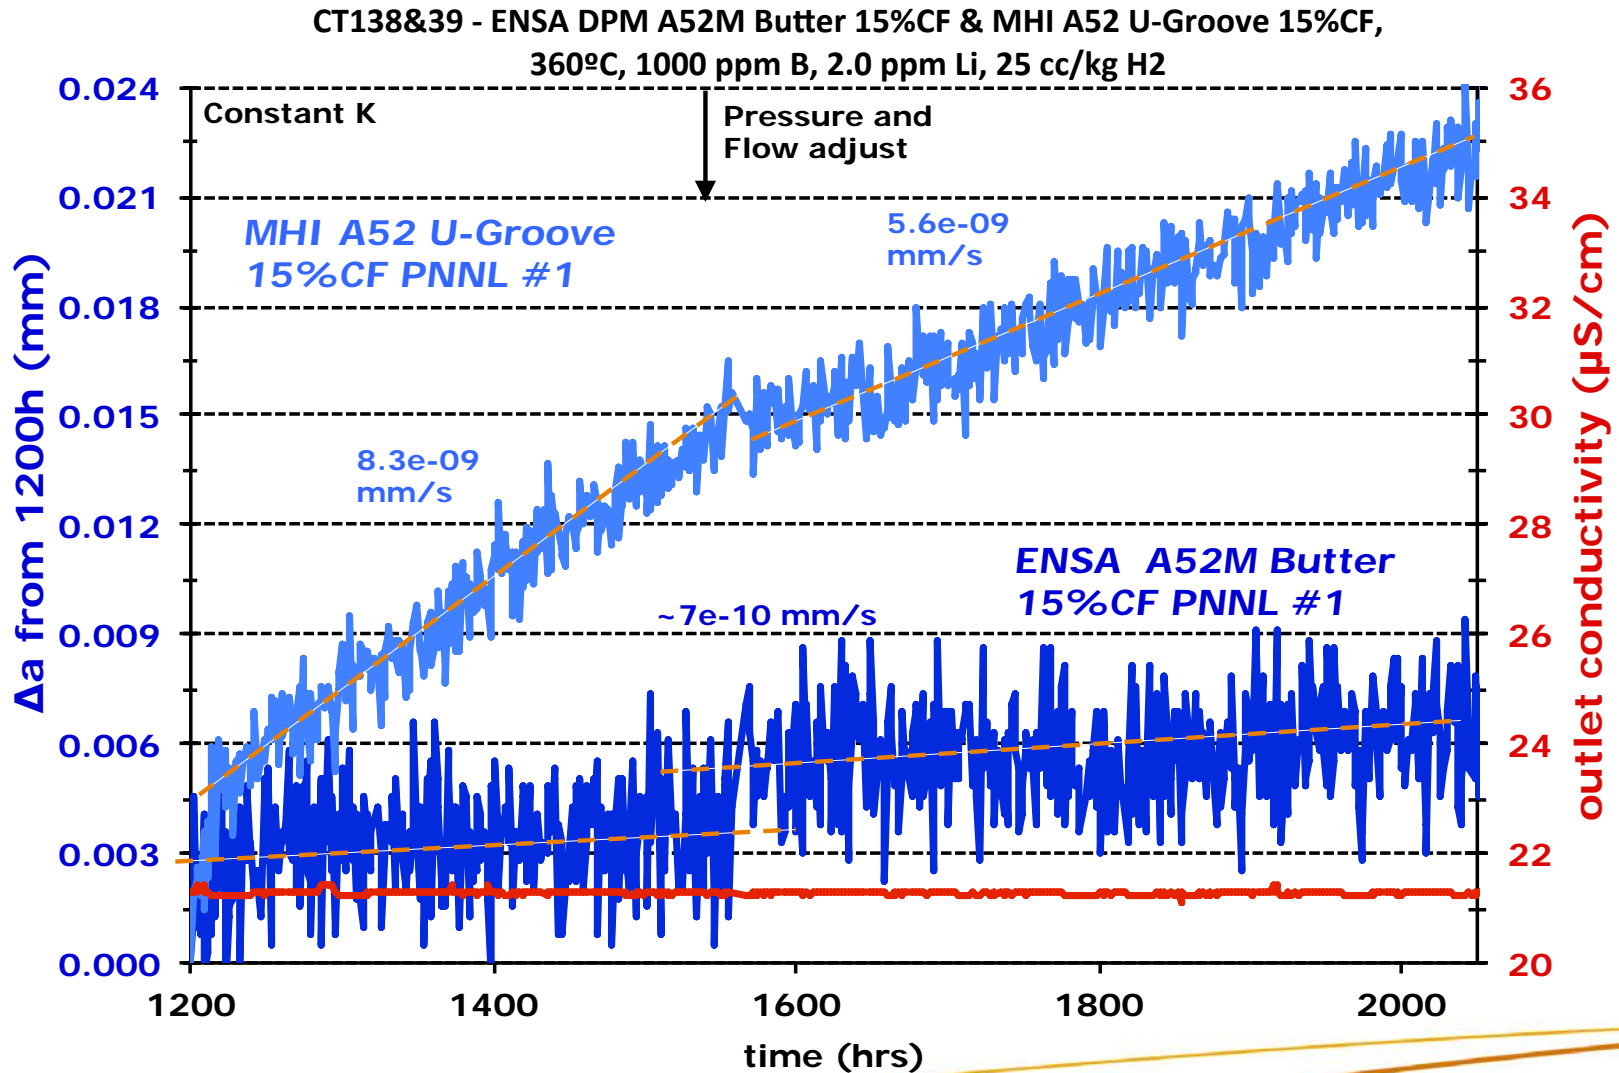
Typical SCC Growth Response for 15%CF 52M Specimens at Constant K

Some enhancement (5X) in SCC growth rates for 15%CF MHI (to $\sim 6 \times 10^{-9}$ mm/s) over as-welded, none observed for 15%CF ENSA ($\sim 7 \times 10^{-10}$ mm/s).

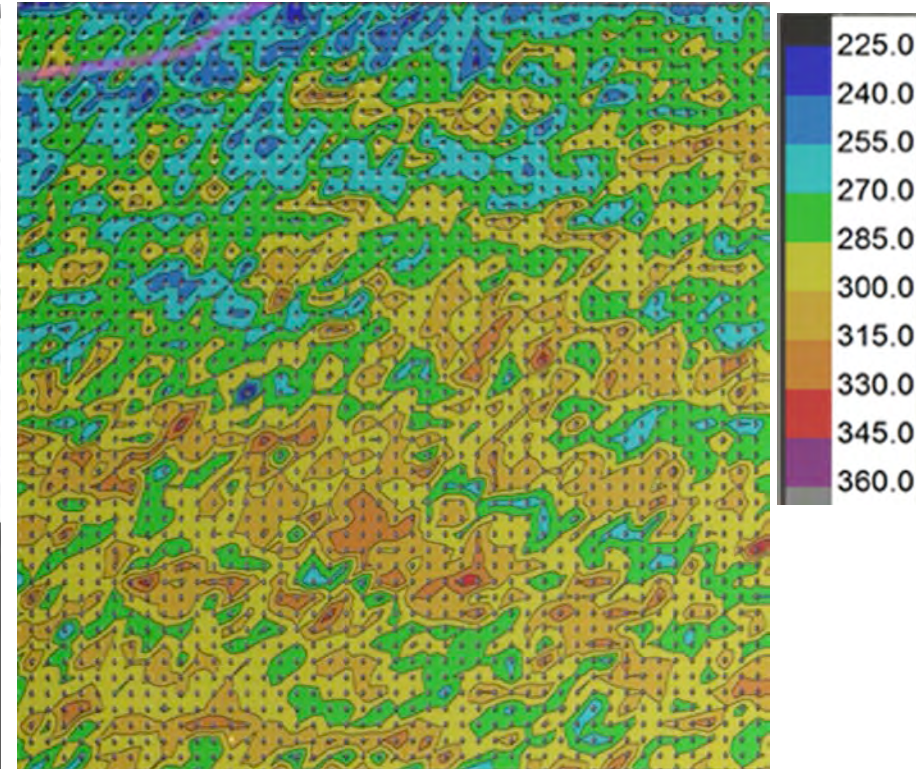
15%CF IHI Alloy 152M
Hardness Range: 230-340 HV
Est. Test Plane: ~300 HV

Cold forging increases weld metal hardness by ~25% over as-welded condition. Highest hardness near center of weld corresponding to CT crack-growth plane.

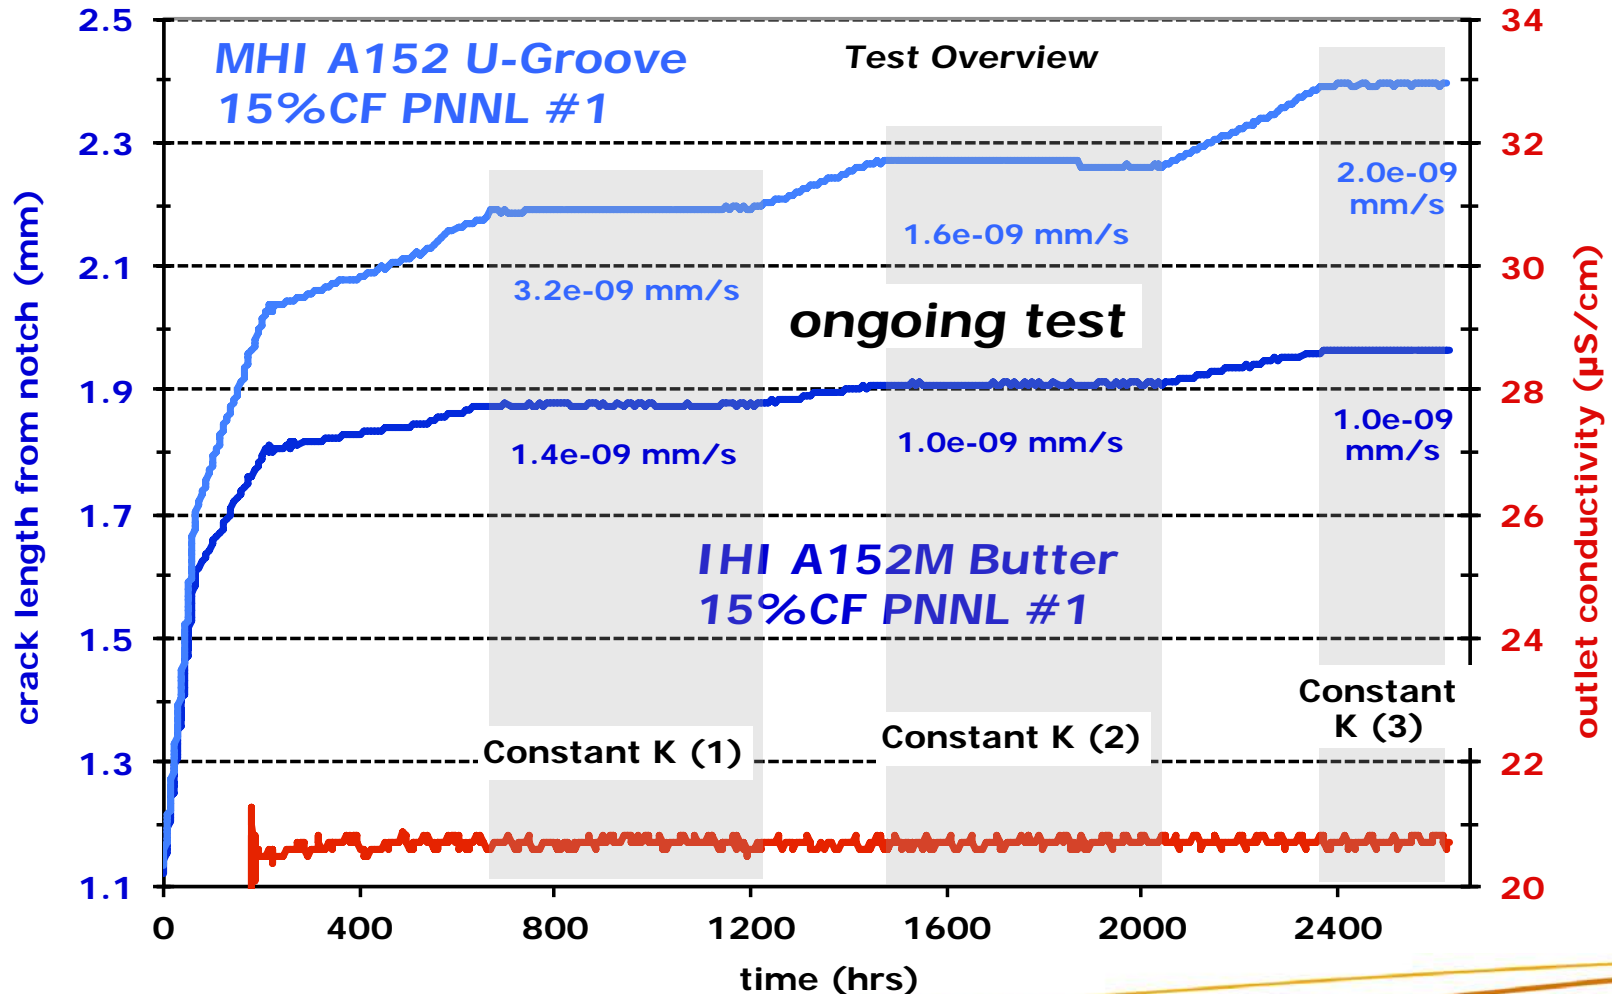
Overview of Crack-Growth Test for 15%CF Alloy 152/152M Specimens

CT140&41- 0.5T CT - IHI A152M 15% CF PNNL #1 & MHI A152 U-Groove
 15% CF PNNL #1, 360°C, 1000 ppm B, 2.0 ppm Li, 25 cc/kg H2

Low SCC growth rates measured for 15%CF MHI ($\sim 2 \times 10^{-9}$ mm/s) and 15%CF IHI ($\sim 1 \times 10^{-9}$ mm/s), no enhancement over as-welded.

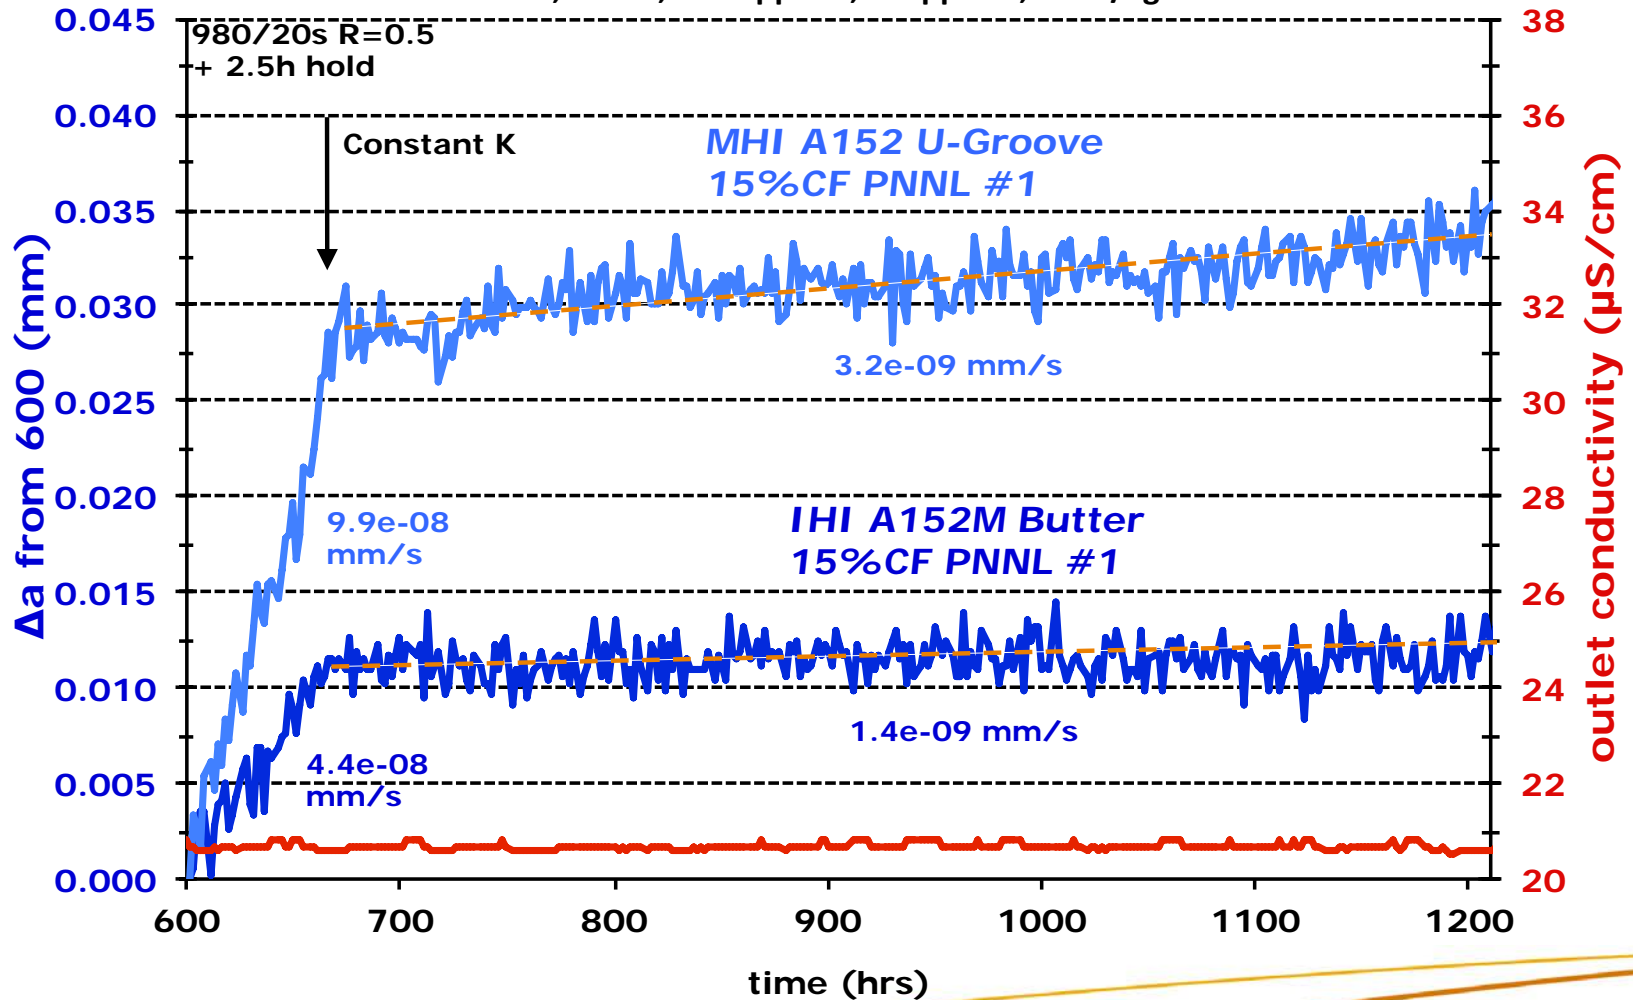
Typical SCC Growth Response for 15%CF 152/152M Specimens

CT140&41- 0.5T CT - IHI A152M 15% CF PNNL #1 & MHI A152 U-Groove 15% CF PNNL #1, 360°C, 1000 ppm B, 2.0 ppm Li, 25 cc/kg H2

Low SCC growth rates measured for 15%CF MHI (3.2×10^{-9} mm/s) and 15%CF IHI (1.4×10^{-9} mm/s)

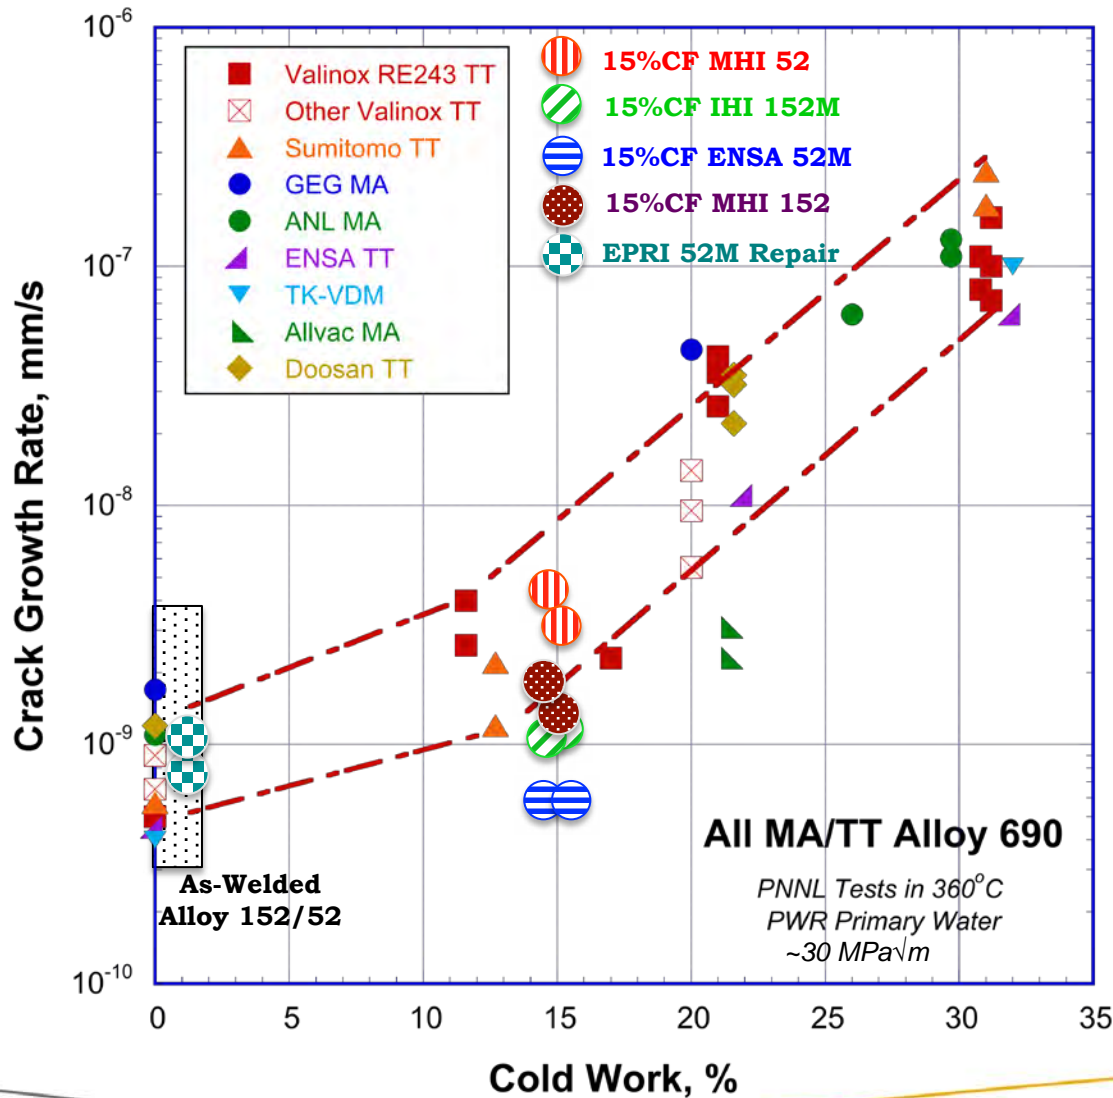
Cold Work Effects on Measured SCC Growth Rates

Consistent increase in measured SCC growth rates as a function of cold work for alloy 690 materials in the as-received MA or TT condition. Data on these alloy 690 heats suggest a transition in SCC susceptibility for materials cold worked to >15% reduction.

Preliminary results for CF alloy 52/52M/152/152M reveal SCC growth rates within the data spread for as-welded materials.

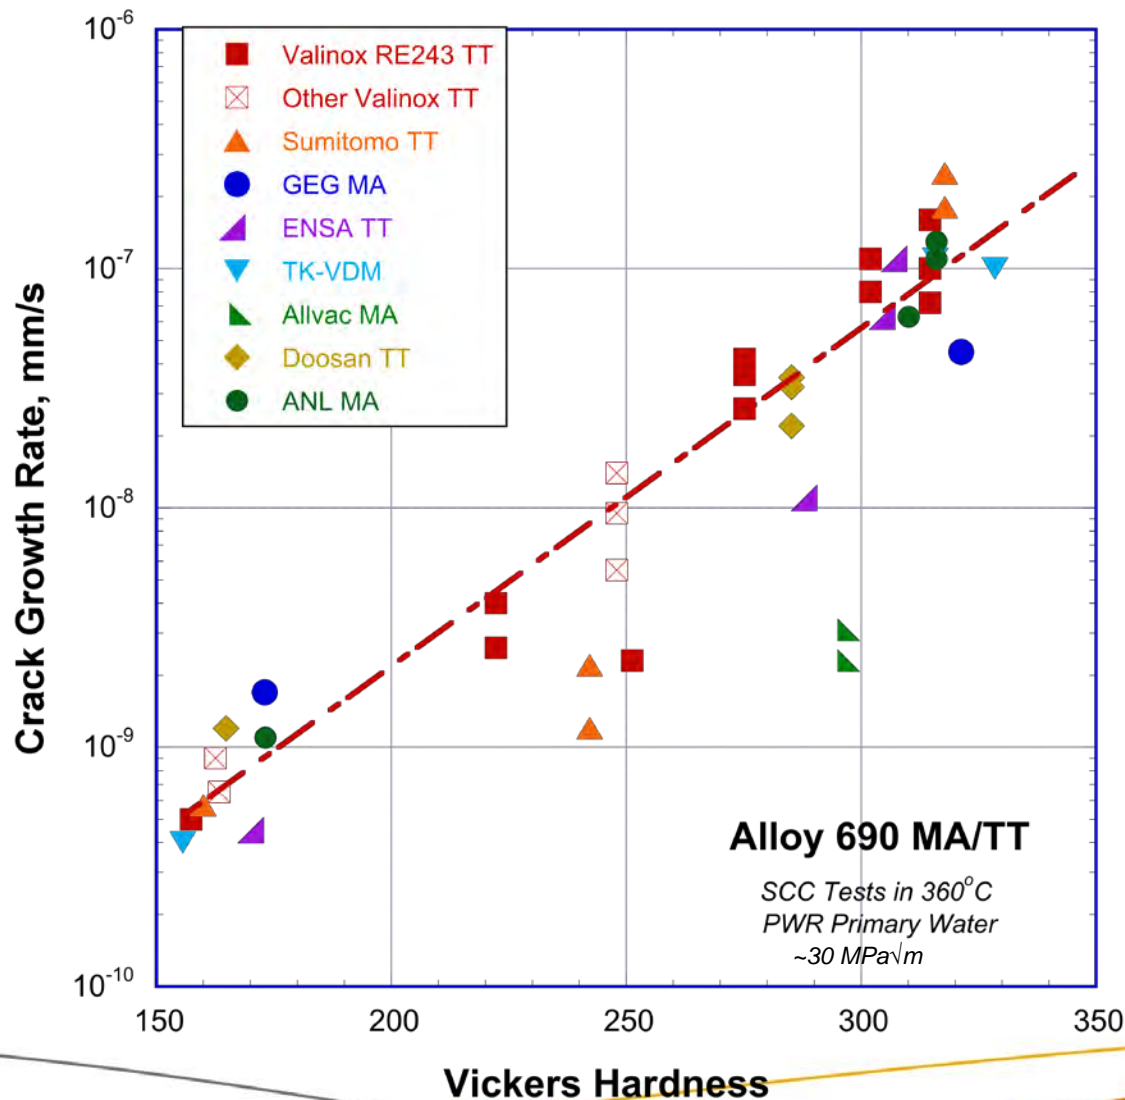
Correlation Between Hardness and SCC Growth Rates

Measured SCC rates suggest a continuous increase in susceptibility with hardness for cold-worked alloy 690 materials. Low SCC growth rates ($< \sim 10^{-8}$ mm/s) at hardness values at $< \sim 240$ HV.

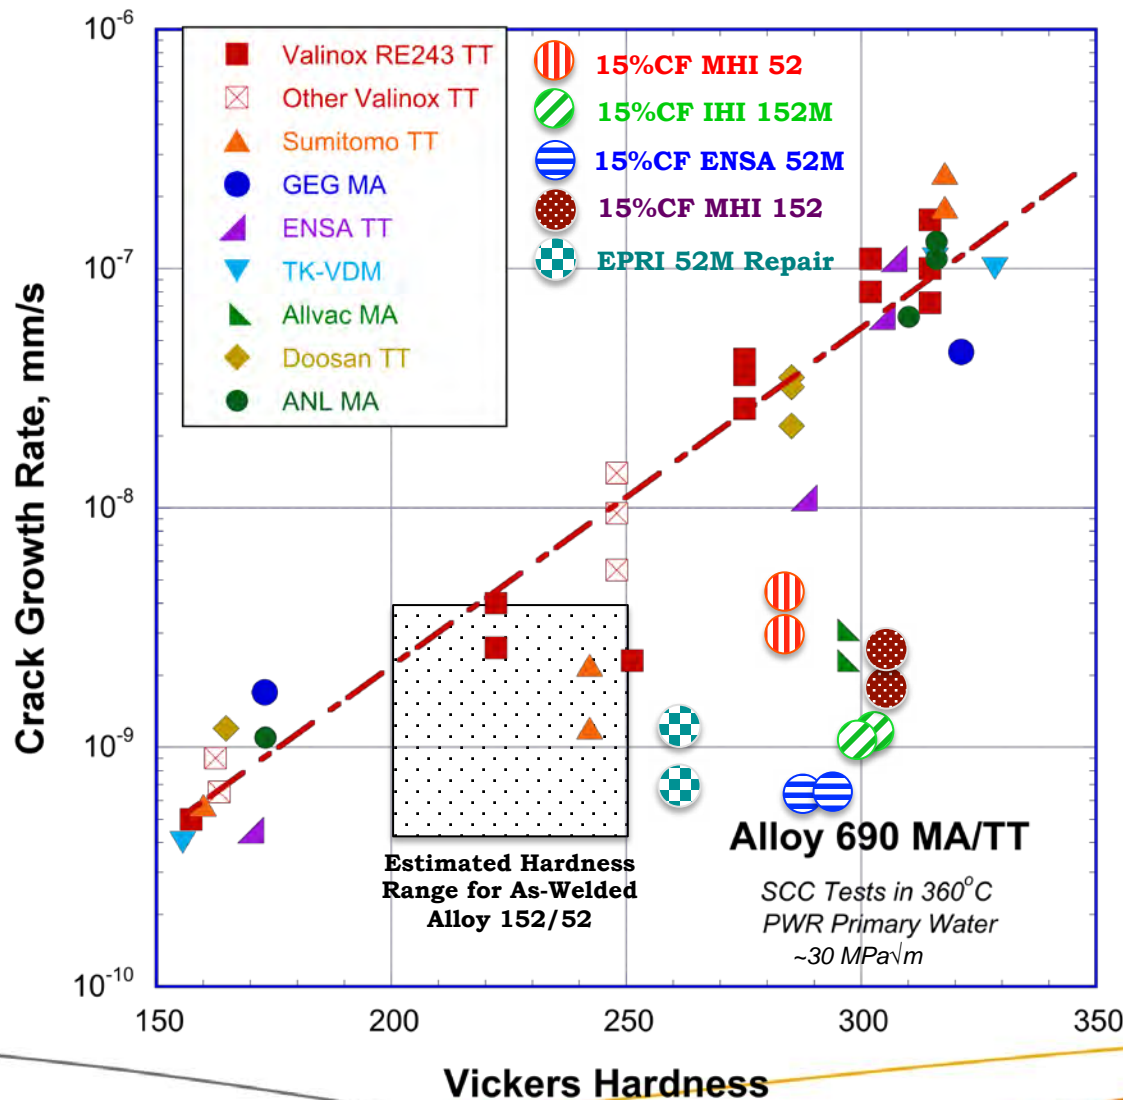
Correlation Between Hardness and SCC Growth Rates

Measured SCC rates suggest a continuous increase in susceptibility with hardness for cold-worked alloy 690 materials. Low SCC growth rates ($< \sim 10^{-8}$ mm/s) at hardness values at $< \sim 240$ HV.

Alloy 52M repair weld exhibits SCC rates of $\sim 1 \times 10^{-9}$ mm/s even though hardness level has reached ~ 260 HV.

Preliminary results on CF alloy 52/52M/152/152M welds reveal low SCC growth rates ($< \sim 6 \times 10^{-9}$ mm/s) at hardness values reaching ~ 300 HV.
