Applies To: **1999-04 Odyssey EX** – ALL
1998-02 Accord EX V6 – ALL
2001-02 Accord EX – ALL

Remote Audio Controls Do Not Work Properly (Supersedes 03-022, dated May 20, 2003)

The steering shaft resistance varies because the ground path does not have full contact through the bearing.

Dimple the copper shield on the steering column ball bearing in eight places.

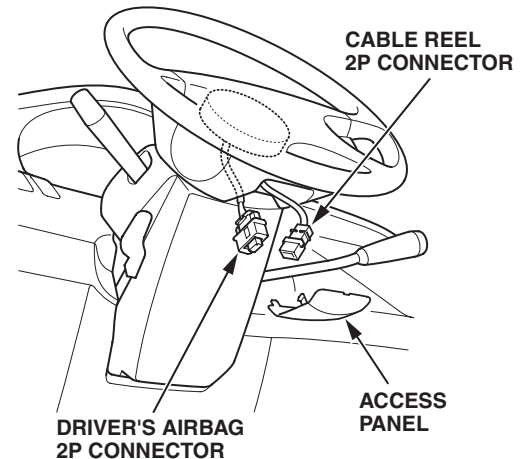
3. Remove the access panel from under the steering wheel.
4. *1999-01 models:* Unplug the cable reel 2P connector from the driver's airbag 2P connector.

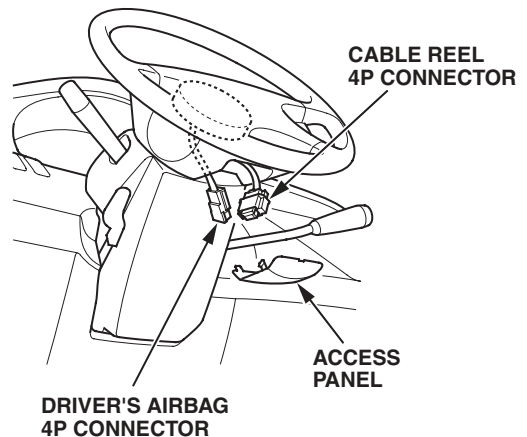
2002-04 models: Unplug the cable reel 4P connector from the driver's airbag 4P connector.

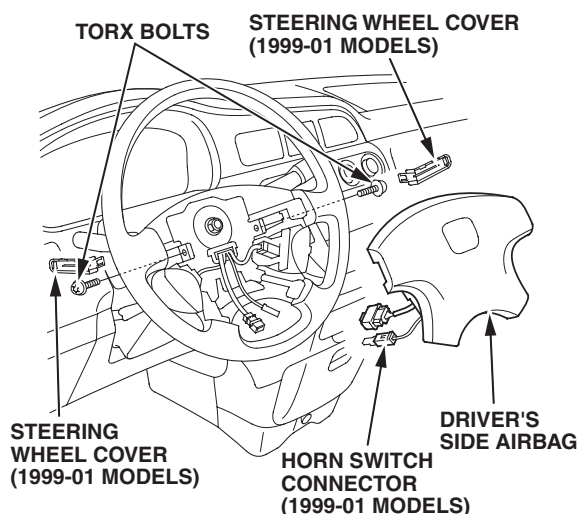
5. **1999–01 models:** Remove the two steering wheel covers. Use a Torx T30 bit to remove the two Torx bolts. Lift up the driver's airbag, disconnect the horn switch 1P connector, and remove the driver's airbag.

2002–04 models: Use a Torx T30 bit to remove the two Torx bolts. Remove the driver's airbag

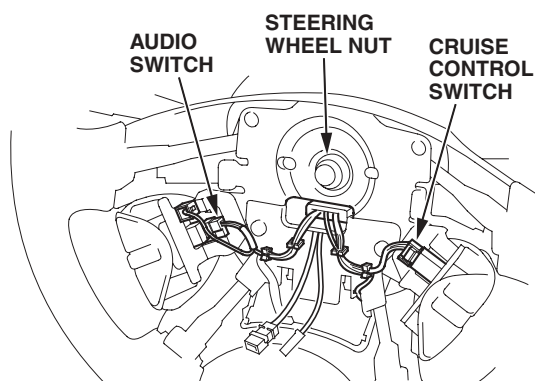
6. **1999–01 models:** Unplug the connectors from the remote audio and cruise control switches.

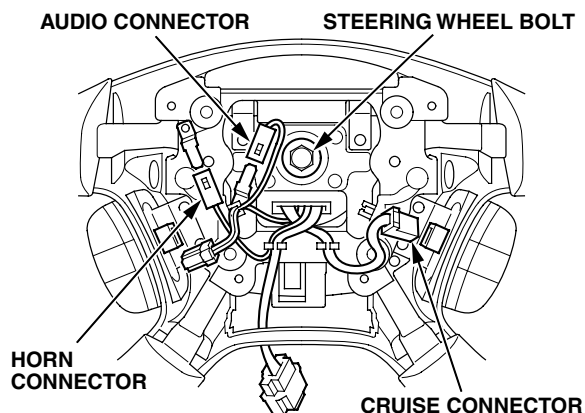
2002–04 models: Unplug the connectors from the horn, remote audio, and cruise control switches

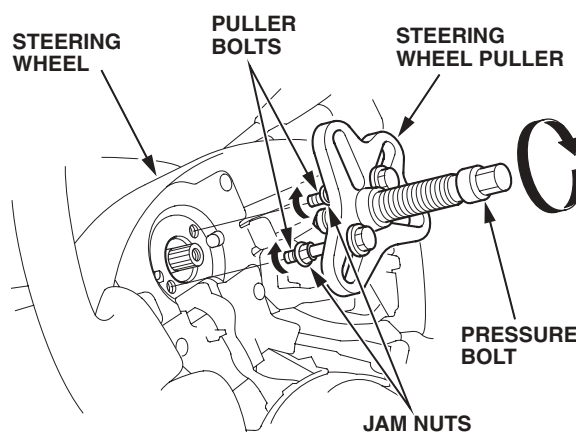
9. Using a commercially available steering wheel puller, release the steering wheel from the steering shaft. While pulling on the steering wheel, note these items:

- Do not tap on the steering wheel or the steering column shaft when removing the steering wheel.
- If you thread the puller bolts into the wheel hub more than five threads, the bolts will hit the cable reel and damage it. To prevent this, install a pair of jam nuts five threads up on each puller bolt.

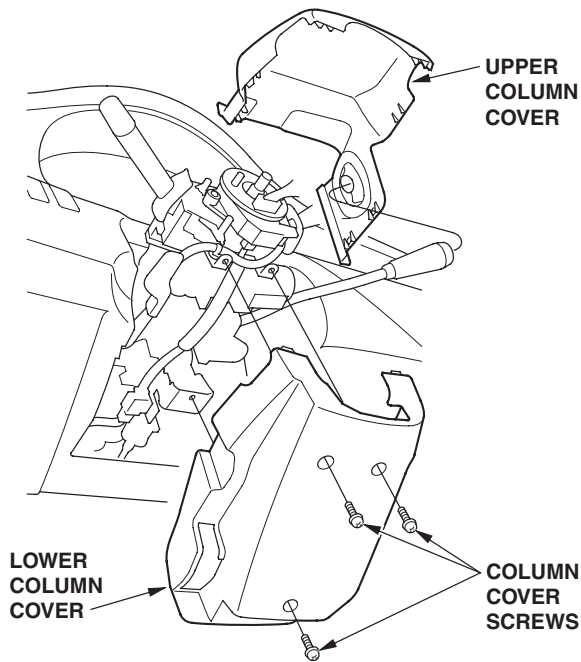
12. Remove the upper and lower steering column covers.

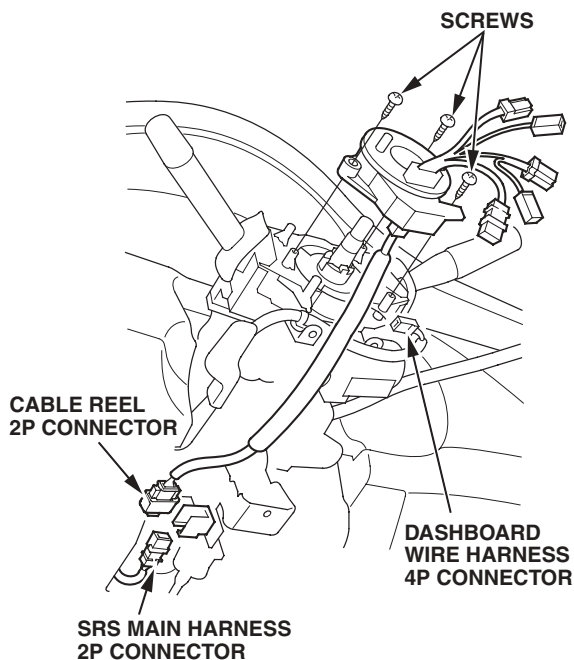
13. 1999–01 models: Unplug the SRS main harness 2P connector from the cable reel 2P connector, and then detach the dashboard wire harness 4P connector from the cable reel. Remove the screws from the cable reel, and then remove the cable reel from the column.

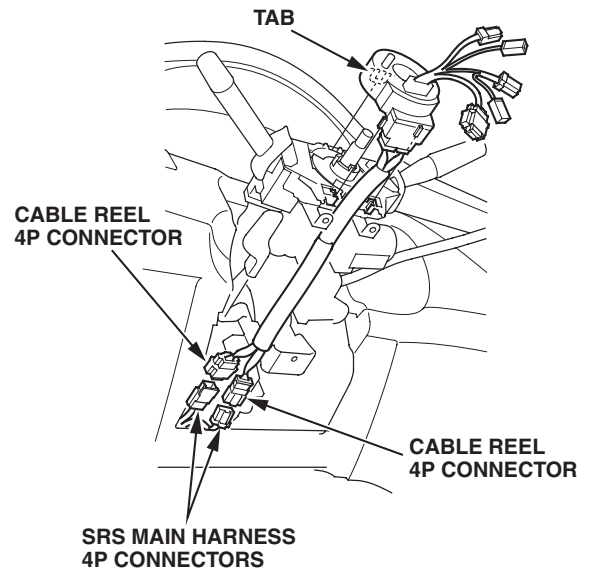
2002–04 models: Unplug the SRS main harness 4P connectors from the cable reel 4P connectors. Release the tab, and then remove the cable reel from the column.

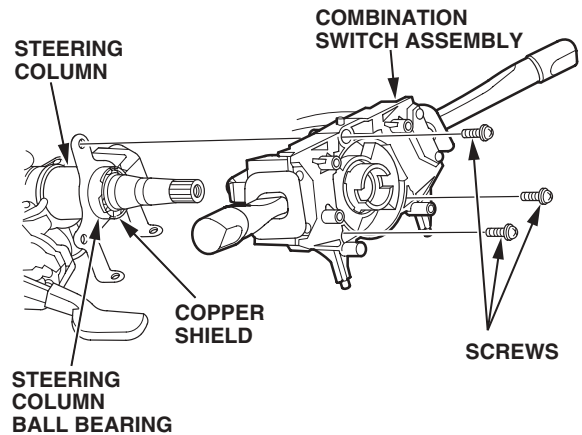
14. Unplug the combination switch 14P connector and both wiper/washer 8P connectors. Remove the three screws from the combination switch assembly, and then remove the combination switch from the steering column.

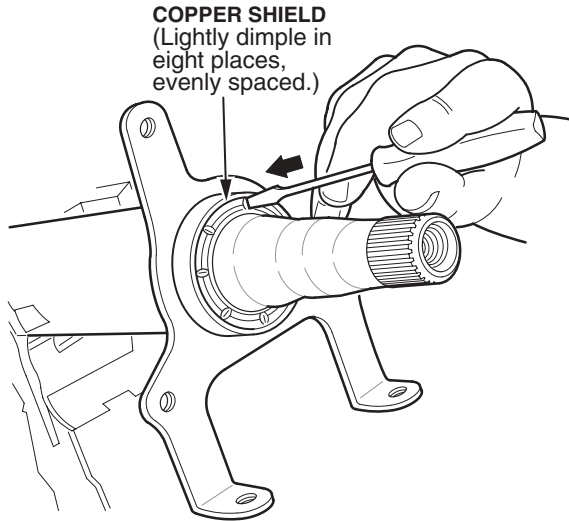
15. Use a small, flat-tipped screwdriver to lightly dimple the shield in eight places as shown.

Do not press too hard with the screwdriver when dimpling the shield. The dimples should be deep enough to catch your fingernail on. If the dimples are too deep, the steering effort will be too high and the steering column would have to be replaced.

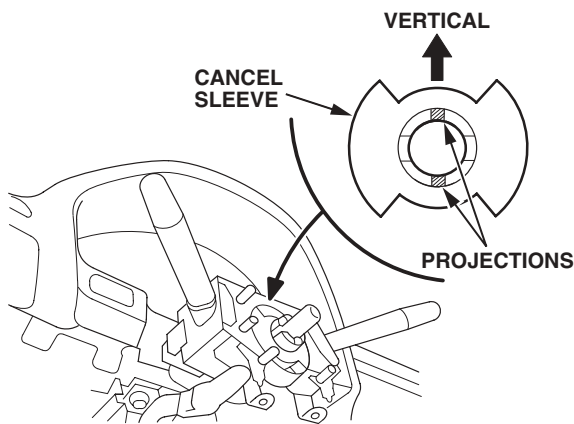
16. Reinstall the combination switch assembly, and secure it with the three original screws. Reconnect the combination switch 14P connector and both wiper/washer 8P connectors.
17. Position the cancel sleeve on the combination switch assembly so that the projections on the sleeve are aligned vertically.

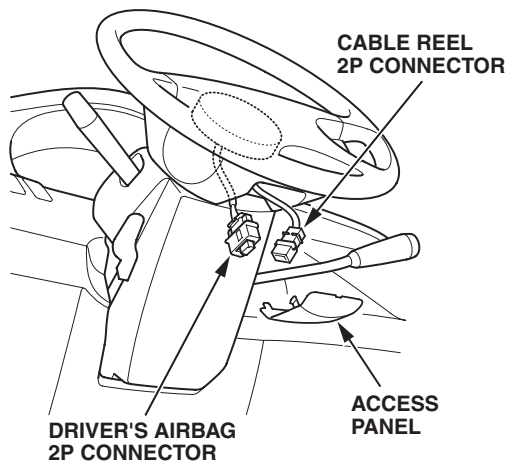
1. Make sure you have the anti-theft code for the radio. Write down your customer's radio station presets.
2. Disconnect the battery negative cable. Wait at least 3 minutes to allow the SRS control unit to discharge.
3. Remove the access panel from under the steering wheel.
4. *1998–00 models:* Unplug the cable reel 2P connector from the driver's airbag 2P connector.

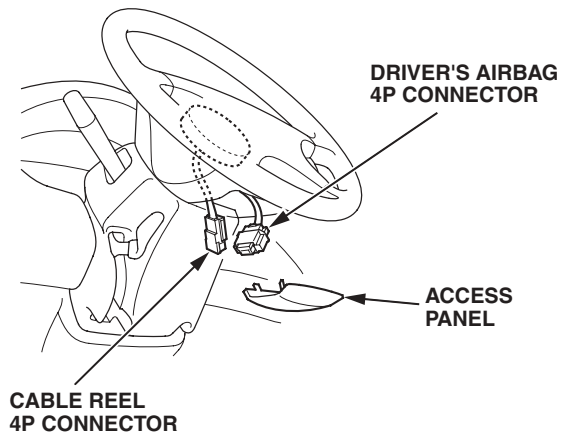
2001–02 models: Unplug the cable reel 4P connector from the driver's airbag 4P connector.

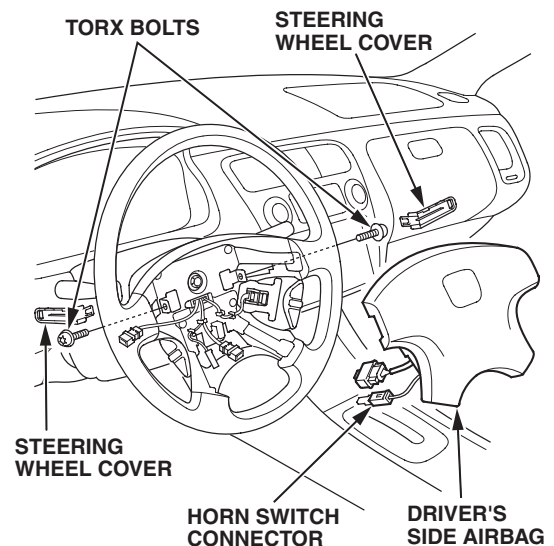
5. Remove the two steering wheel covers. Use a Torx T30 bit to remove the two Torx bolts. Remove the driver's airbag, and disconnect the horn switch 1P connector.

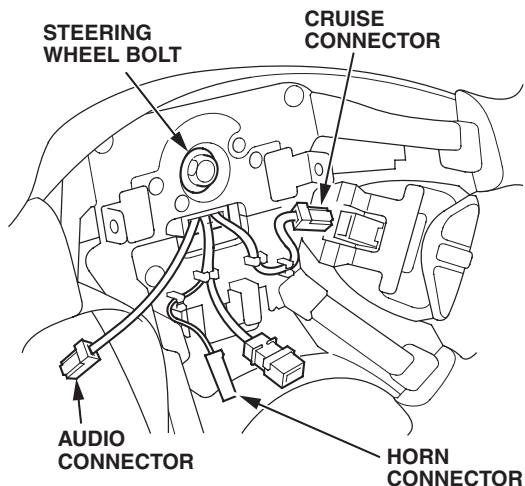
1998-00 MODELS:

6. Unplug the connectors from the remote audio and cruise control switches.

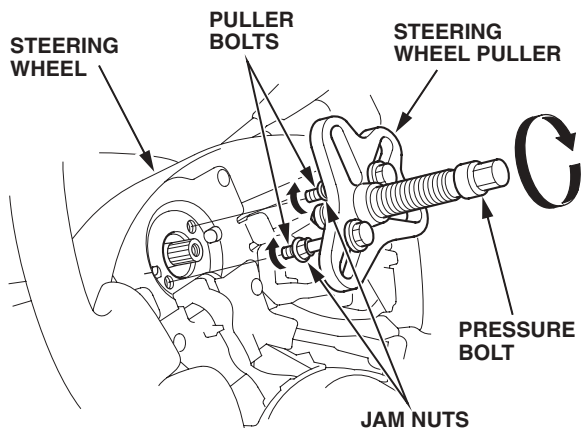
8. Loosen the steering wheel bolt. Make an alignment mark on the steering shaft with a paint strip. Using a commercially available steering wheel puller, release the steering wheel from the steering shaft.

- Do not tap on the steering wheel or the steering column shaft when removing the steering wheel.
- If you thread the puller bolts into the wheel hub more than five threads, the bolts will hit the cable reel and damage it. To prevent this, install a pair of jam nuts five threads up on each puller bolt.

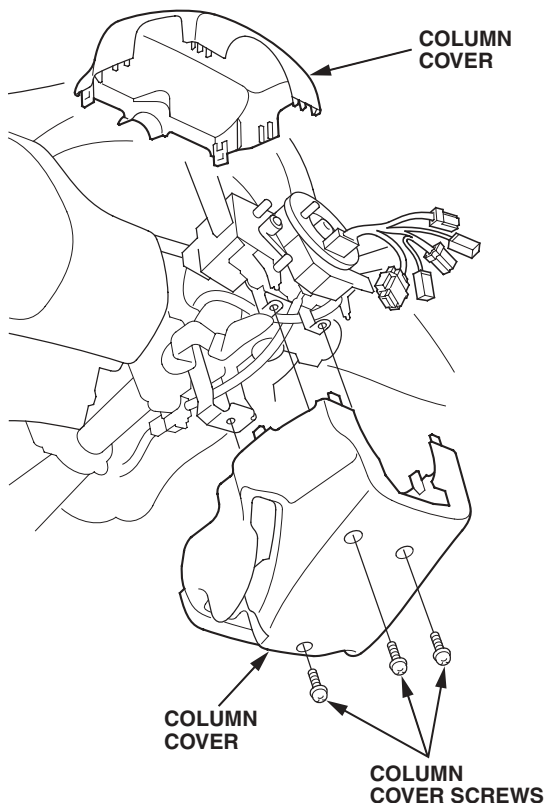
9. Remove the steering wheel puller. Remove the bolt, and then remove the steering wheel from the steering column.
10. Remove the upper and lower steering column covers.

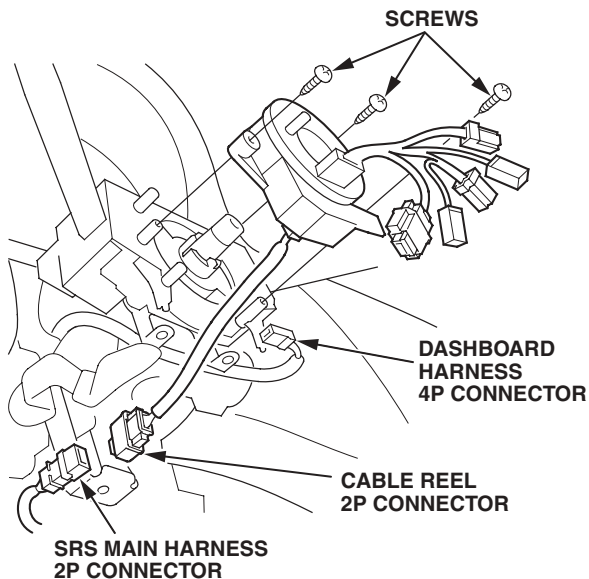
11. 1998–00 models: Unplug the SRS main harness 2P connector from the cable reel 2P connector, and then detach the dashboard wire harness 4P connector from the cable reel. Remove the screws from the cable reel, and then remove the cable reel from the column.

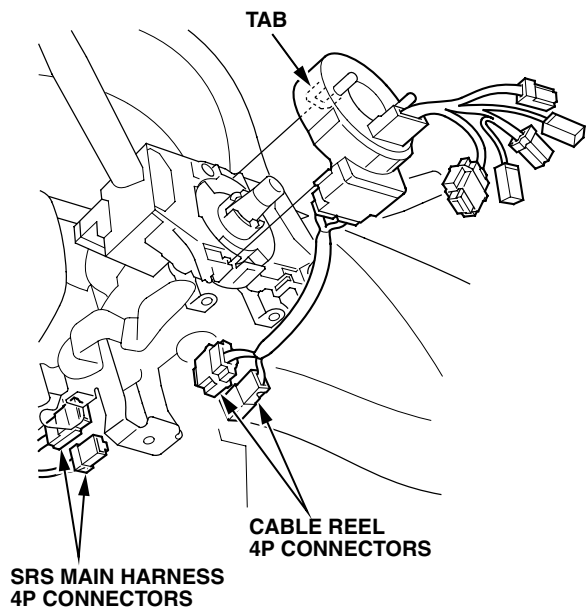
2001–02 models: Unplug the SRS main harness 4P connectors from the cable reel 4P connectors. Release the tab, and then remove the cable reel from the column.

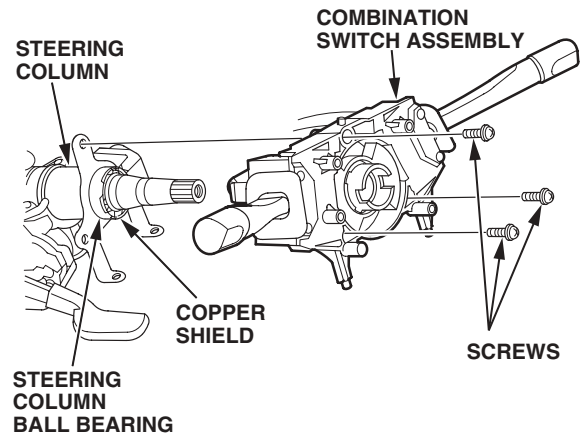
12. Unplug the combination switch 14P connector and both wiper/washer 8P connectors. Remove the three screws from the combination switch assembly, and then remove the combination switch from the steering column.

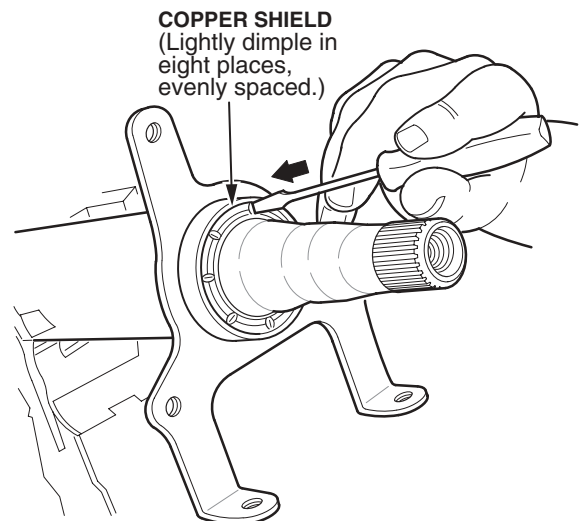
13. Use a small, flat-tipped screwdriver to lightly dimple the shield in eight places as shown.

Do not press too hard with the screwdriver when dimpling the shield. The dimples should be deep enough to catch your fingernail on. If the dimples are too deep, the steering effort will be too high, and the steering column would have to be replaced.

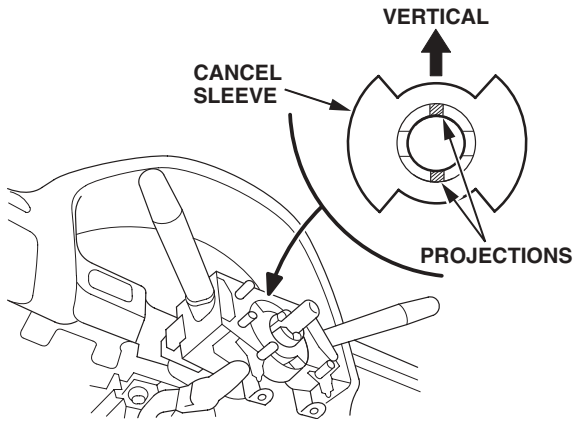
15. Position the cancel sleeve on the combination switch assembly so that the projections on the sleeve are aligned vertically.
