**SPARK PLUG REMOVAL INSTRUCTIONS - 4.6L 3V/5.4L 3V/6.8L 3V****TECHNICAL SERVICE BULLETIN**

Reference Number(s): 08-7-6, Date of Issue: April 18, 2008

FORD: 2005-2008 Mustang; 2004-2008 F-150; 2005-2008 Expedition, F-Super Duty; 2006-2008 Explorer, F-53 Motorhome Chassis; 2007-2008 Explorer Sport Trac

Some 2004-2008 F-150, 2006-2008 Mark LT, 2005-2008 F-Super Duty, Expedition, and Navigator, with 5.4L 3-V engine; 2005-2008 Mustang, 2006-2008 Explorer, Mountaineer, and 2007-2008 Explorer Sport Trac with 4.6L 3-V engine; 2005-2008 F-Super Duty, 2006-2008 and F-Stripped Chassis, with 6.8L 3-V engine may experience difficulty with spark plug removal. This may cause damage to the spark plug and leave part of the spark plug in the cylinder head. Affected engine build dates are as follows: 5.4L 3-V and 6.8L 3-V before 10/9/07, 4.6L 3-V before 11/30/07.

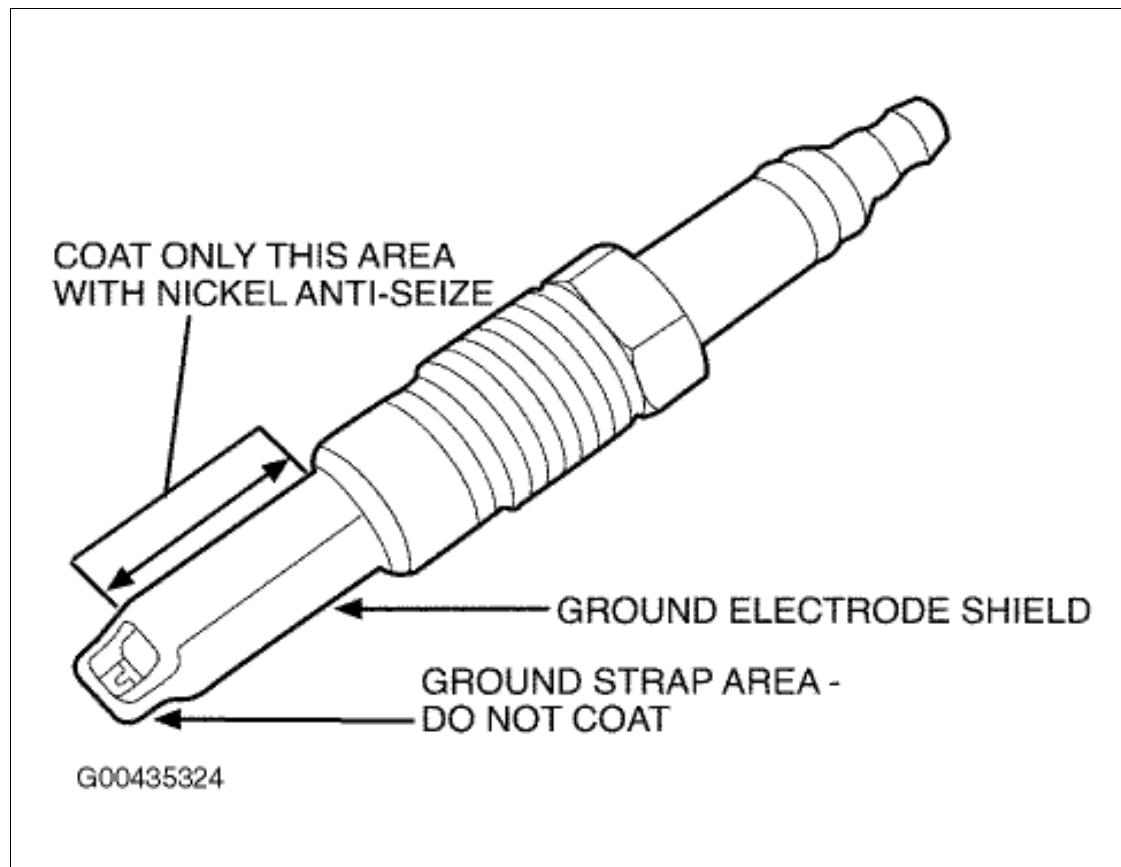
Fig 1: Anti-Seize Lubricant Application To Ground Electrode Shield

**📌 NOTE: NEW PLUGS SHOULD BE INSTALLED USING A FILM COATING OF MOTORCRAFT® HIGH TEMPERATURE NICKEL ANTI-SEIZE LUBRICANT ON THE GROUND ELECTRODE SHIELD. DO NOT COAT THE ELECTRODE STRAP. (Fig 1)**

**NOTE: NEW PLUGS SHOULD BE INSTALLED USING A FILM COATING OF MOTORCRAFT® HIGH TEMPERATURE NICKEL ANTI-SEIZE LUBRICANT ON THE GROUND ELECTRODE SHIELD. DO NOT COAT**

**📌 NOTE: NEW PLUGS SHOULD BE INSTALLED USING A FILM COATING OF MOTORCRAFT® HIGH TEMPERATURE NICKEL ANTI-SEIZE LUBRICANT ON THE GROUND ELECTRODE SHIELD. DO NOT COAT THE ELECTRODE STRAP. (Fig 1)**

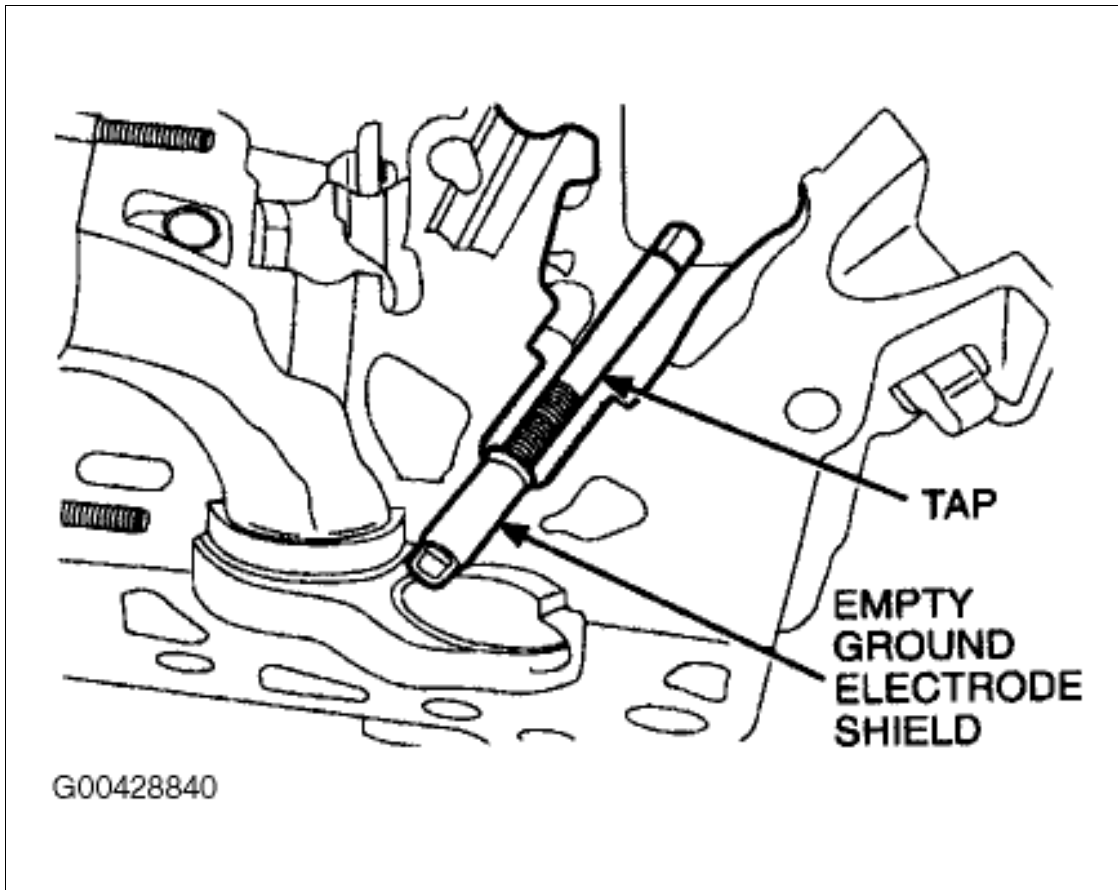
Fig 2: Ground Electrode Shield Left Behind As Empty Shell

- a. Mode 1: The ground electrode shield is left behind as an empty shell. (Fig 2)

Use Rotunda special service tool 303-1203 to remove an empty ground electrode shield from the cylinder head. (Fig 6)

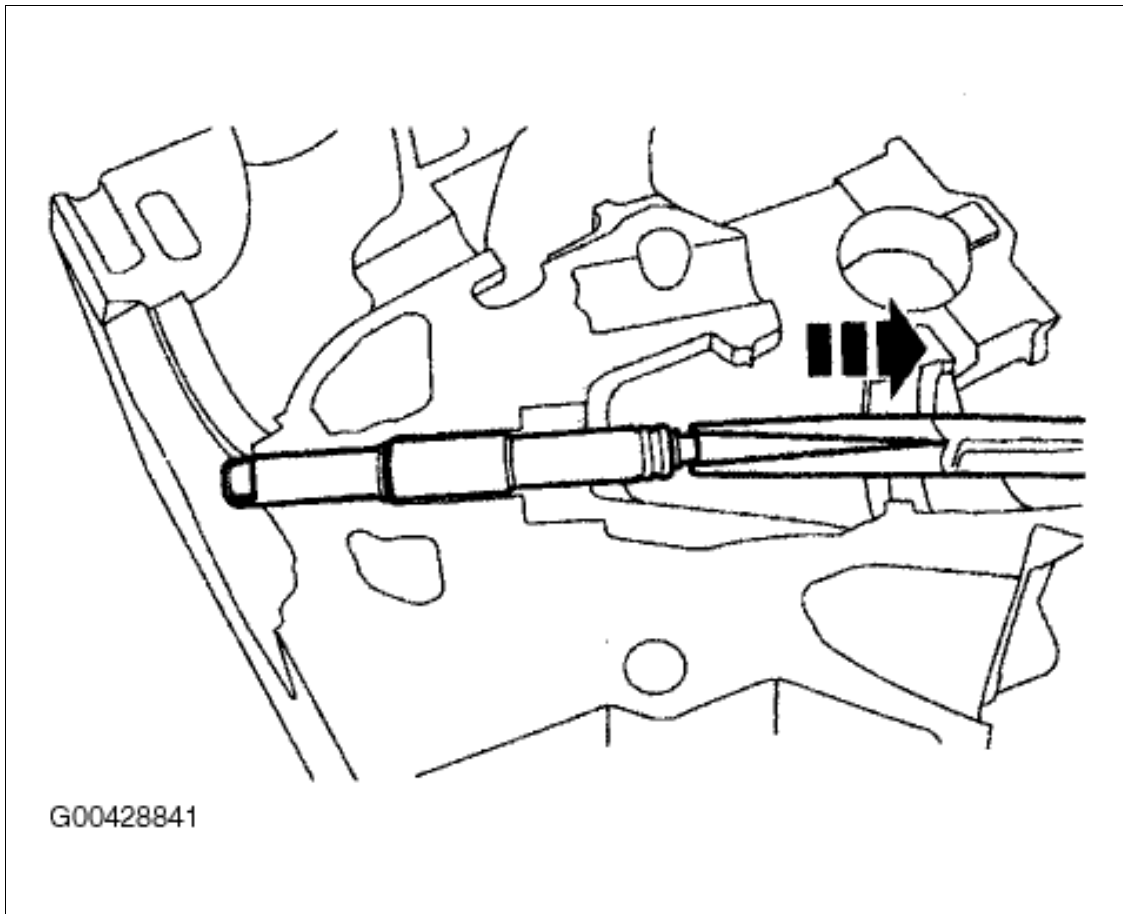
Fig 3: Entire Porcelain Insulator And Ground Electrode Shield Remains In Cylinder Head

- b. Mode 2: The entire porcelain insulator and ground electrode shield remains in the cylinder head. (Fig 3)

1. Add an additional 1/2 teaspoon Motorcraft® Carburetor Tune-Up Cleaner fluid into spark plug well and allow 15 minutes of soak time.
2. Using long-reach nose pliers grasp and remove the porcelain with an up and down motion taking care not to fracture the porcelain.
3. Refer to Mode 1 Procedure to remove the remaining ground electrode shield from the cylinder head.

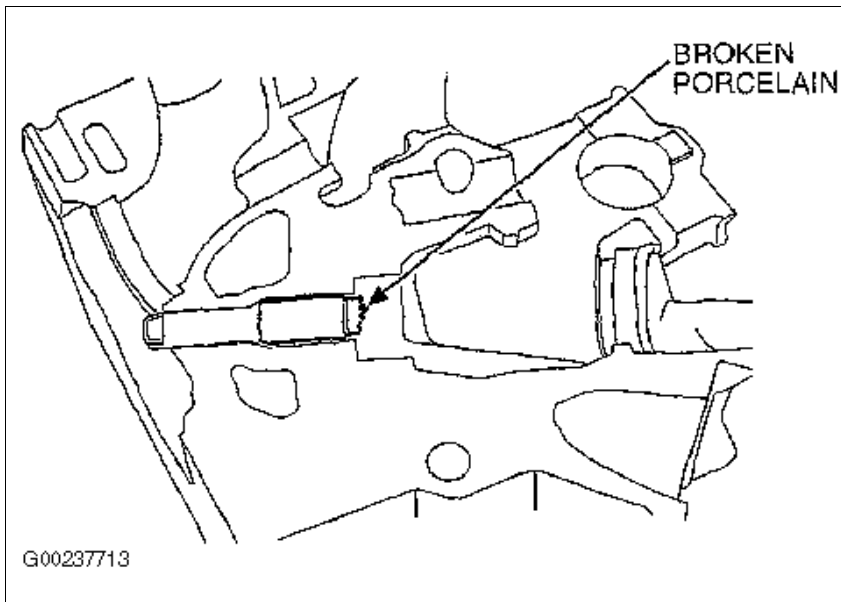
Fig 4: Broken Porcelain Remains In Cylinder Head

c. Mode 3: The upper section of porcelain broke off with remaining porcelain left inside the ground shield. (Fig 4)

Use Rotunda special service tool kit 303-1398 to remove porcelain broken inside the ground electrode shield. (Fig 10)

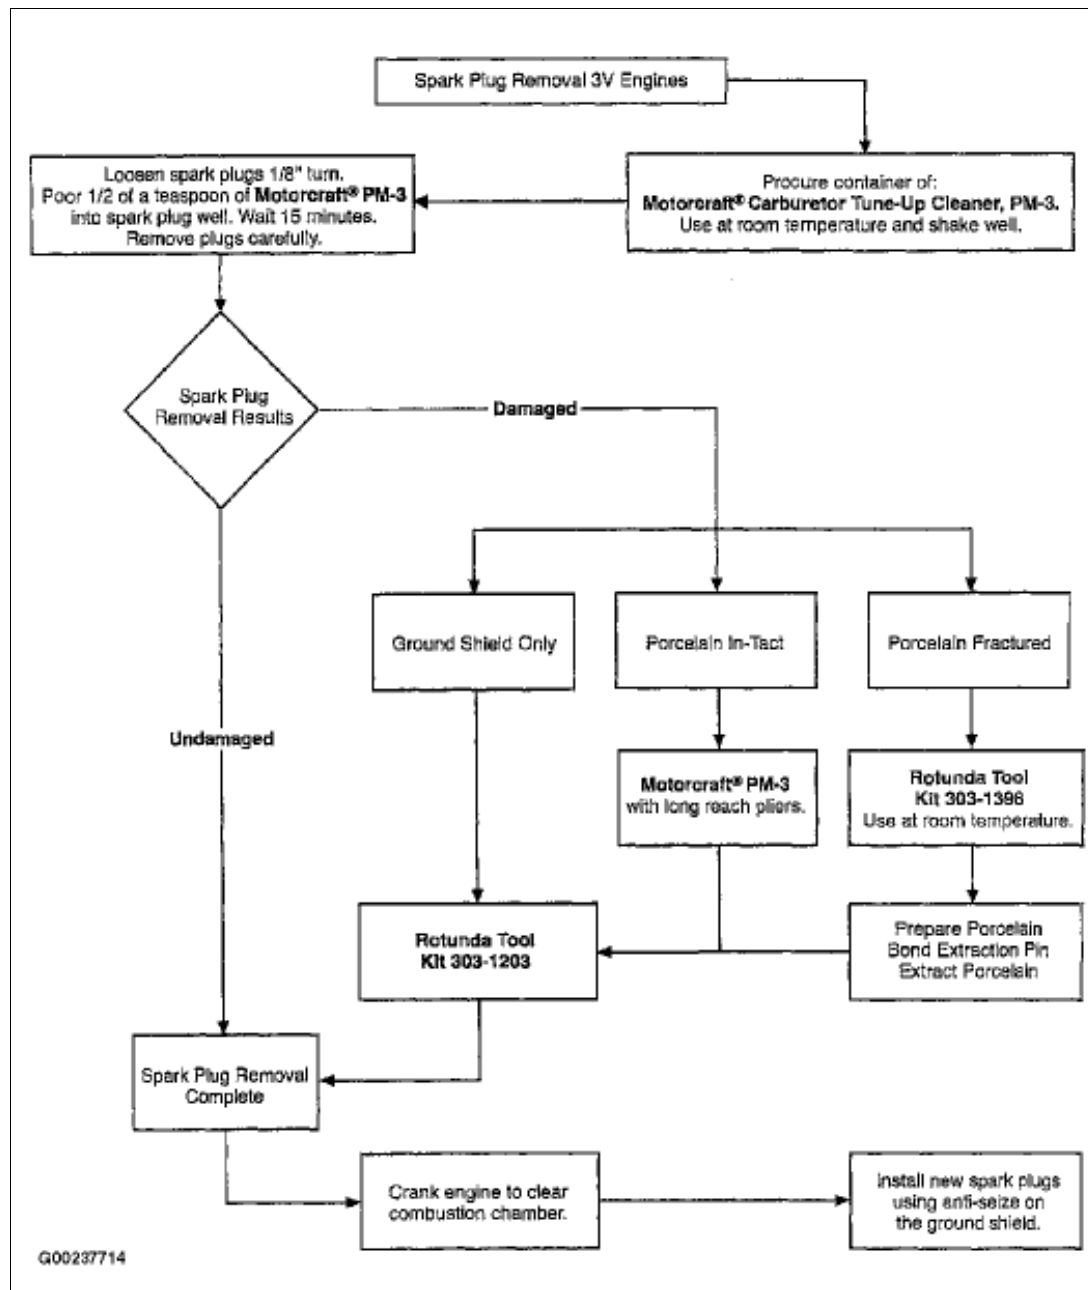
Fig 5: Flowchart Of Procedure

If the spark plug separates after following the Spark Plug Removal Procedure, it will fail in one of three modes. Refer to the appropriate removal procedure as required.

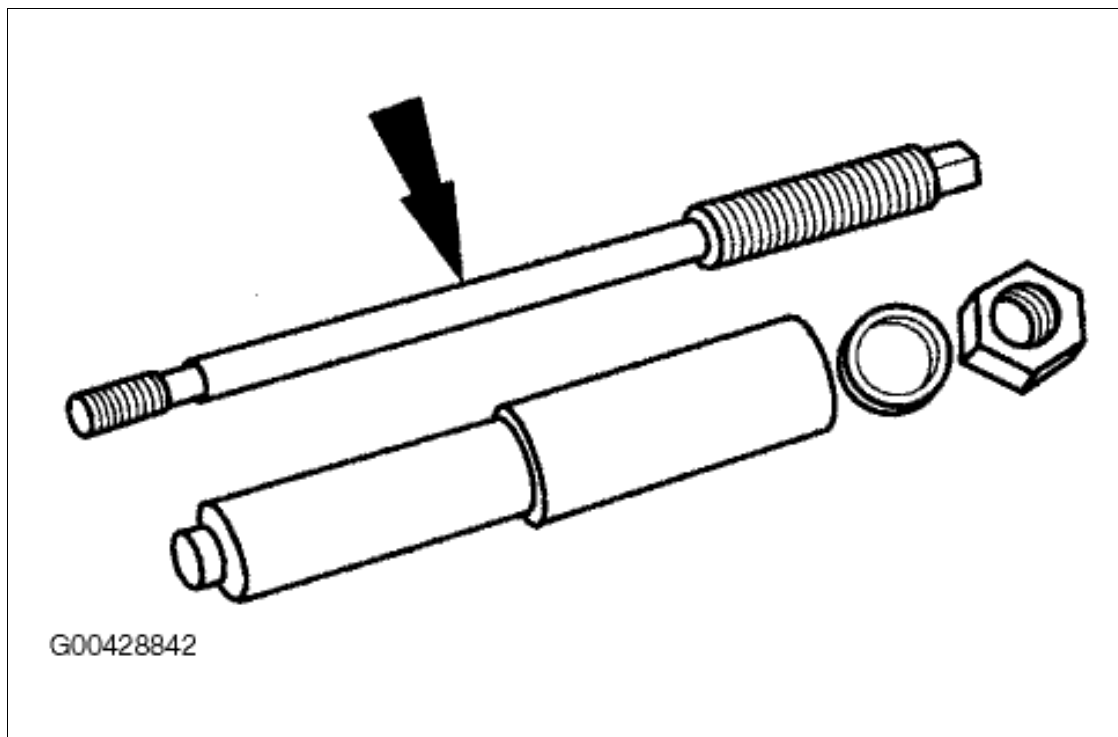
Fig 6: Rotunda Special Service Tool 303-1203

**NOTE: THIS TOOL IS ONLY DESIGNED TO WORK WITH AN EMPTY GROUND ELECTRODE SHIELD. IF PORCELAIN REMAINS, PROCEED TO MODE 2 OR 3 REMOVAL.**

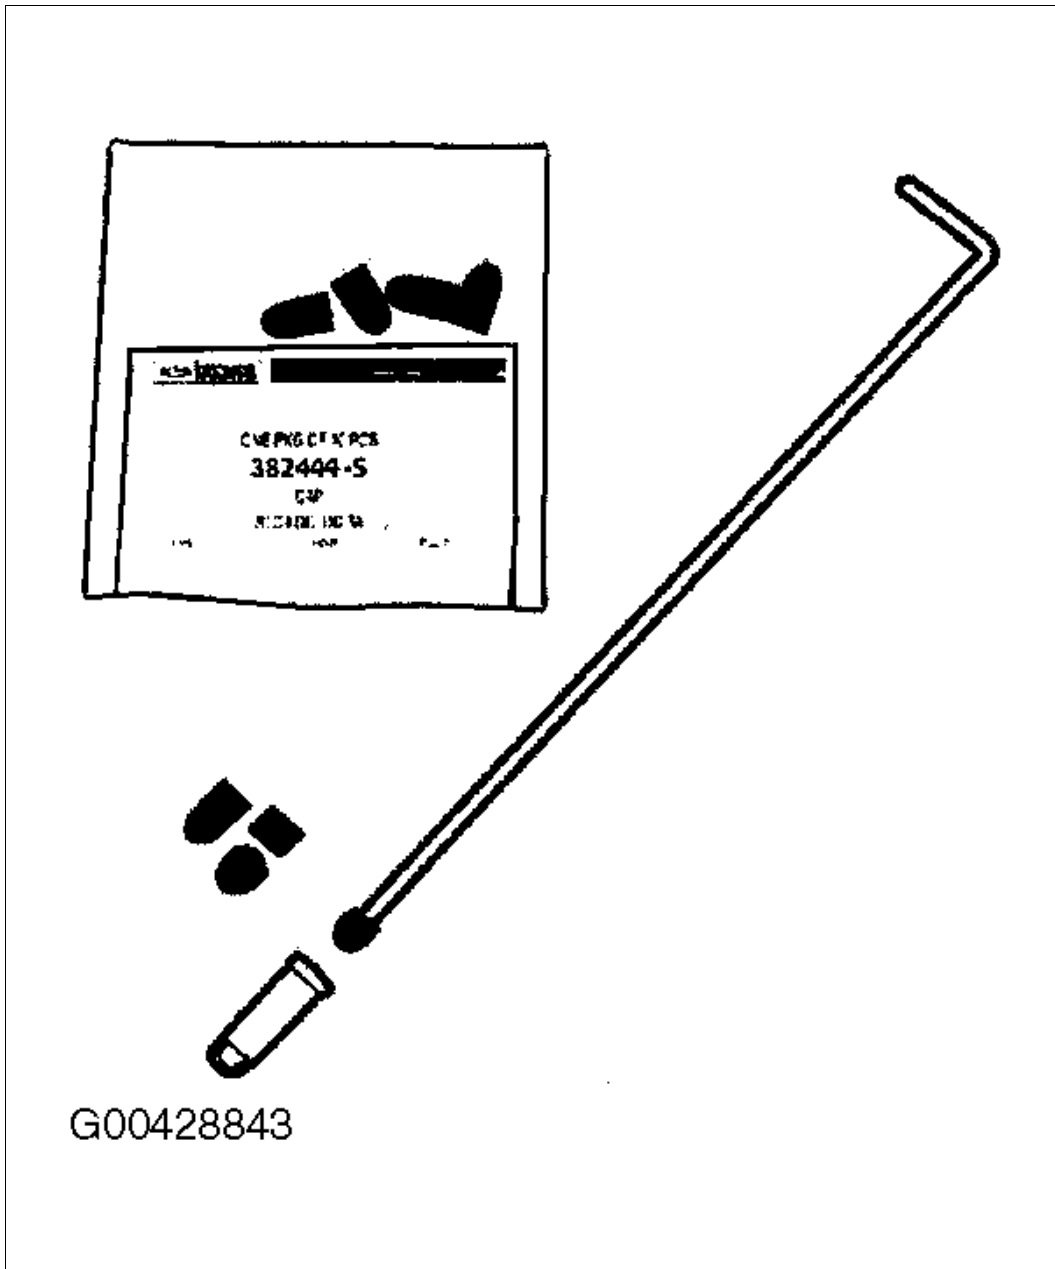
Fig 7: Installing Modified Vacuum Cap

1. Modify vacuum cap to a 3/8" (10 mm) length for each ground electrode shield that needs to be removed. (Fig 7)

2. Use the installation rod (J) provided with service tool 303-1203 update to install the modified vacuum cap. Push the cap into the ground shield down to the electrode strap. This will plug and protect the combustion chamber from contamination. (Fig 7)
3. Thread-tap the ground electrode shield using a 9.0 x 1.0 mm plug tap (tap profile is about 3-4 reduced diameter threads on the tip end).
  - a. Coat the end of the tap with general purpose grease. (Fig 8)

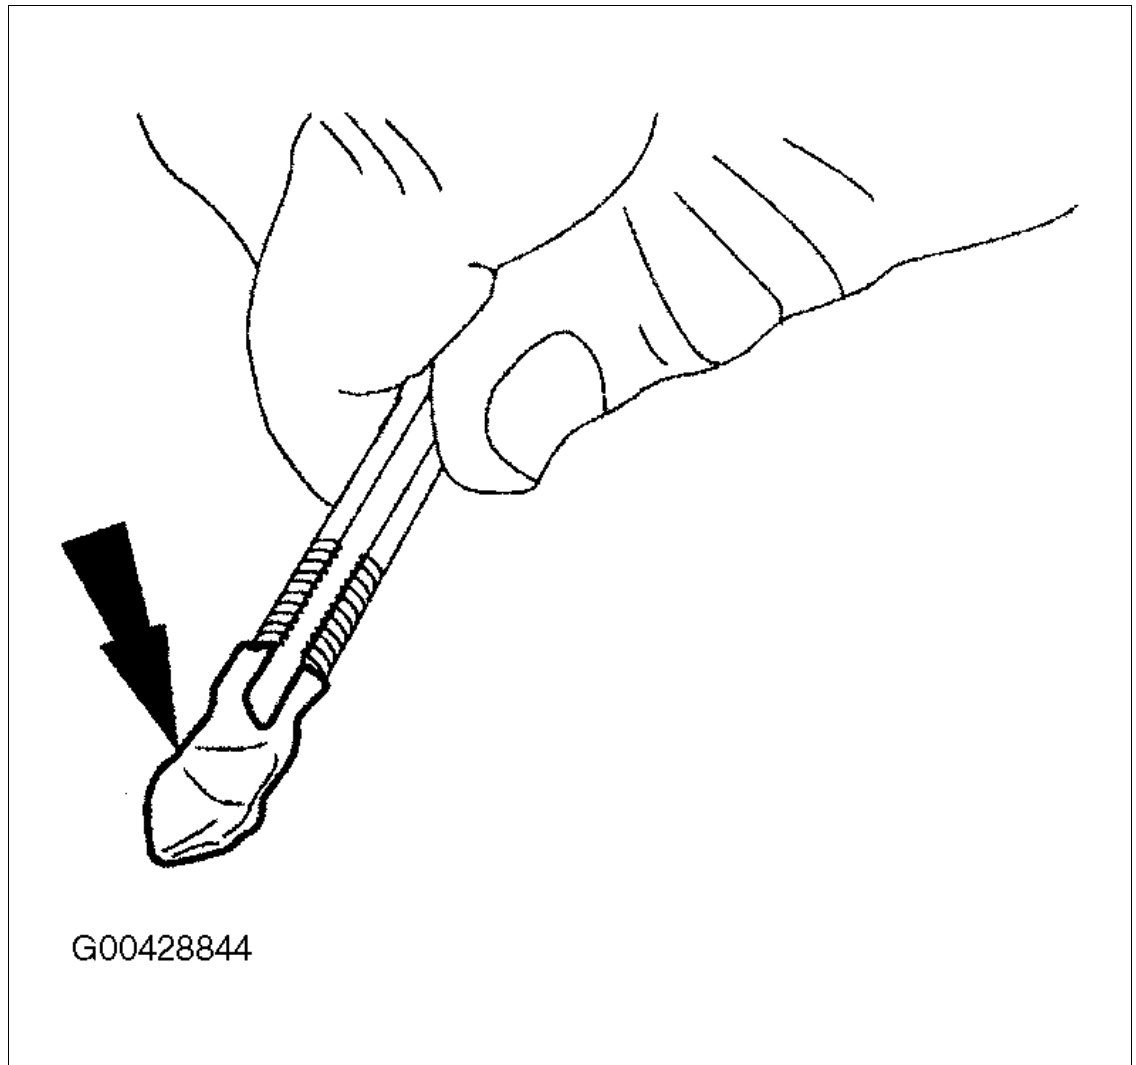
Fig 8: Coating Tap With Grease

- b. Turn the tap about 3 to 4 turns into the ground electrode shield. Back the tap up frequently to break chips and avoid cut material from coiling-up in the spark plug well. A tap socket adaptor (K) is provided with service tool 303-1203 update to connect the tap to a 3/8" socket drive.

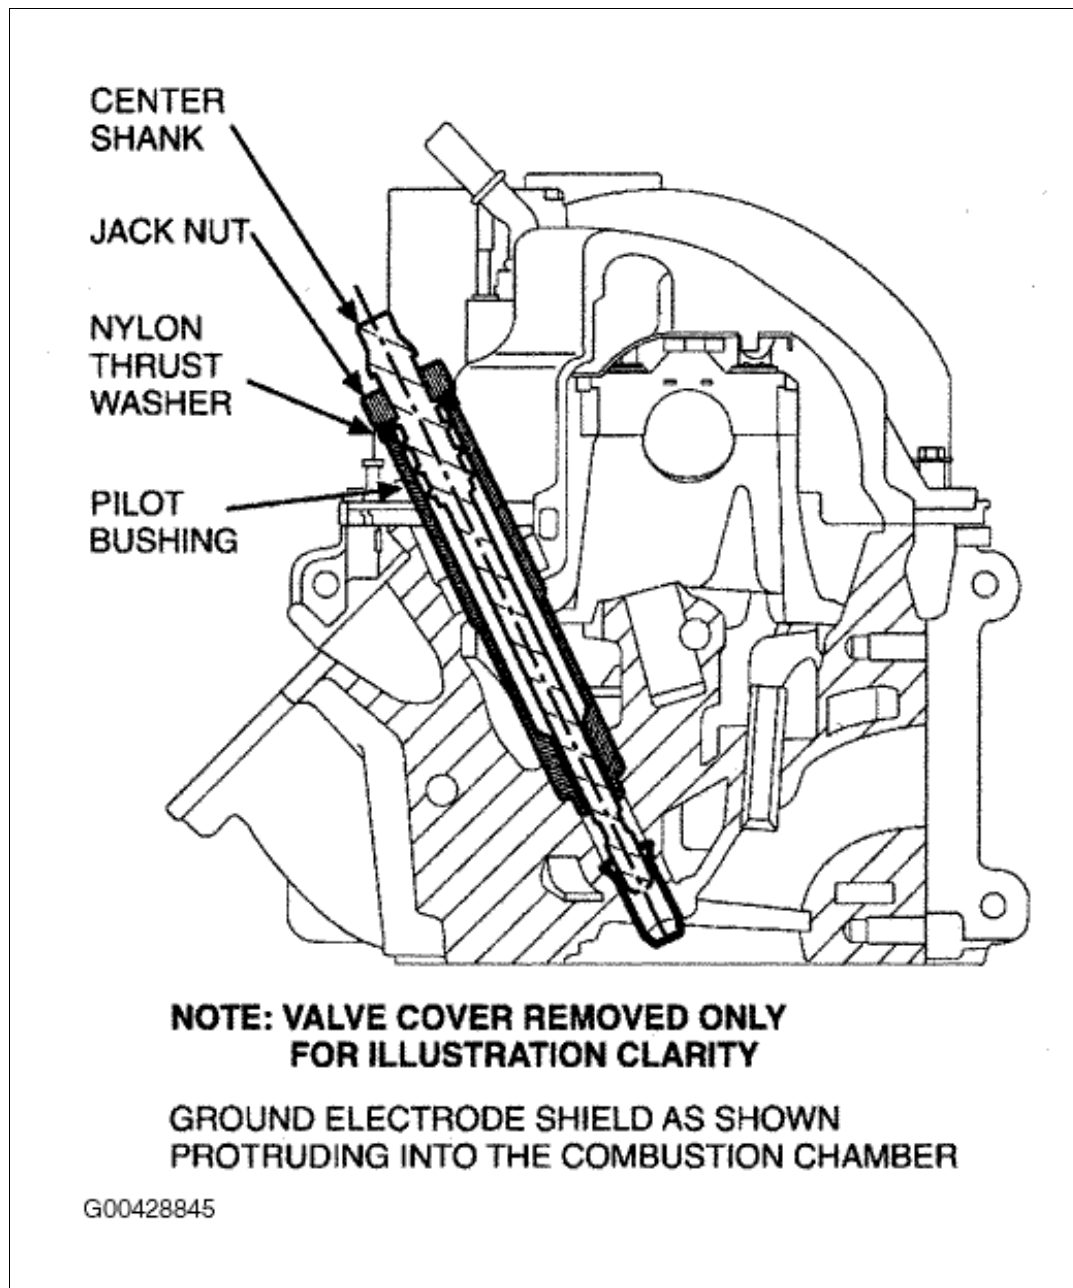
Fig 9: Details Of Tool As Installed In Head

4. Thread Rotunda special service tool 303-1203 into the ground electrode shield. (Fig 9)

- a. Install the stepped end of the tool pilot bushing into the spark plug well ensuring it bottoms out.
- b. Screw the center shank into the ground electrode shield. Do not over tighten the shank, to prevent thread stripping.
- c. Install the nylon washer and jack nut until finger tight.
- d. Turn the jack nut until the ground electrode is freed from the cavity and withdraw the tool assembly.

9. Add additional Loctite® 638™, repeating Steps 6-8.
10. Leave the pin fully inserted in the porcelain while the adhesive cures. Replace the steel tool pilot with the aluminum alignment sleeve (G), Fig 9, to support the threaded rod while the adhesive cures if additional porcelain fragments are present in other cylinders. (Fig 19).

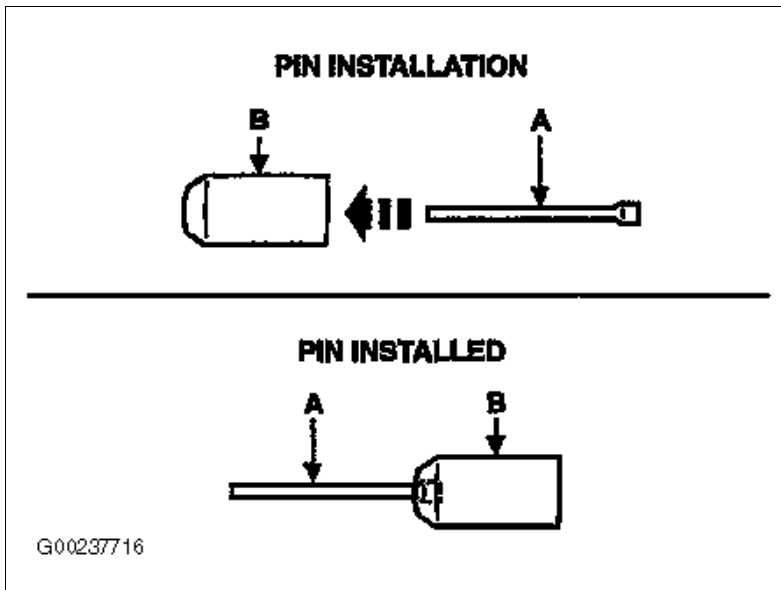
Fig 11: Inserting Pin Into Collet

3. Insert a pin (A) into the collet (B). Screw the collet onto the threaded rod (C). Install the assembled collet, pin, and threaded rod into the steel tool pilot (F). (Fig 11 and Fig 12 )

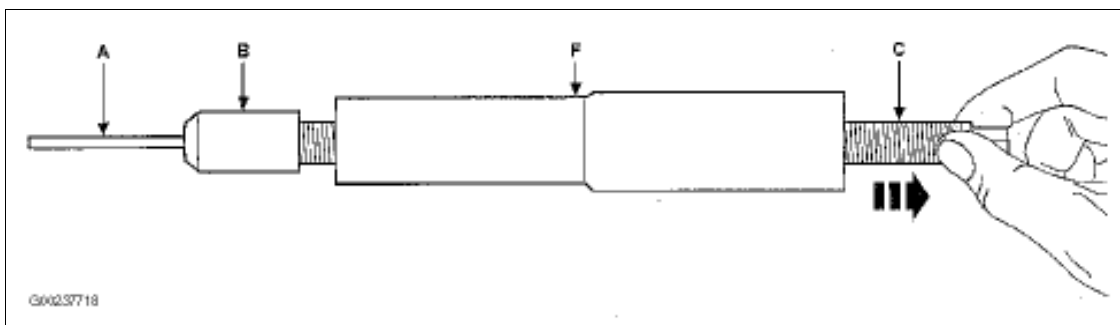
Fig 13: Retracting Collet And Pin Into Steel Tool Pilot

4. Retract the collet and pin into the steel tool pilot, protecting the pin. (Fig 13 and Fig 14 )

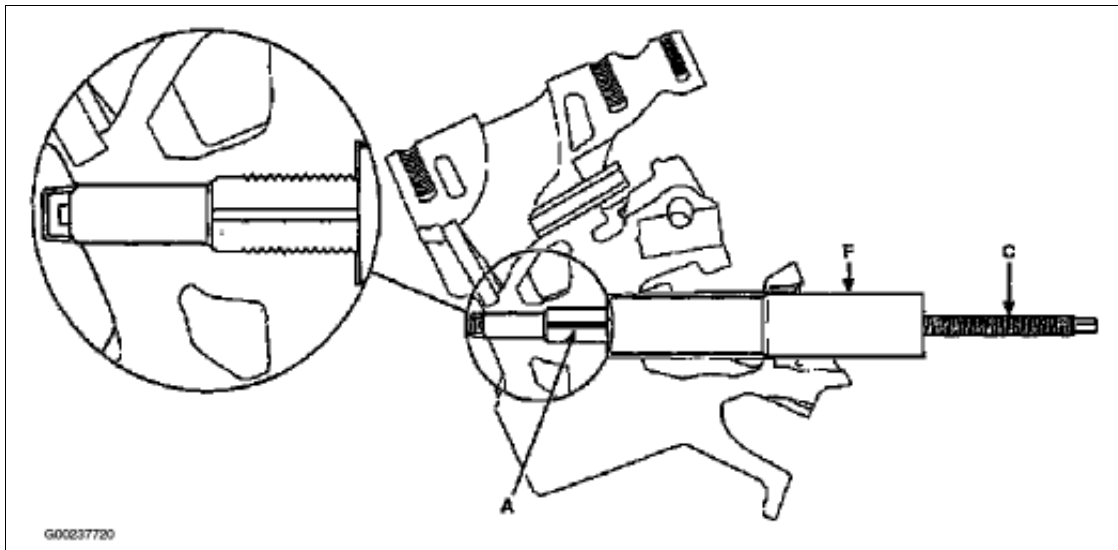
Fig 15: Inserting Completed Assembly Into Spark Plug Well

5. Insert the completed assembly into the spark plug well and fully engage the pin into the porcelain. (Fig 15)

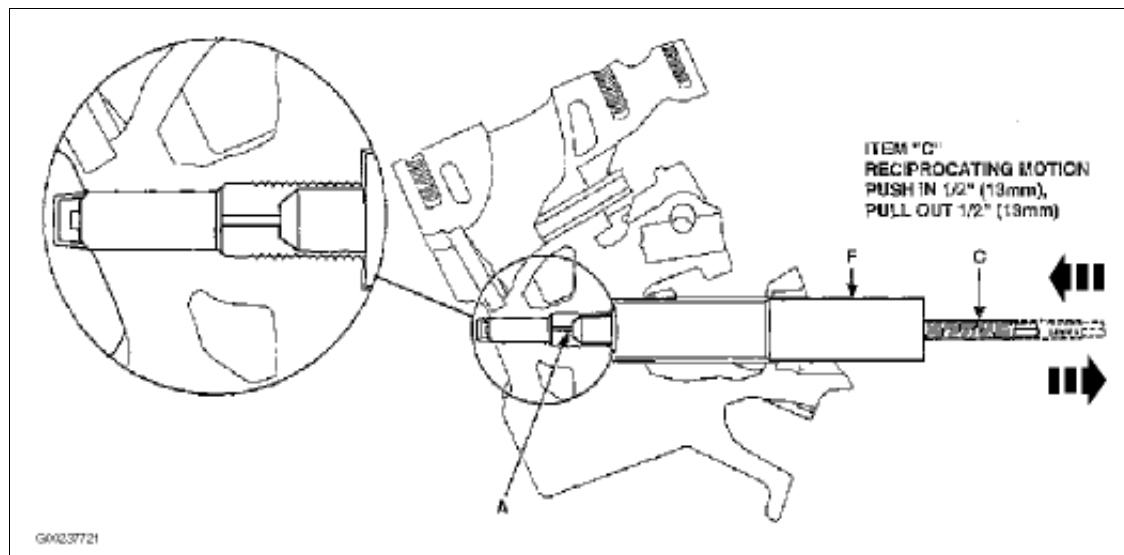
Fig 16: Scrubbing Porcelain Inside Diameter

6. Spray Motorcraft® Metal Brake Parts Cleaner 2-4 seconds between the spark plug well and steel tool pilot. The steel tool pilot must be lifted up approximately 1/2" to allow brake cleaner to flood the porcelain and pin.
7. Scrub the porcelain inside diameter by moving the threaded rod up and down vigorously. Take care making sure the pin does not disengage the porcelain. (Fig 16).

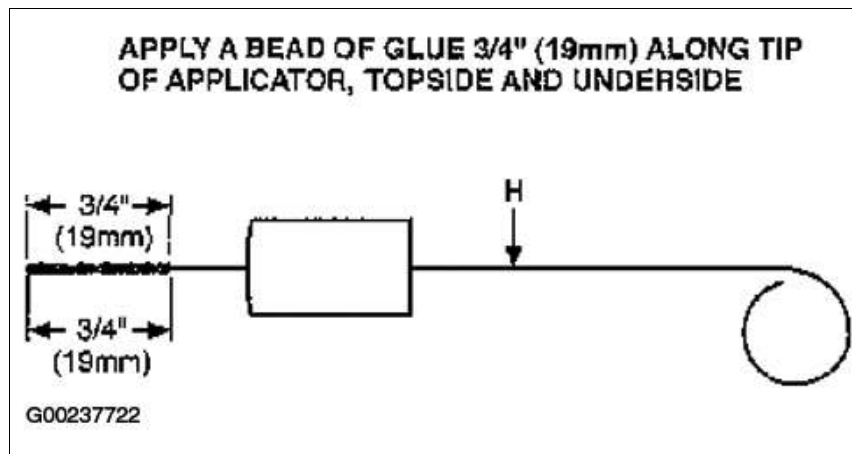
Fig 17: Bead Of Loctite® On Applicator

1. Apply two 3/4" (19 mm) long stripes of Loctite® 638™ to opposite sides of a clean and dry applicator (H). Excessive amounts of Loctite® 638™ are being used if it drips off the applicator. (Fig 17)

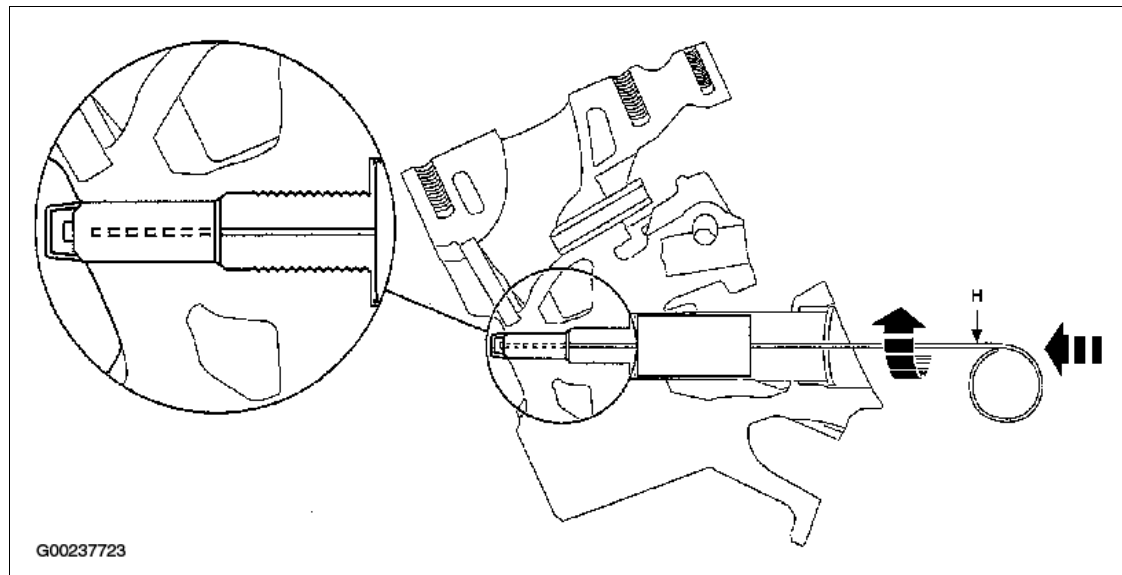
Fig 18: Spreading Loctite® On Inside Of Porcelain

2. Insert applicator into the porcelain and move applicator up and down 1/2" (13 mm) while turning to spread the Loctite® 638™ on the inside of the porcelain. (Fig 18).
