St Mary the Virgin,
Black Bourton.
The Story told in pictures.

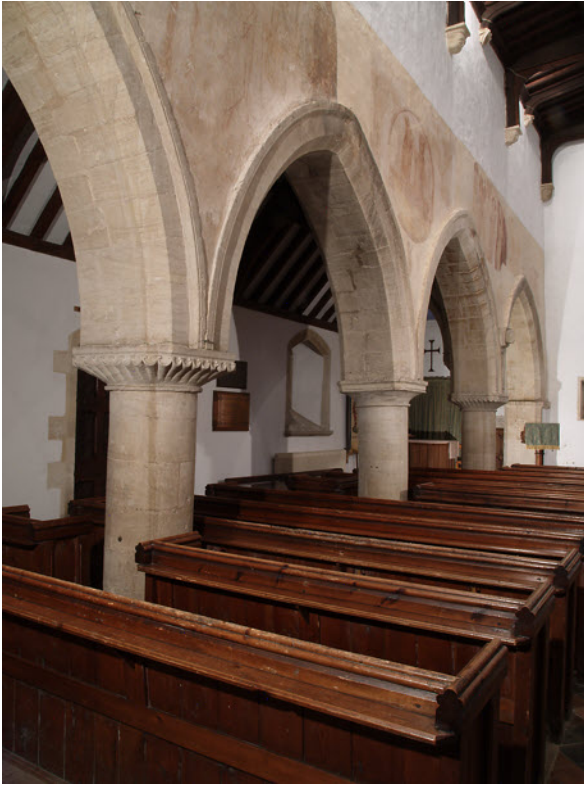
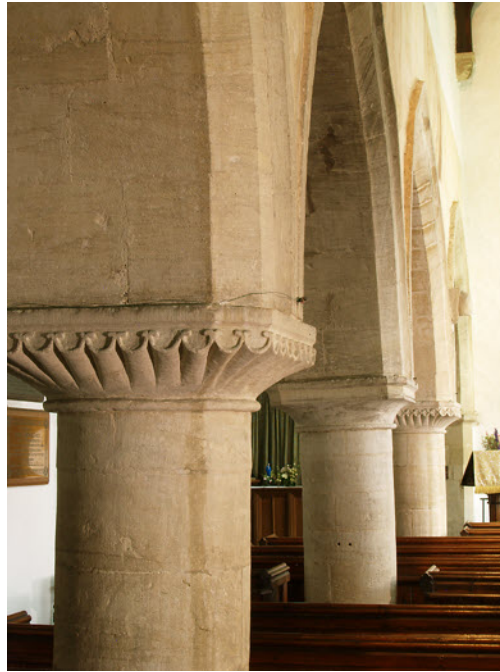
Norman chapel judging by the three lancet east windows and the small Norman priest's door with a Maltese cross in the tympanum. In 1180 this chapel was presented to the Abbey of Oseney by Hugh de Burton and Ralph de Murdac who were probably Norman lords of the manors here. The monks built the nave and probably inscribed the sun dial type “service marker” (above left) on the window stone (far left).

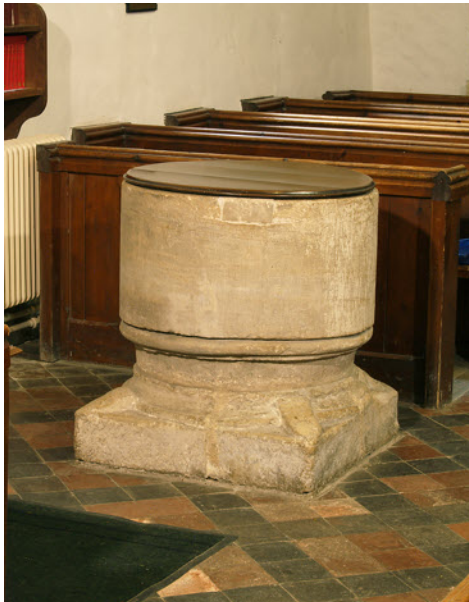
The cylindrical font on a square base with carved feet dates from the time the arcade was built, 1190.

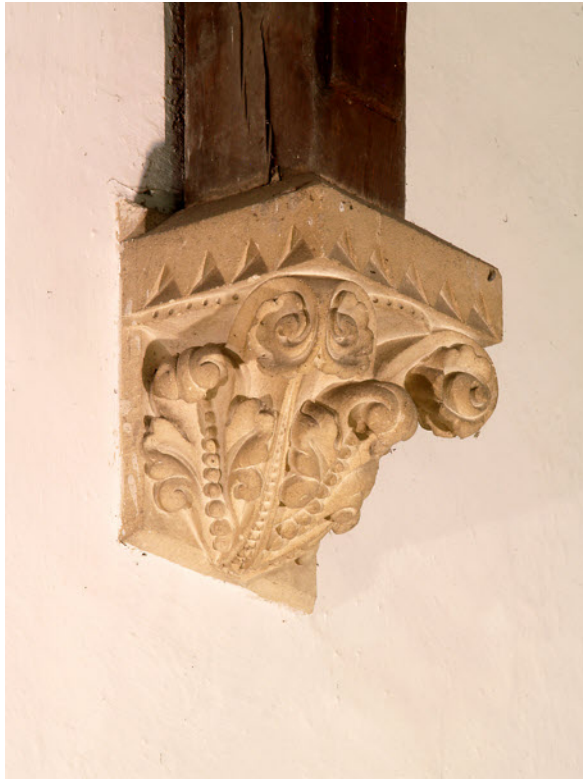
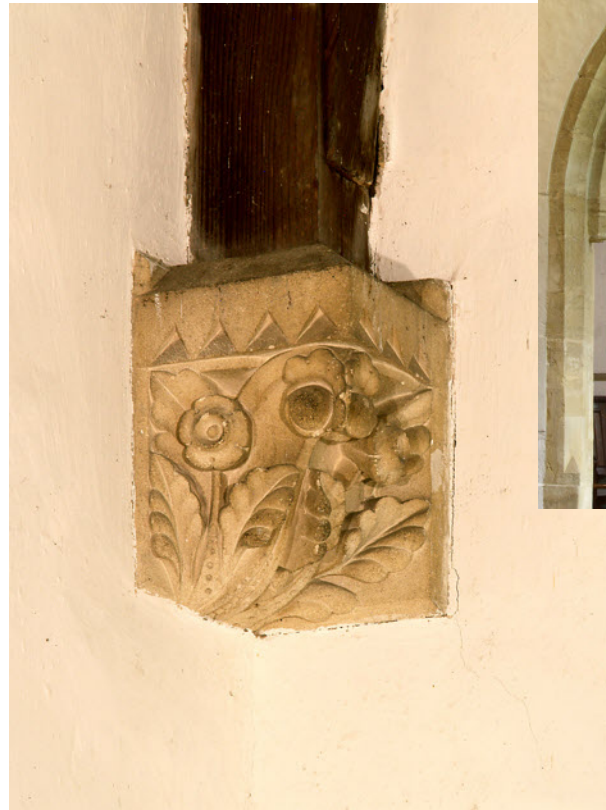
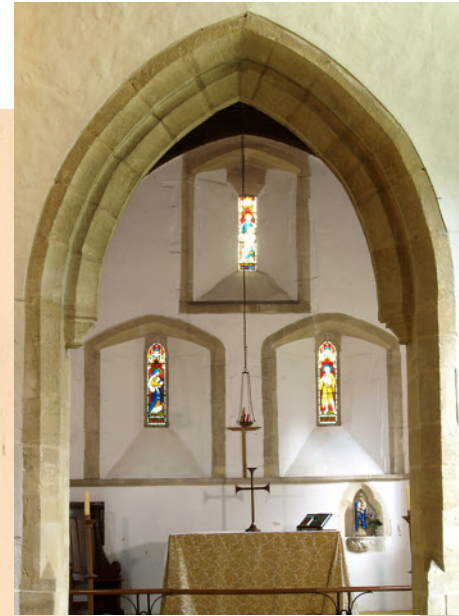
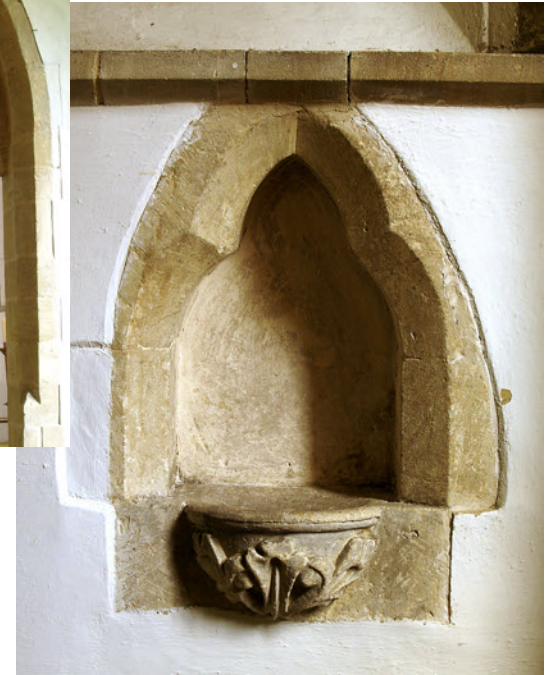
The chancel arch is 13th century leading to the 12th century chancel, the original chapel, beyond. The three lancet east windows are original in wide splays although the heads may have been altered in the 15th or 16th century. The piscina, for washing the chalice, in the east wall, above right, has a trefoil head and carved foliage corbel and probably dates from the 12th century. An aumbry, dry cupboard, is also in the east wall to the left of the altar. The chancel has a flat headed perpendicular period window with deeply cusped lights and a Tudor hood moulding, 1450 - 1550, in the south wall to the west of the priest's door, external view below right. Two windows of the same design and period are in the north chancel wall. The church was reroofed in 1847 and extensively restored in 1866 by E.G.Bruton under the direction of the Diocesan Architect George Edmund Street. Consequently all the roof-supporting corbels, above left, are recarved versions.

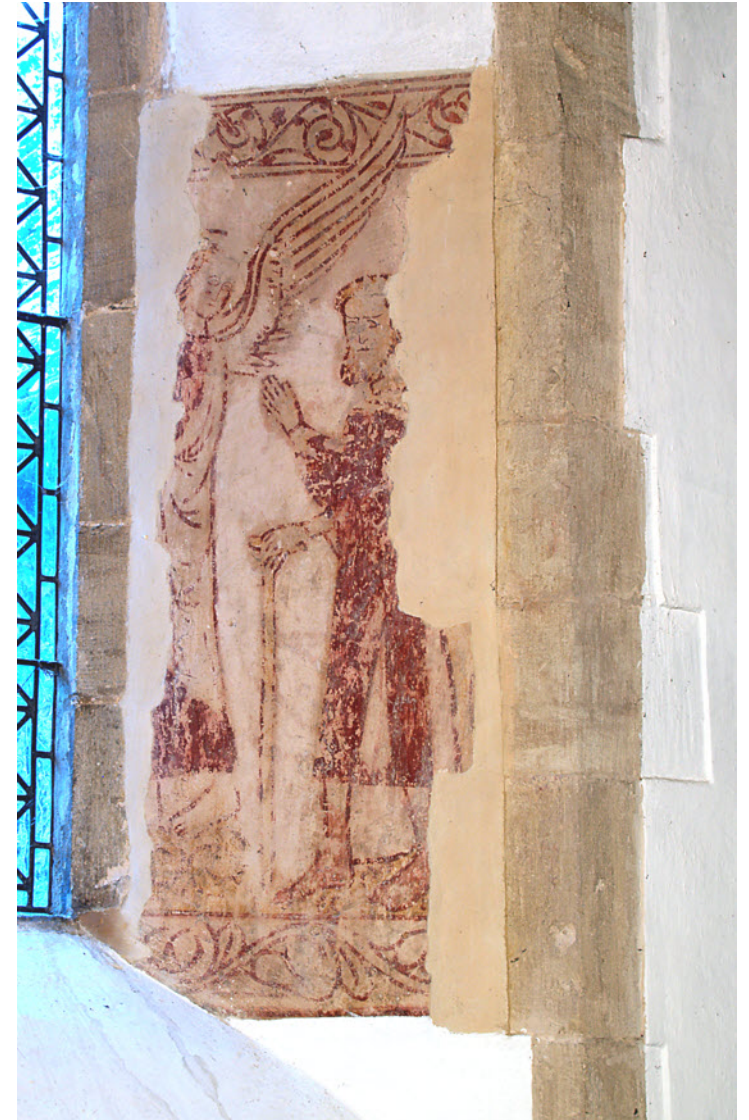
Angel appearing to St Joseph.

Mainly the common earth pigments, red and yellow ochre, were used for painting, other colours were expensive and rare. The painting is made directly onto prepared dry plaster and the fresco method, painting on wet plaster was not used.
