**TECHNICAL INSTRUCTIONS**  
**FOR**  
**SAFETY RECALL GLG**  
**FRONT PASSENGER AIRBAG MODULE**  
**CERTAIN 2007 – 2010 MY ES 350**  
**UPDATED JUNE 15, 2017**

## II. BACKGROUND

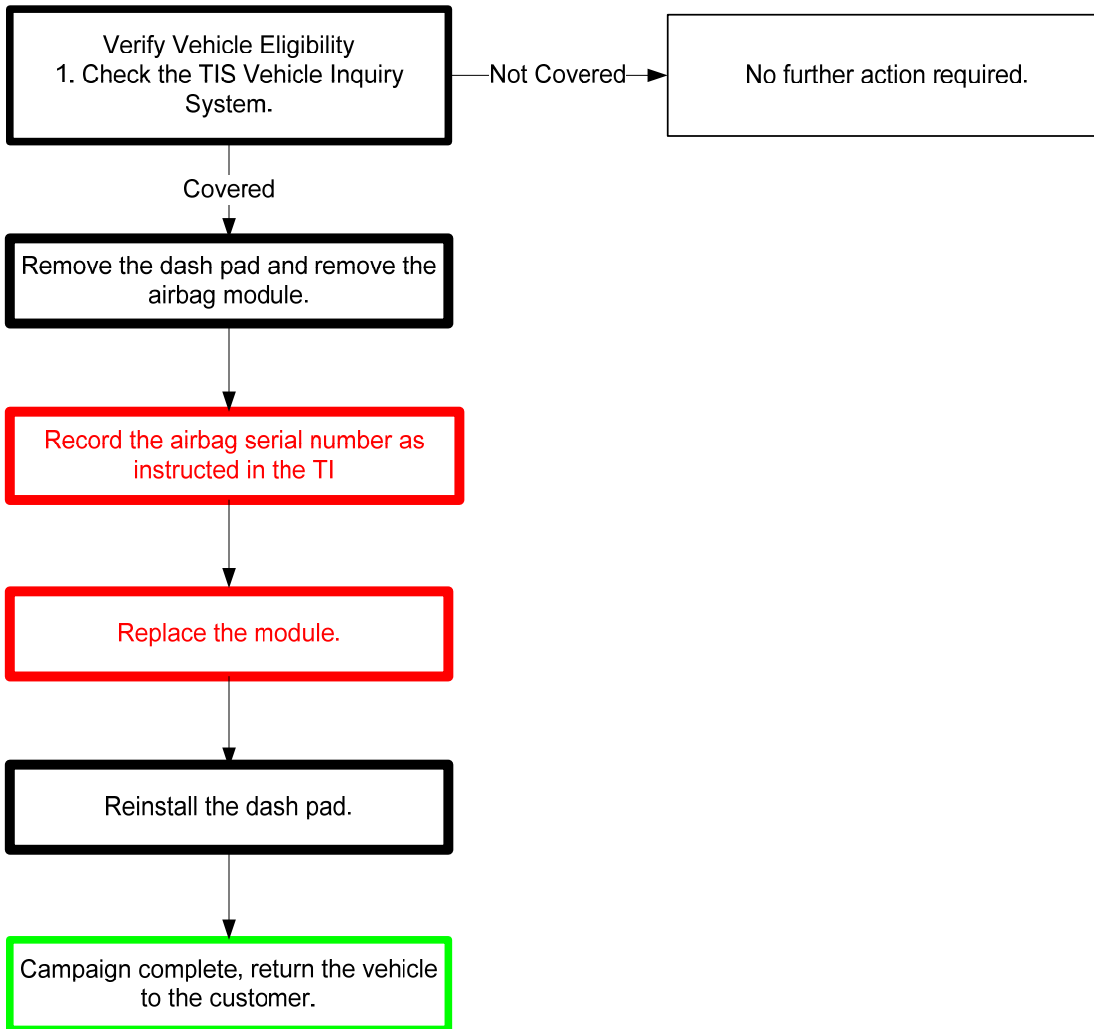
## I. OPERATION FLOW CHART

The flow chart is for reference only. **DO NOT** use it in place of the full technical instructions. Follow **ALL** steps as outlined in the full technical instructions to confirm the campaign is completed correctly.

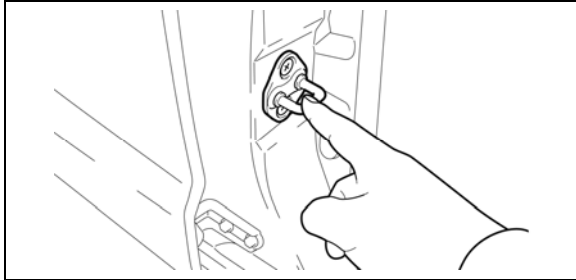
#### 1. ELIMINATE STATIC ELECTRICITY

- a) Before starting work and periodically while working on the vehicle, touch a metallic part of the vehicle to discharge static electricity in the body.

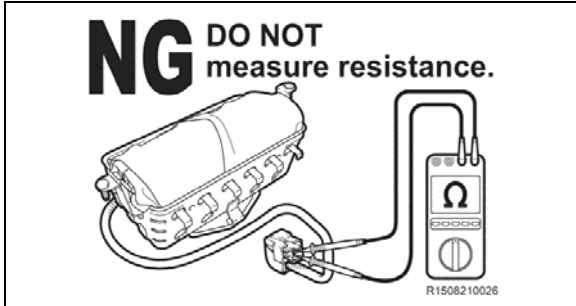
#### 2. DO NOT MEASURE RESISTANCE

- a) **NEVER** measure the resistance of an airbag, this may cause accidental activation.

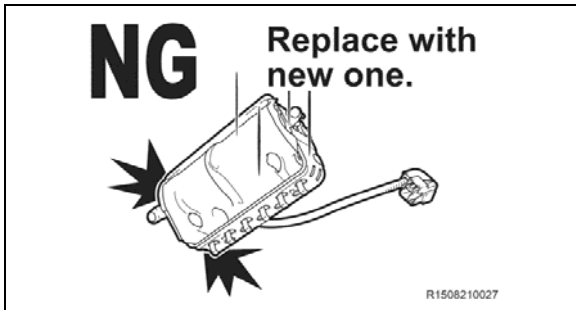
#### 3. HANDLE THE AIRBAG CAREFULLY

- a) If the airbag is dropped, replace it with a **NEW** one.

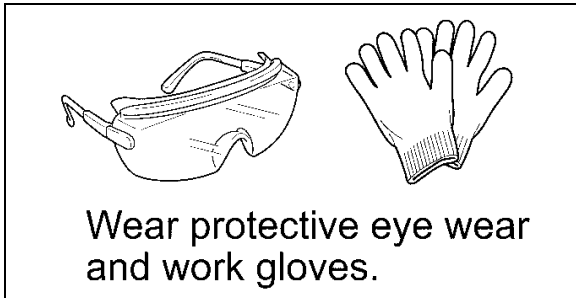
#### 4. WEAR PROTECTIVE EQUIPMENT

- a) Always wear appropriate protective equipment when working on the SRS.

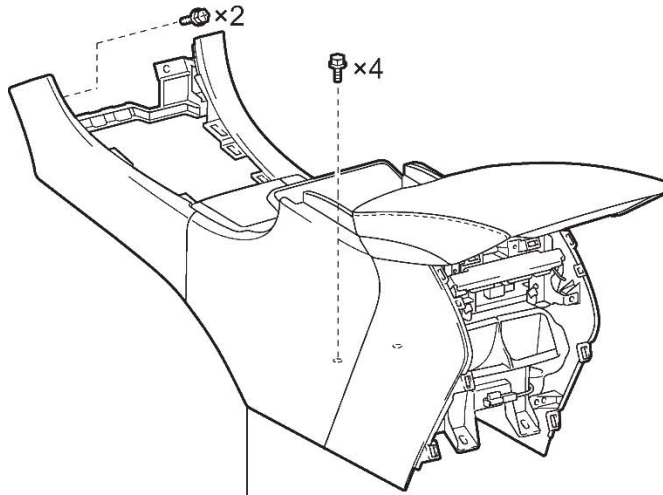
R1701240004

# VII. FRONT PASSENGER AIRBAG REMOVAL COMPONENTS

UPPER CONSOLE PANEL ASSEMBLY WITH FRONT ASH RECEPTACLE

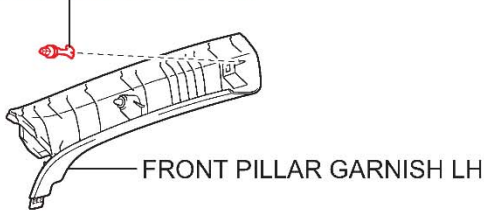
● FRONT PILLAR GARNISH CLIP

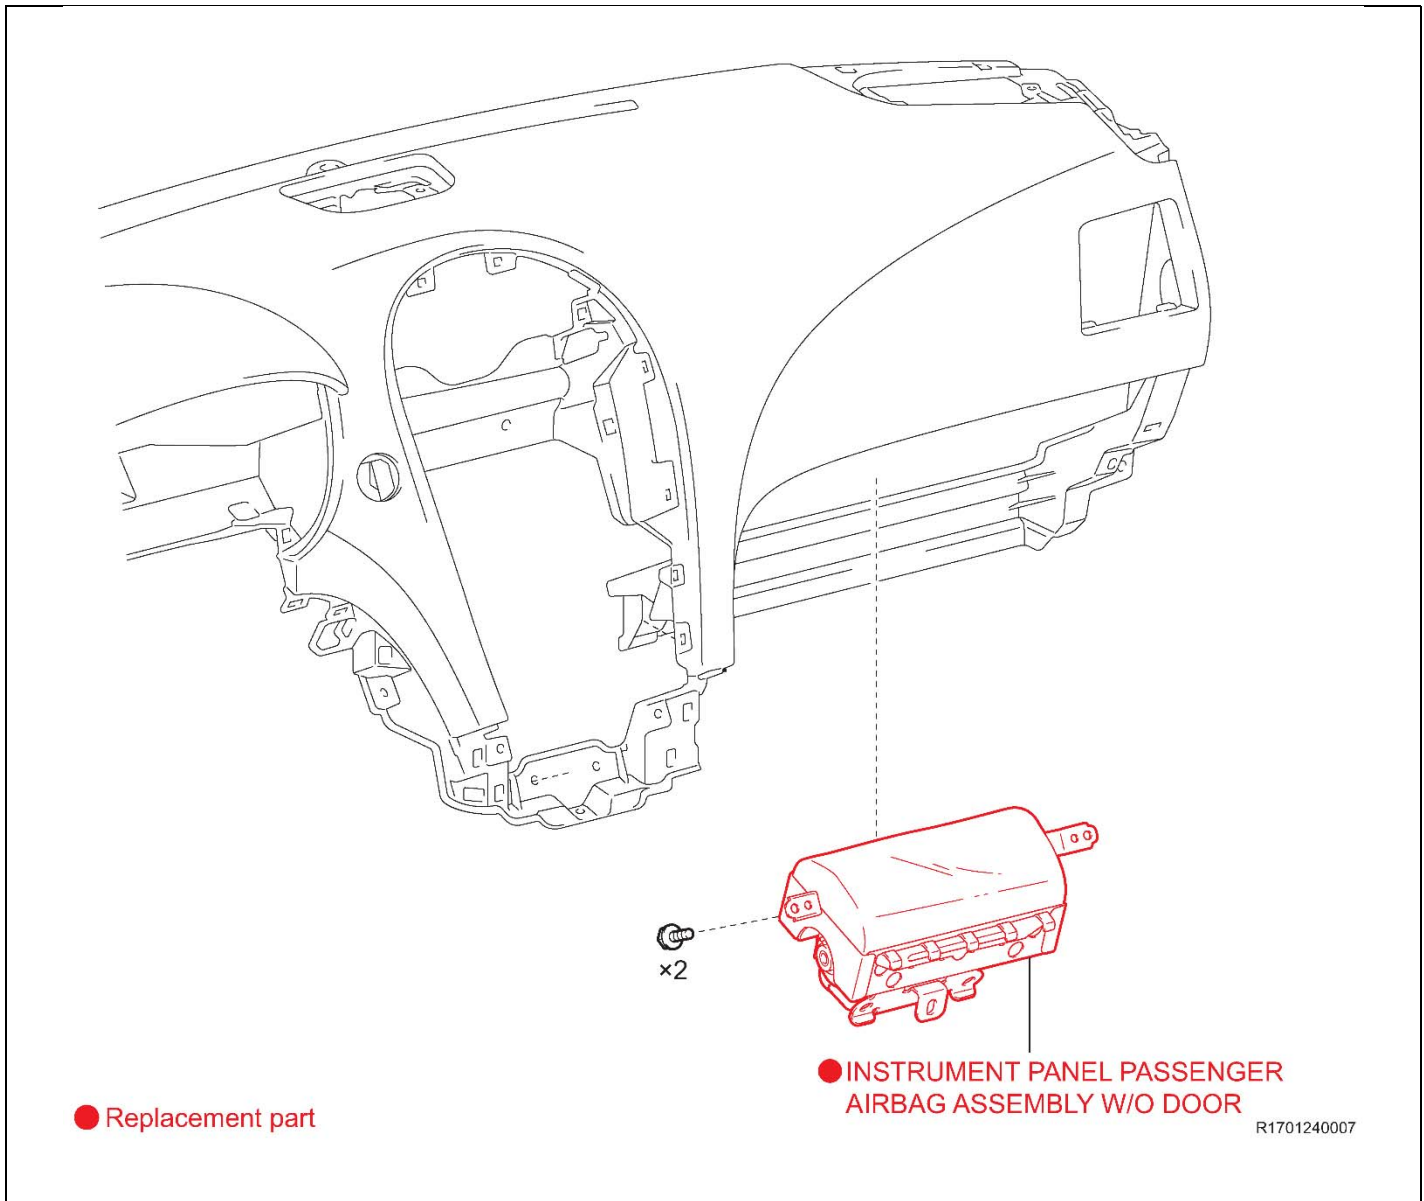
R1701240006

No. 1 INSTRUMENT PANEL SPEAKER  
PANEL SUB-ASSEMBLY

INSTRUMENT PANEL  
SAFETY PAD ASSEMBLY

No. 1 INSTRUMENT PANEL  
MOUNTING BRACKET

● Replacement part

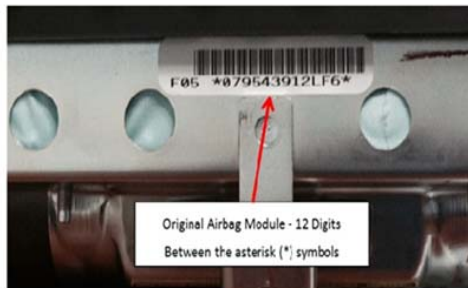
#### Airbag Serial Number Label Example

- The airbag serial number is **ALWAYS** the **12 DIGITS** located between the asterisks.
- The **3 digits** before the asterisk **ARE NOT** part of the serial number, and **SHOULD NOT** be entered or an inaccurate response may be returned.

Original Airbag Module - 12 Digits  
Between the asterisk (\*) symbols

The Airbag module Assembly serial number is a **12 digit code**. It can be found along with a bar code on opening the Airbag assembly unit. To manually enter these details into the application, the technician has to identify the 12 digit code between two Asterisks (\*) inside the Airbag assembly unit. The first seven characters of this 12 digit code are numbers and the 10<sup>th</sup> digit is either 'K' or 'L' always.

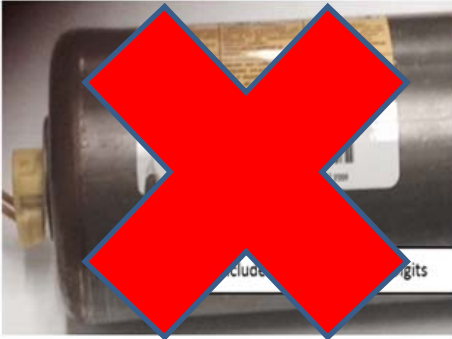
**Original Inflator**

How to identify the inflator serial code on the Original and Replacement Inflator can?

The Inflator serial code is an **11 digit code** on the Inflator can. It can be found with a bar code on removing the Inflator can from the Airbag Assembly unit.

The first two characters of the **Original Inflator Serial code** will be from [AA, AB, AJ, FD or JD].

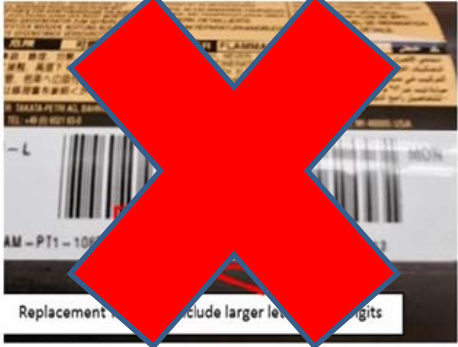
**Replacement Inflator**

The first two characters of the **Replacement Inflator Serial code** will be either 'LT' or 'LR'.

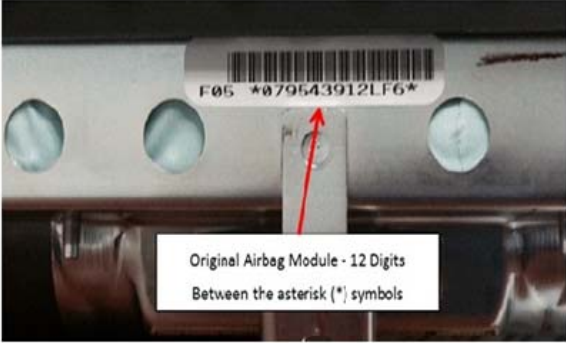
Original Airbag Module - 12 Digits  
Between the asterisk (\*) symbols

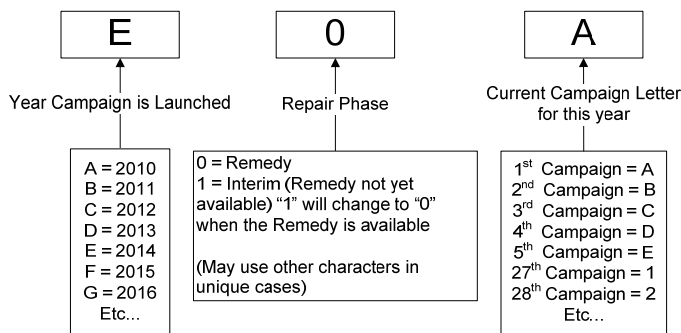
### A. CAMPAIGN DESIGNATION DECODER

Examples:

A0D = Launched in 2010, Remedy Phase, 4<sup>th</sup> Campaign Launched in 2010

B1E = Launched in 2011, Interim Phase, 5<sup>th</sup> Campaign Launched in 2011

C1C = Launched in 2012, Interim Phase, 3<sup>rd</sup> Campaign Launched in 2012
