BEARING DAMAGE ANALYSIS REFERENCE GUIDE

TIMKEN EXPERTISE

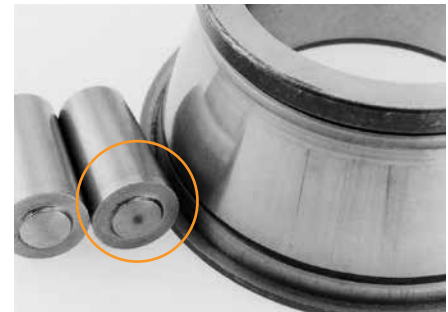
Fine particle contamination caused abrasive wear on this tapered roller bearing.

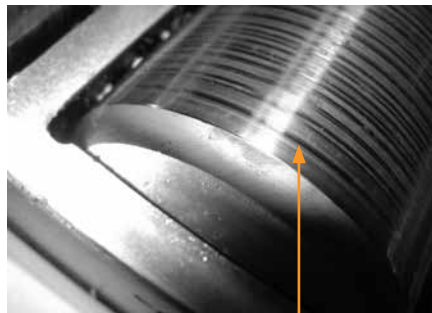
Circumferential grooving on rollers.

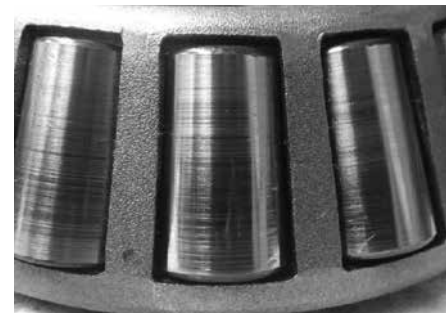
Circumferential grooving.

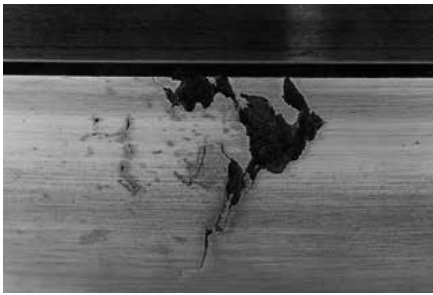
A tapered roller bearing inner ring with spalling from debris contamination bruises.

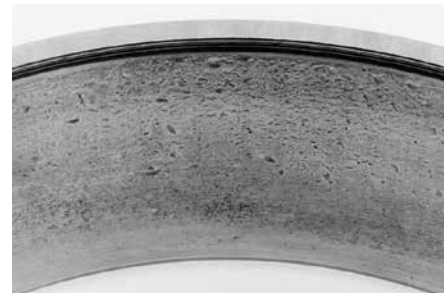
Debris from other fatigued parts, inadequate sealing or poor maintenance caused bruising on this tapered roller bearing race.

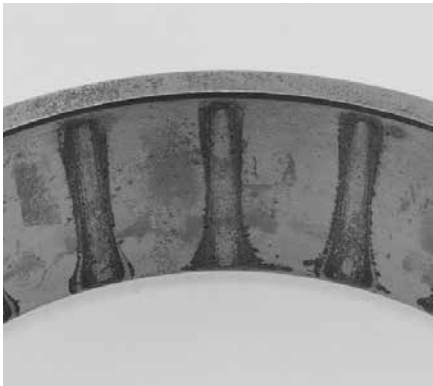
This outer ring has heavy corrosion on the race. This type of corrosion may only be a surface stain without pitting. If the staining can be cleaned with a fine emery cloth or crocus cloth, the bearing may be reused. If there are pits that cannot be cleaned with light polishing, the bearing should either be discarded or, if practical, refurbished.

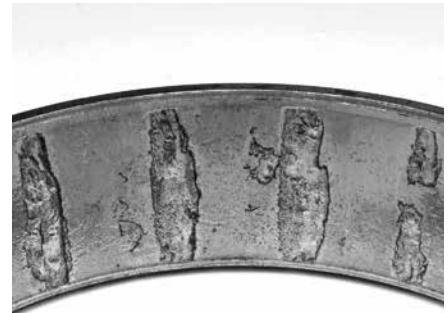
Advanced spalling initiated at water etch marks on the outer ring race makes this bearing unsuitable for further service.

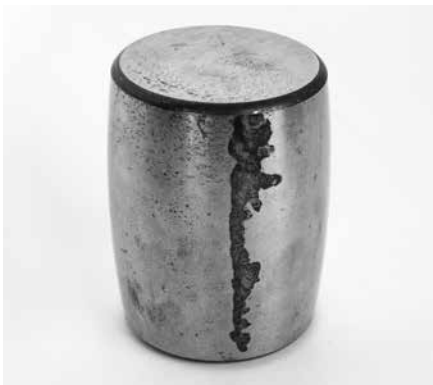
Advanced etching.

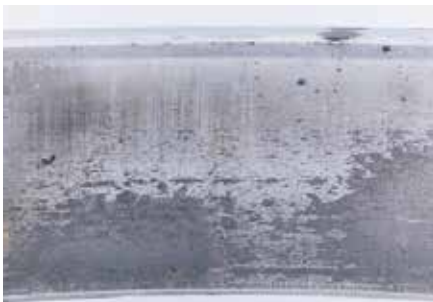
Level 2 – Micro-spalling or peeling results from thin lubricant film due to high loads/low speed or elevated temperatures.

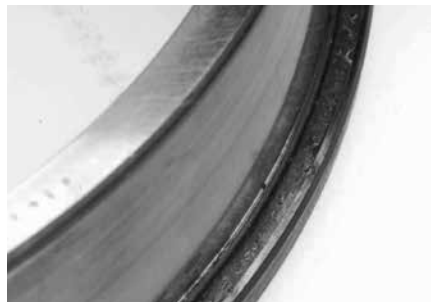
Level 2 – Advanced rib scoring is due to inadequate lubricant film.

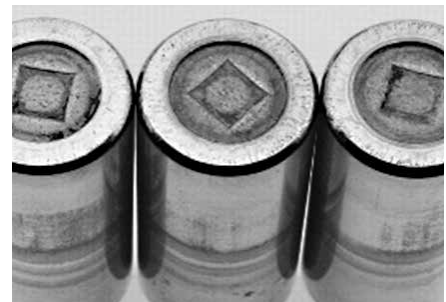
Scoring damage on roller end.

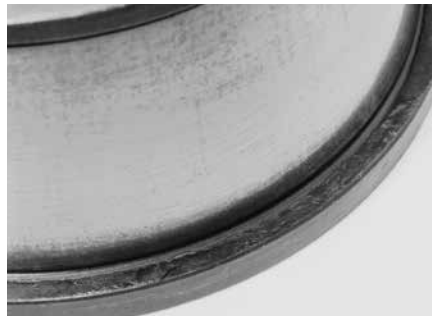
Rib and roller end heat damage.

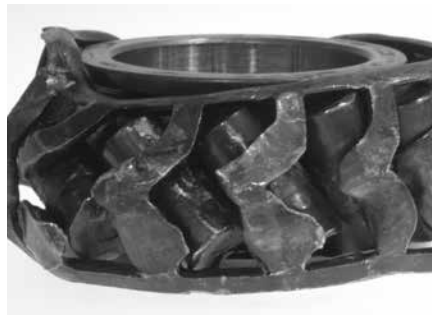
Cage damage from bearing lockup.

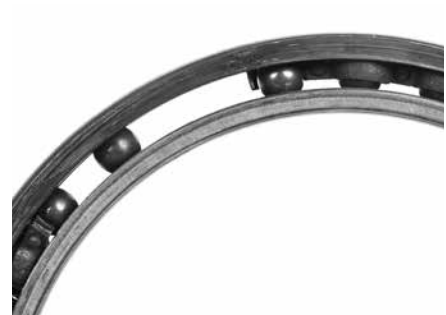
Cage damage from bearing lockup.

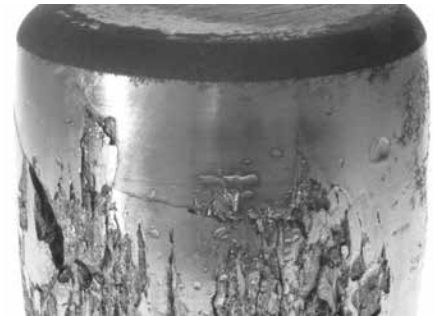
Heavy spalling and fracturing from high loads on this spherical roller bearing.

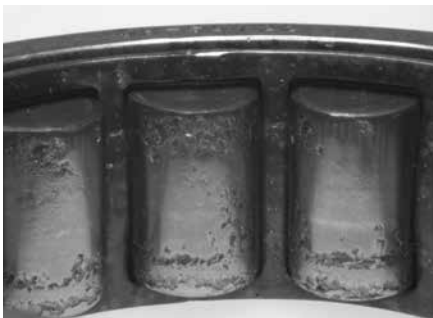
High loads resulted in fatigue spalling on this cylindrical roller bearing.

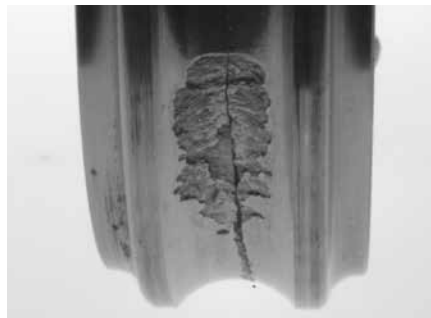
This ball bearing inner ring depicts fatigue spalling from high loads. The fracture is a secondary damage mode.

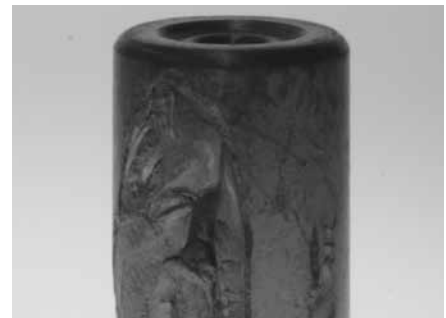
Overloading on this cylindrical roller bearing caused roller surfaces to fracture.

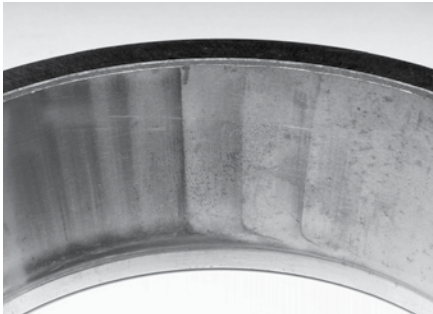
Scalloping marks in the outer ring are common with excessive endplay. This occurs when unloaded rollers enter the small load zone and are suddenly exposed to heavy loads.

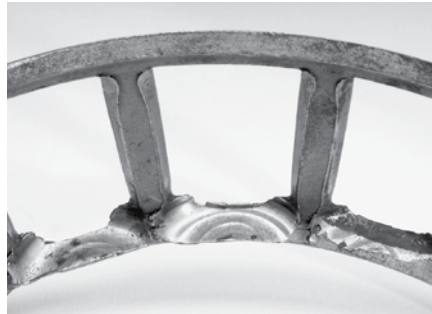
Cage pocket damage results from excessive roller movement.

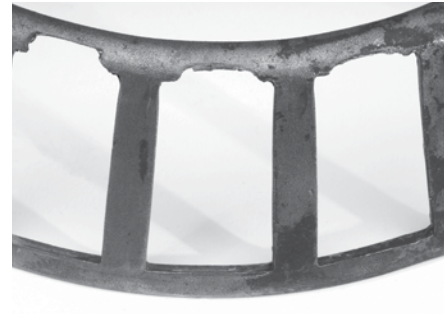
Heavy wear in the small end of the cage pockets is typical of excessive endplay.

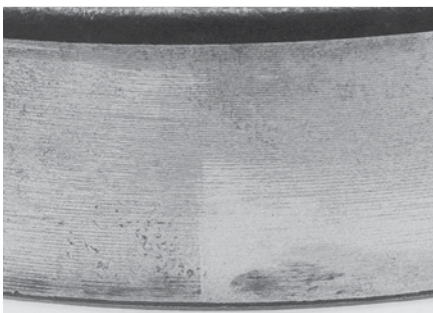
The marks visible on the outside diameter of this outer ring are caused by a high spot on the housing. The outer ring race was found spalled at the location that corresponds to the outer ring mark from heavy contact with the housing high spot.

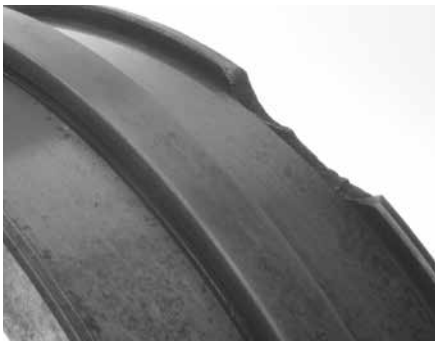
This spherical roller bearing inner race depicts a fractured small rib caused by the use of improper installation tools.

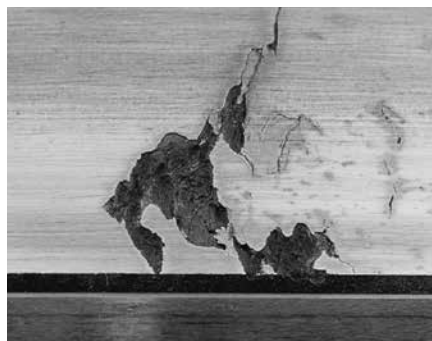
Point Surface Origin (PSO) spalling.

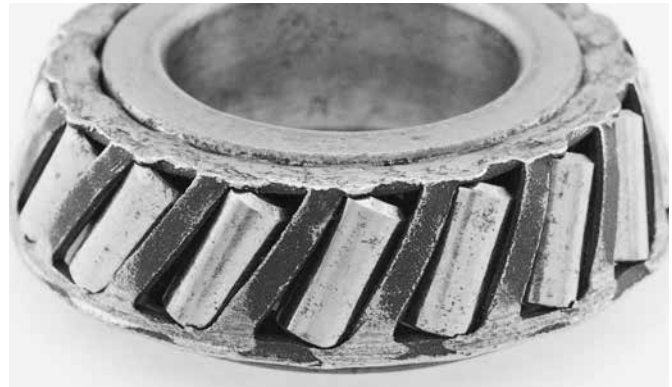
Binding and skewing of these tapered rollers was due to compression of cage ring during installation or interference during service.

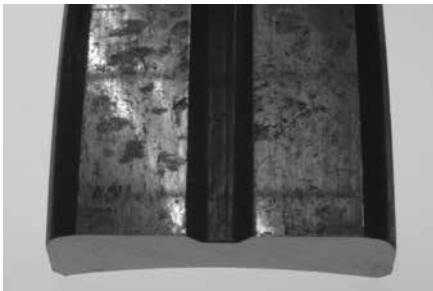
A worn-out housing caused this bearing to lose fit and fret (move) during service. As a result, metal tearing and wear occurred on this spherical outer ring.

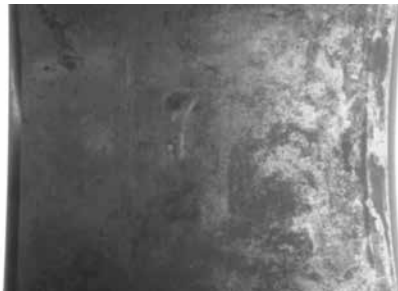
Classic fretting corrosion from poor fitting practice is depicted here. Relative movement under load between the bearing and its seat caused this worn and corroded condition.

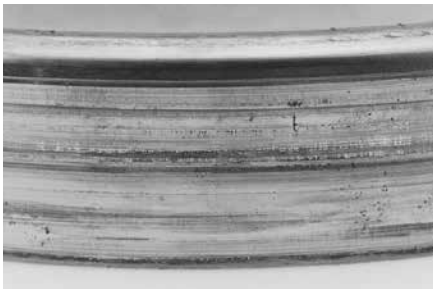
A loose outer ring fit in a rotating wheel hub (typically tight) caused this bearing race damage.

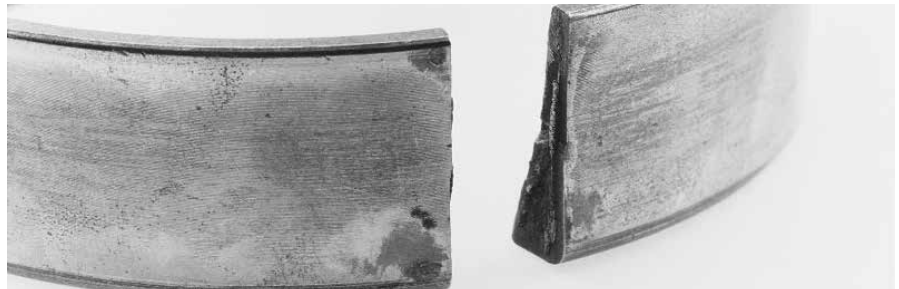
Cracked outer ring in a wheel hub. The outer ring turns and wears the outer ring seat so the fit becomes more loose. Then the outer ring starts to stretch or roll out. Wear and stretching continues to the point where the metal reaches its breaking point and the outer ring cracks open.

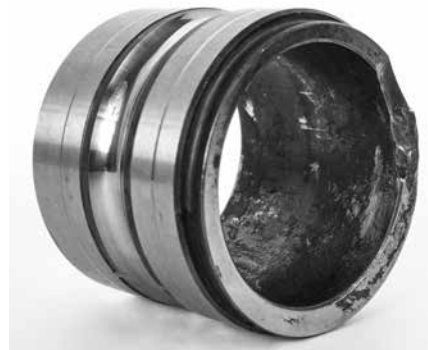
Fractured wide inner ring with locking collar due to undersized shaft

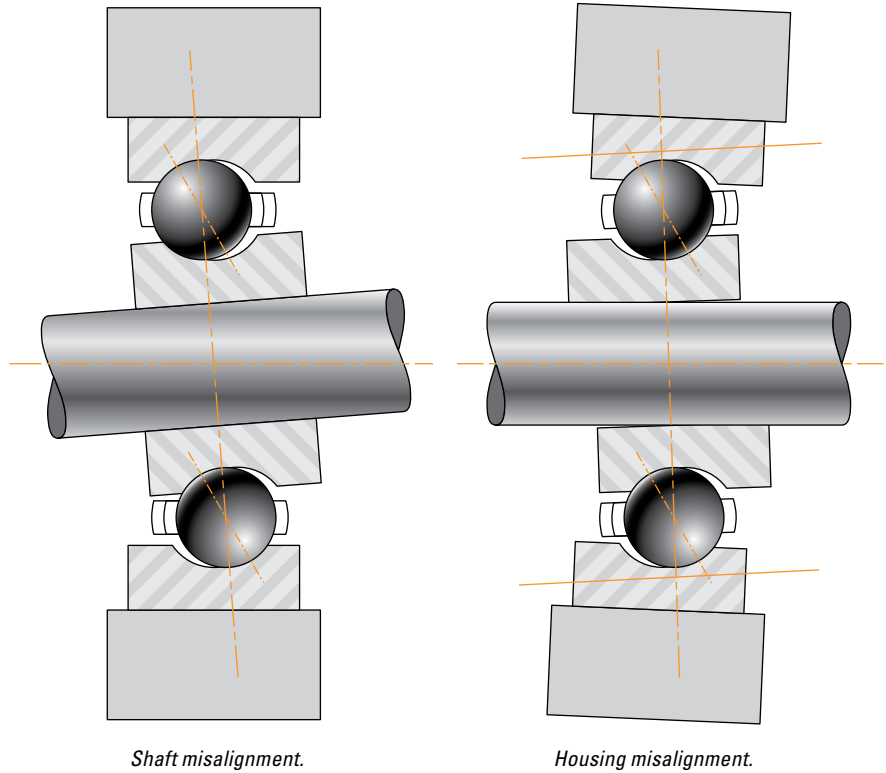
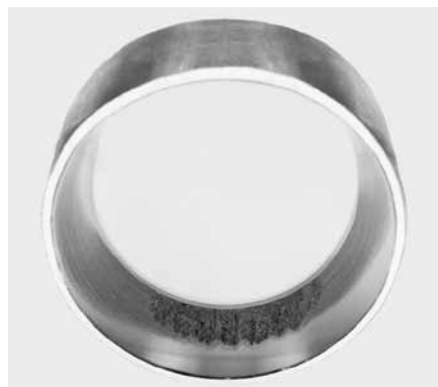
Deflection, inaccurate machining or wear of bearing seats caused an irregular roller path on this tapered roller bearing outer ring.

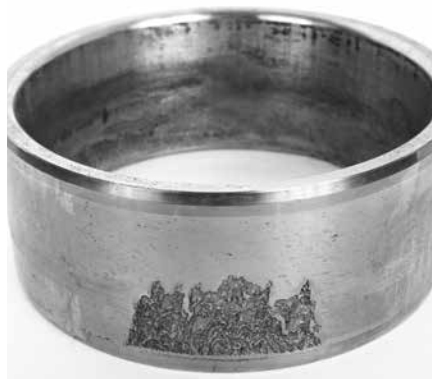
Heavy loads causing shaft deflection can lead to GSC spalling in this cylindrical roller bearing inner ring.

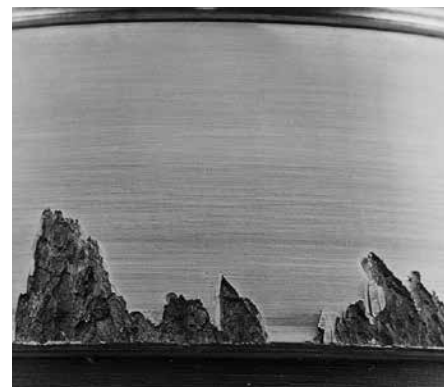
Geometric Stress Concentration (GSC) spalling.

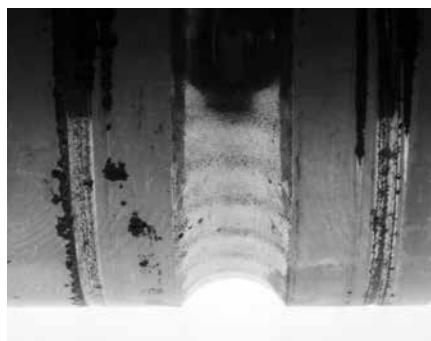
Note shock loading caused brinell damage on this ball bearing inner ring.

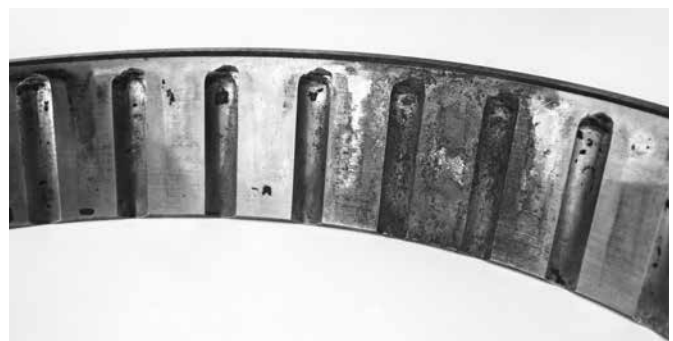
Heavy false brinell on outer race.

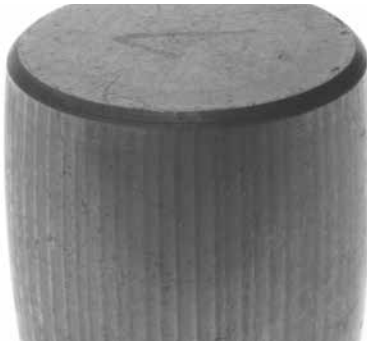
Welding on a machine, while the bearings were rotating, caused electric arc fluting on this spherical roller bearing.

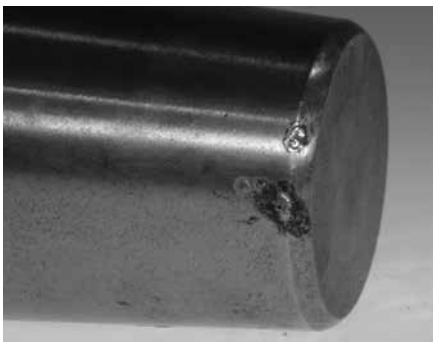
Roller with electric arc burns.

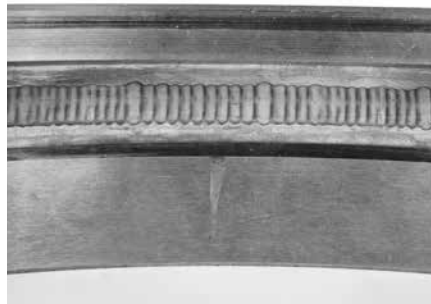
Burns from electric current.
