High Performance Retrofit Yields Lower Operating Costs and Reduced Energy Consumption

Tremco Headquarters

Transforming a 40 year old building into a sustainable showcase

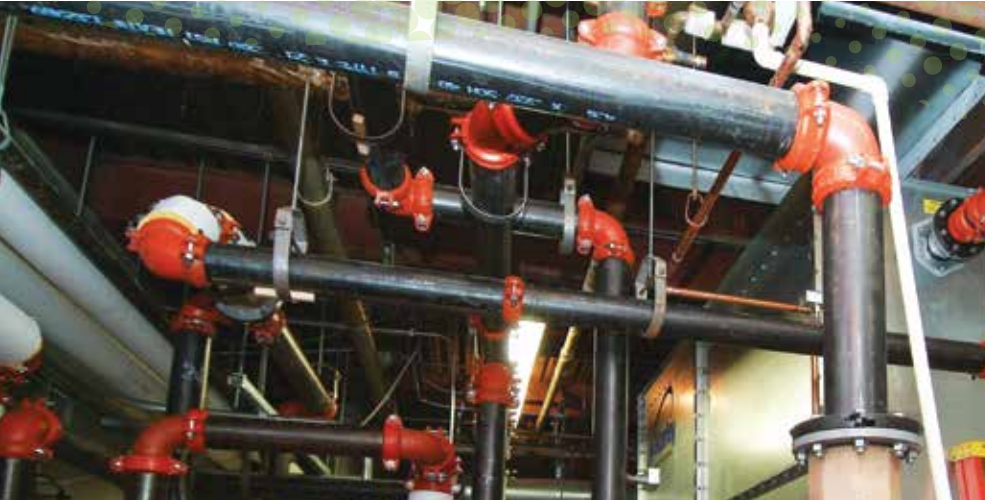
HVAC HEATING SYSTEM Two variable speed heating pumps were installed for more efficient operation. The piping system of the existing boilers was modified to achieve variable hot water flow. The entire perimeter radiation system was removed as a result of the increased performance of the building envelope.

HVAC COOLING SYSTEM The cooling system received an overhaul with the installation of a new, variable speed, dual cell cooling tower; two new variable speed chillers; and new, variable flow pumping systems. This equipment allows for greater energy efficiency by modulating flow and capacity and is precisely matched to the building's new cooling requirements.

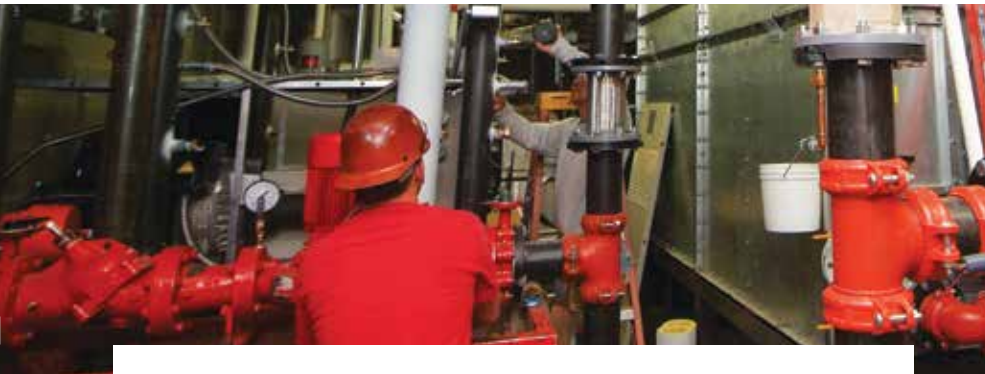
HVAC AIR DISTRIBUTION Distribution system components were converted to variable flow for more efficient operation. An energy recovery ventilator, communication network and occupancy sensors were also installed to meet mandatory energy requirements and improve operational efficiency.

HVAC CONTROL SYSTEM A facility-wide Building Automation System that incorporates "open protocol" communications controls and monitors all HVAC, lighting and renewable energy systems was installed. "Revenue Grade" submetering is utilized to monitor the energy contributions of the renewable energy resources.

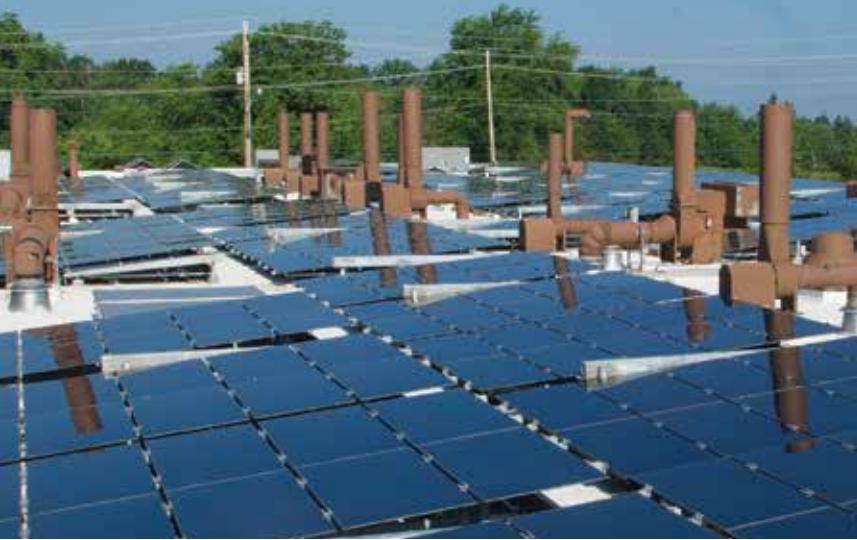
PHOTOVOLTAIC Two solar arrays were installed, one on the roof of the south building and the other atop the new carport, and are expected to generate a combined 100,000 kWh annually. The carport includes four solar-powered electric vehicle charging stations, with room for additional stations, and funnels power to the headquarters building when the charging stations are not in use.

WIND TURBINE Up to 6,000 kWh per year is expected from the wind turbine installed on the campus. The turbine has an instantaneous power rating of 1.8 kW at winds of 25 mph.
