Appendix A—Topographic Maps

409 E. Armour Blvd.
Kansas City, MO 64109

Appendix B – Site Photographs & Drawings

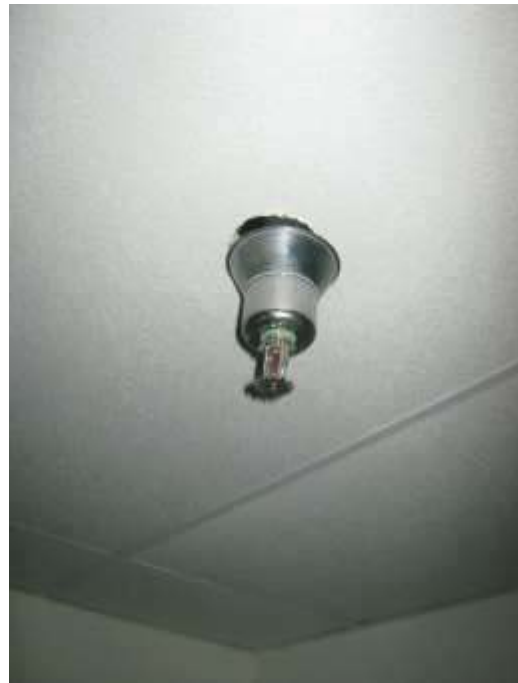
Canteen Retail Store Restroom Ceiling

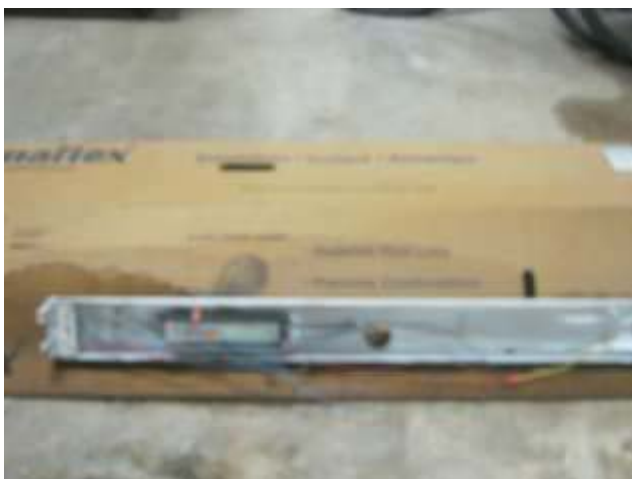
Light Ballast, NW Basement Area

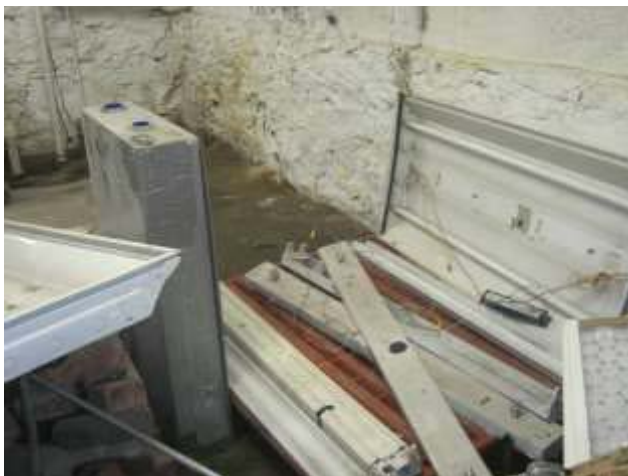
Light Ballasts, NW Basement Area

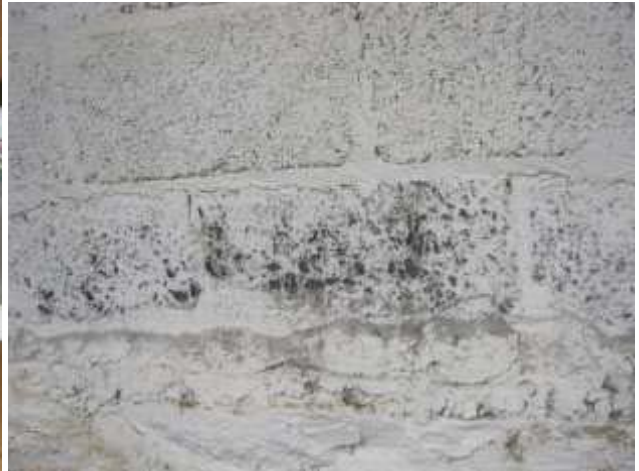
Visible Mold on Wall, NW Basement 1

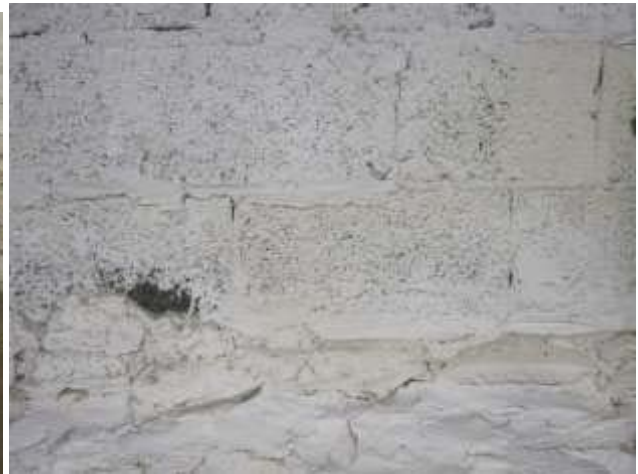
Visible Mold on Wall, NW Basement 2

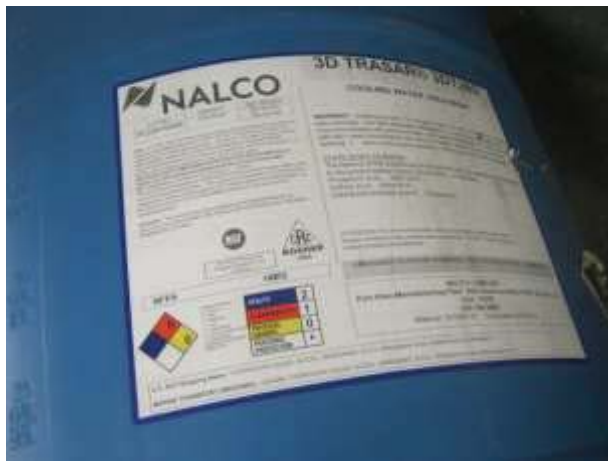
Empty 55-Gallon Drum Label

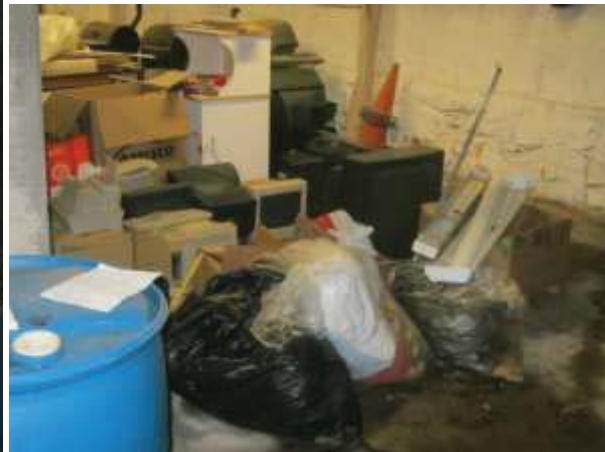
TVs & Computer Monitors, Central Basement

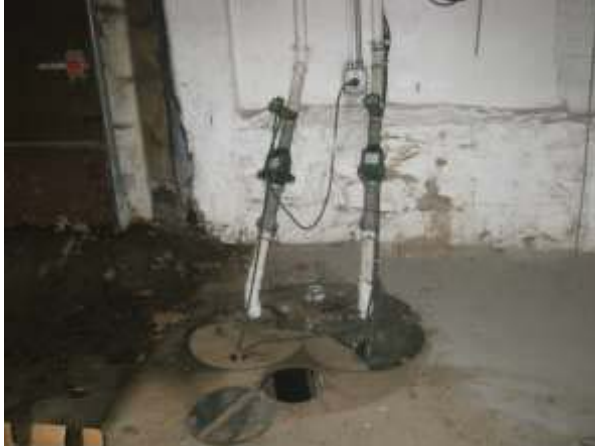
Sump Pump, East Loading Dock Area, Basement

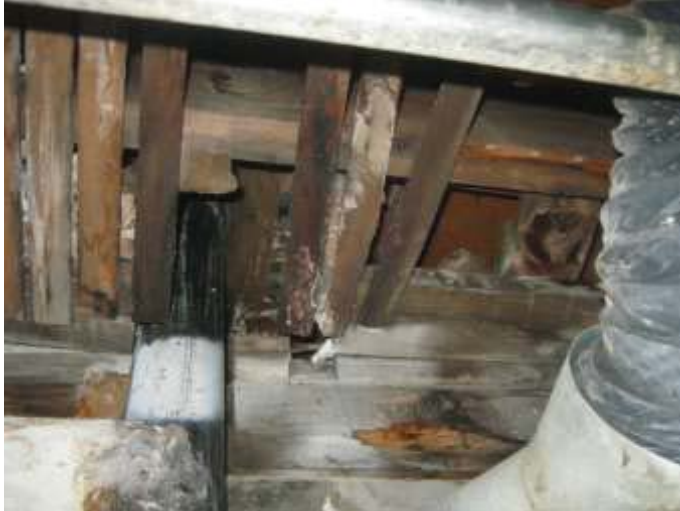
Ceiling Above Central Column, 2nd Floor Game Room

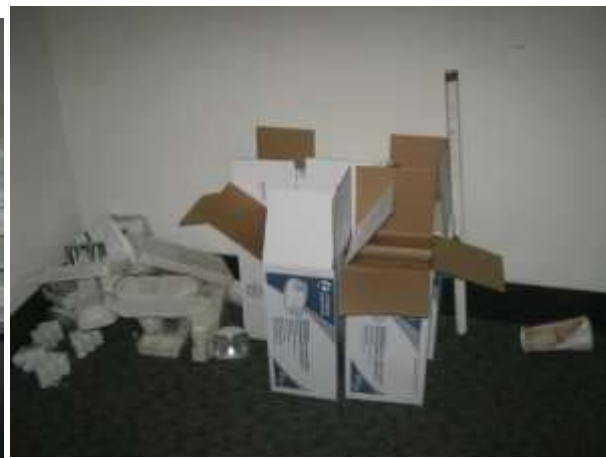
Emergency Lighting/Fluorescent Bulbs, 2nd Fl. Hall

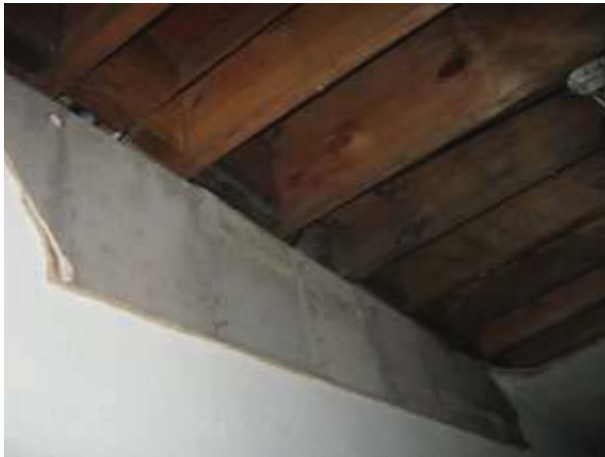
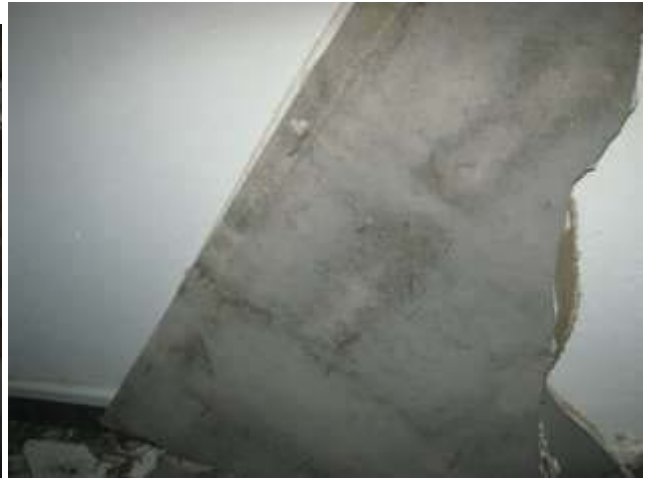
3rd Floor Hallway Ceiling Sheetrock/Texture

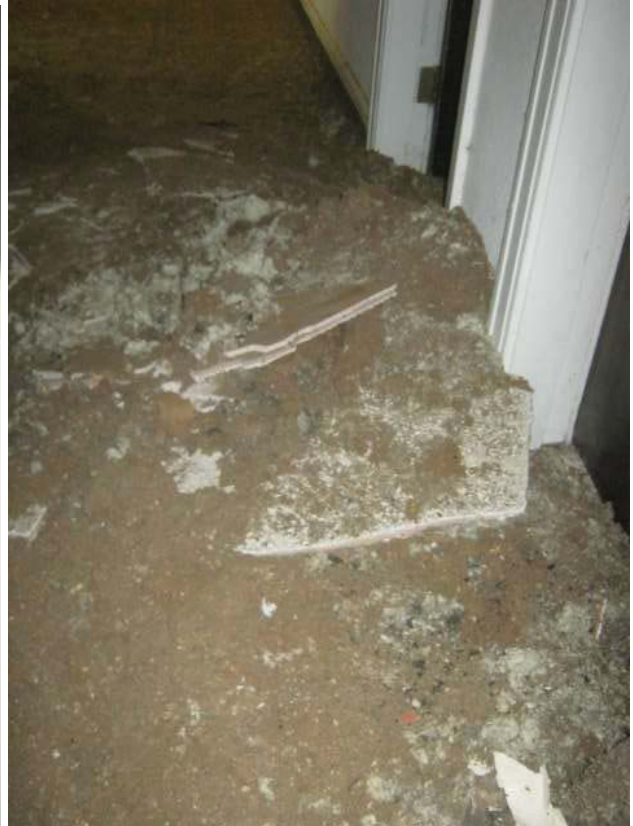
Fallen Ceiling Sheetrock/Insulation, 4th Fl. Hallway

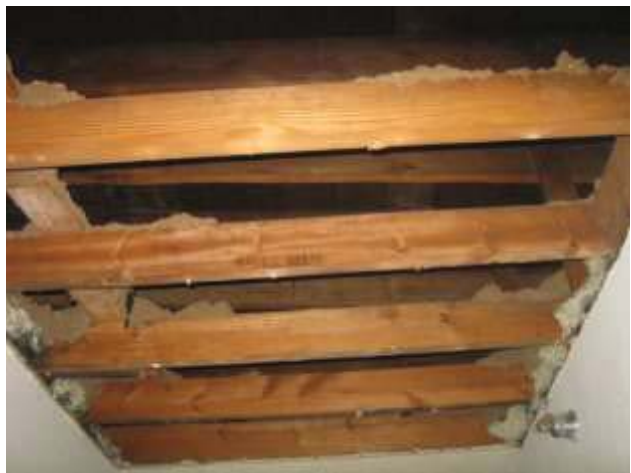
4th Floor Hallway Ceiling

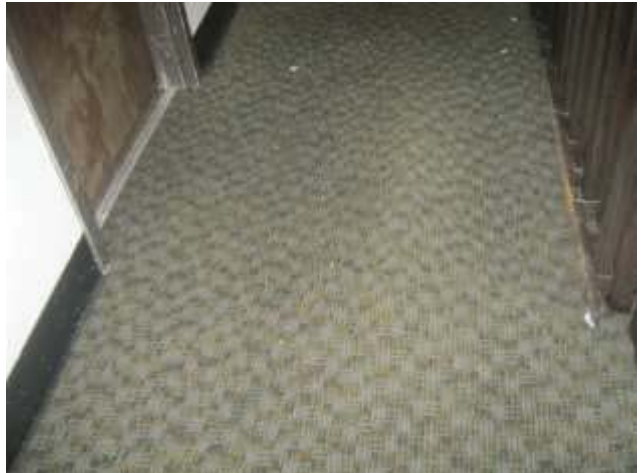
4th Floor Hallway Floor (wood bulging under carpet)

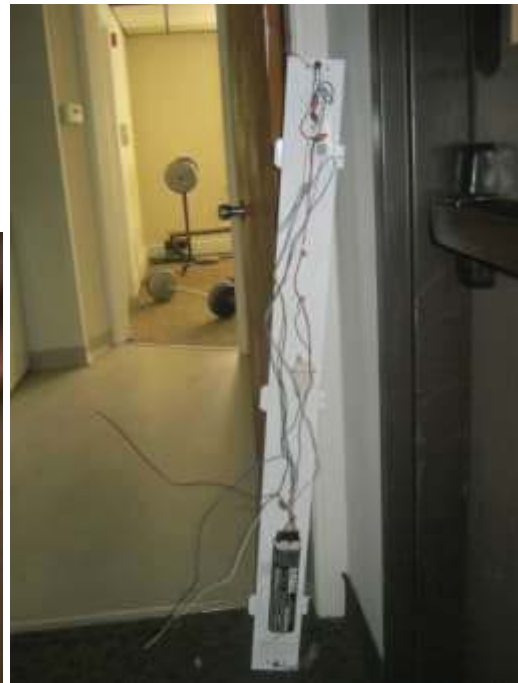
Light Ballast, 4th Floor Hallway

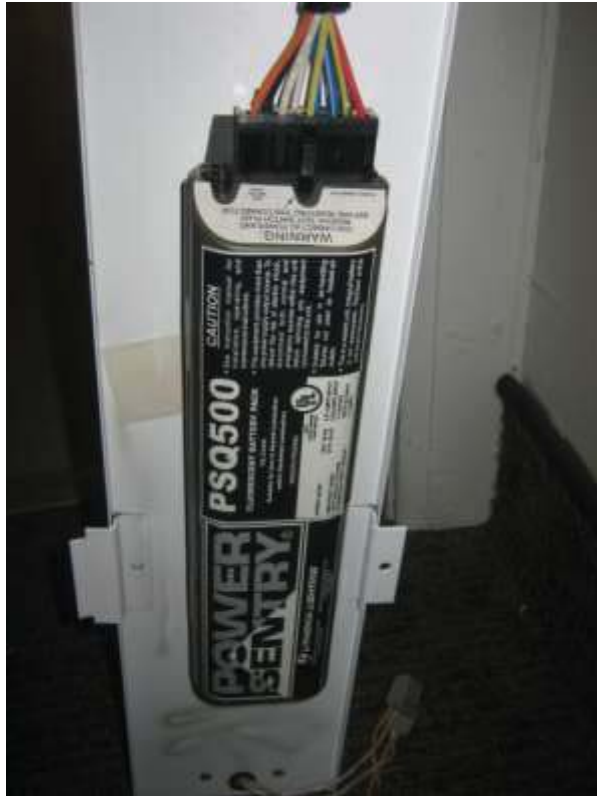
4th Fl. Hallway Light Ballast Label

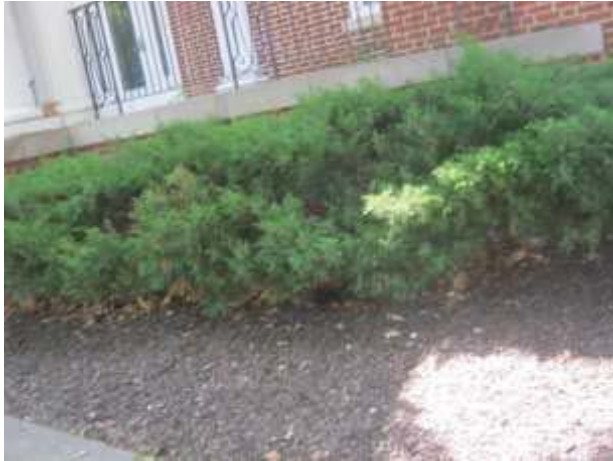
Front Landscaping

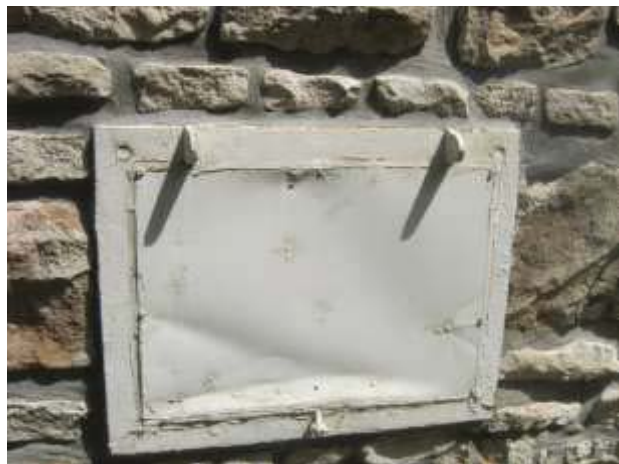
Old Coal Chute

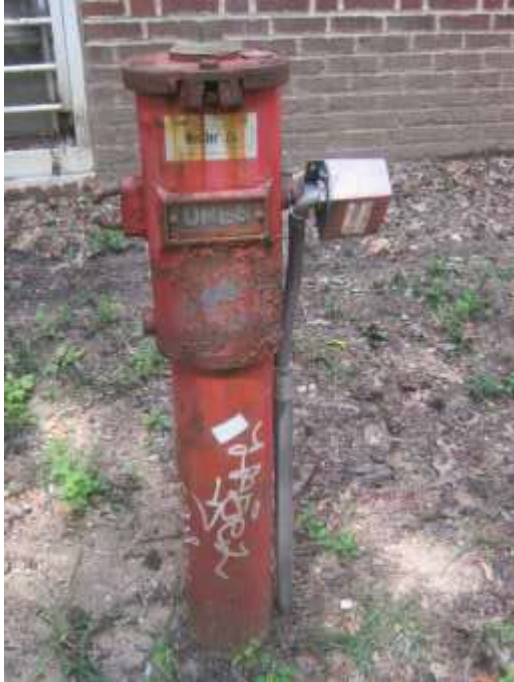
Fire Suppression System

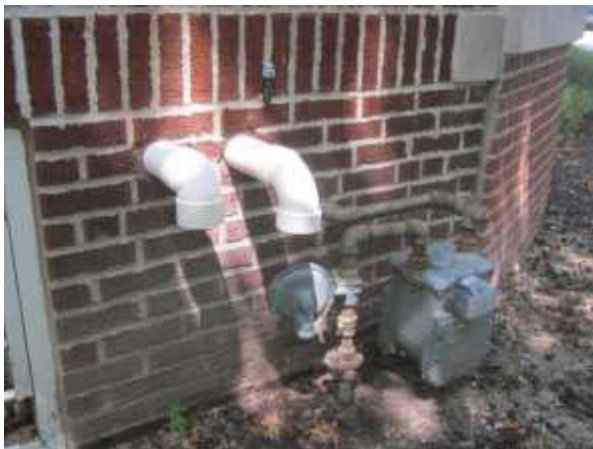
Gas Meter, NE Corner of Building
