EXAMINATION OF COPPER-NICKEL  
SEAWATER PIPING REMOVED FROM  
USS VINCENNES (CG-49)  
DURING POST-SHAKEDOWN AVAILABILITY (PSA)

FINAL REPORT

NORMAN J. CLAYTON

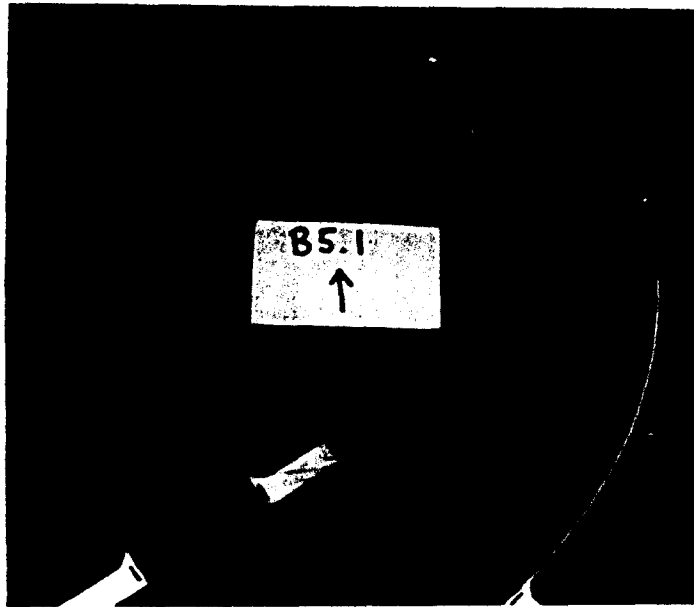
Figure 6b: Sample B5, inlet end, as split.
