EVALUATION OF CROSS MEDIAN CRASHES

Final Report

February 2005

Rowan University
Department of Mechanical Engineering
Glassboro, NJ 08028

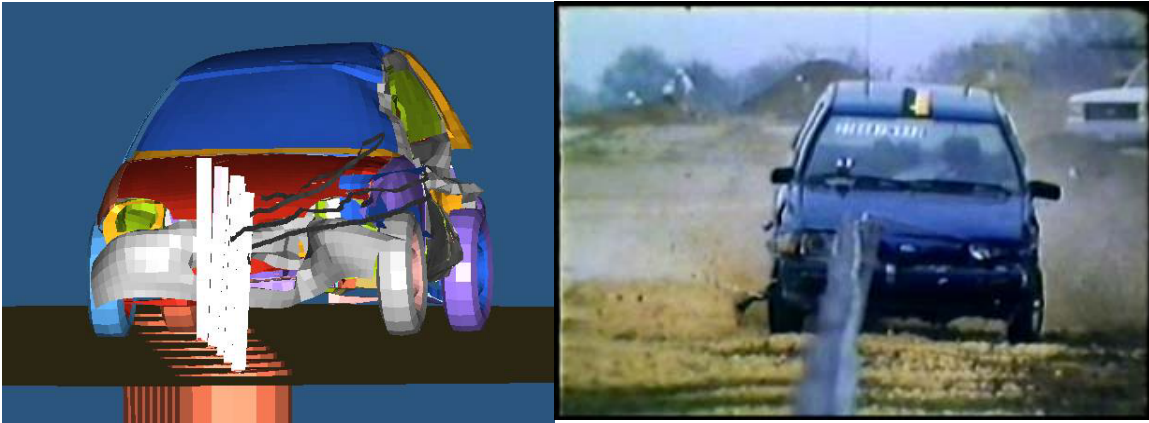
Figure 29. Three Strand Cable Barrier Validation: Model and Crash Test

Table 8 summarizes the comparison between the LS-DYNA three-strand cable model and the NCHRP Report 350 full-scale crash test (test 3-10). Note that there is no comparison of vehicle exit conditions as the vehicle remained in contact with the barrier for the duration of the event for both the crash test and simulation. With respect to the occupant risk criteria, the peak 50 ms average

accelerations had the highest level of correlation. A good correlation was also observed with respect to the occupant impact velocity in the longitudinal direction; however, this strong correlation was not observed in the lateral direction. Also, compared to the thrie beam model, there is a much less agreement between the calculated occupant ridedown accelerations. Similar to the thrie beam, though, there is strong agreement between the peak 50 ms average accelerations. Also, similar to the thrie beam model, the LS-DYNA model under predicts the maximum and permanent deflection of the barrier. These larger discrepancies between the model and crash test may be attributed to the more complex nature of the interaction of the vehicle with the three-strand cable barrier. Refer to Figure 29 for a side-by-side snapshot comparison of the LS-DYNA three-strand cable barrier model and corresponding full-scale crash test.

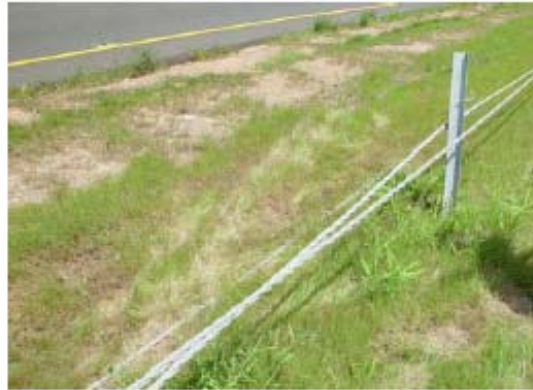
Tire tracks

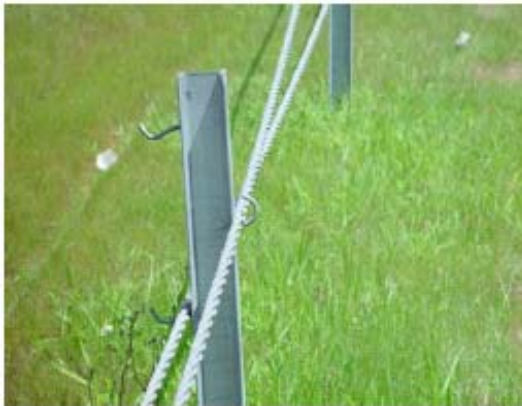
Bent U-Bolts
