# NEWTON PAVILION AT BOSTON MEDICAL CENTER

88 East Newton Street  
Boston, Massachusetts 02118

Report of Property Condition Assessment

Reference: Report of Property Condition Assessment  
Newton Pavilion at Boston Medical Center  
88 East Newton Street  
Boston, Massachusetts 02118  
Faithful+Gould Project No. 100056092

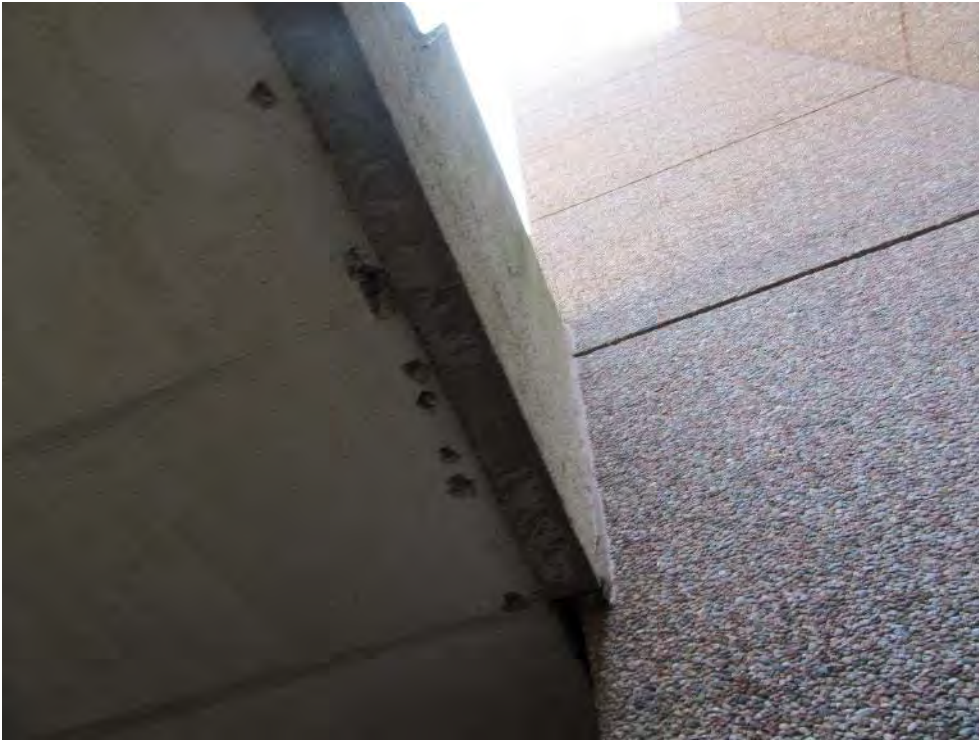
**Photograph No. ST-01**

Exposed Aggregate and Smooth Concrete Panels (Junction of Q and H Buildings)

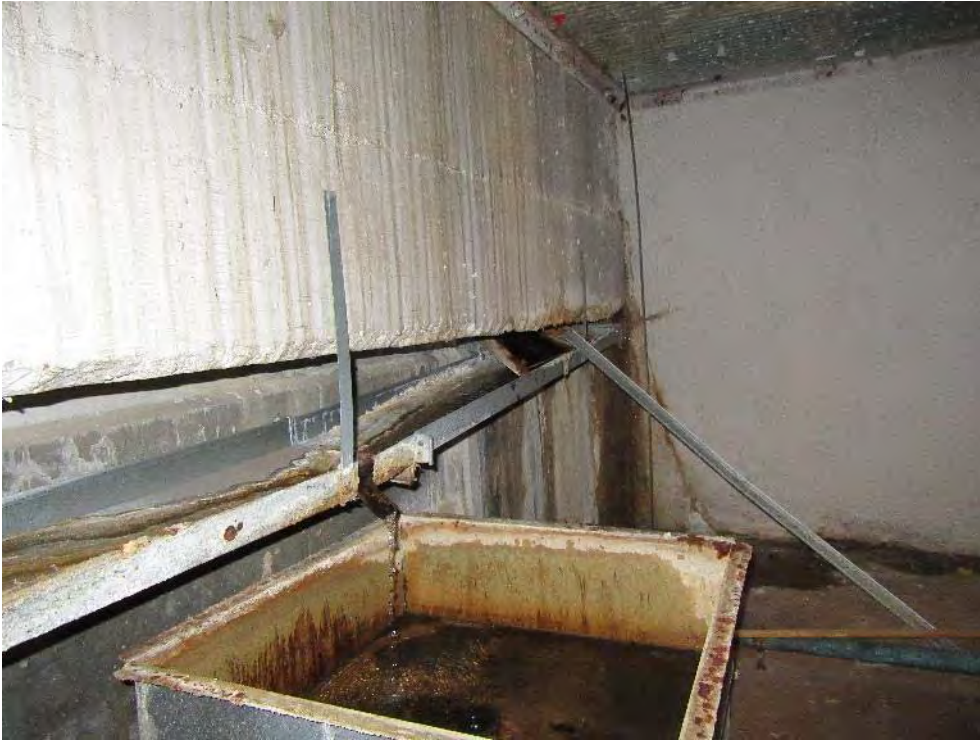
**Photograph No. ST-05**

- We noted water ingress into the basement level. We have included an allowance for evaluation and repair of this condition. Our allowance for repair is a placeholder with the actual cost only known once the aforementioned evaluation is completed.

Water Leak in  
Basement MEP Plant  
Room Collecting in  
Channel and Container

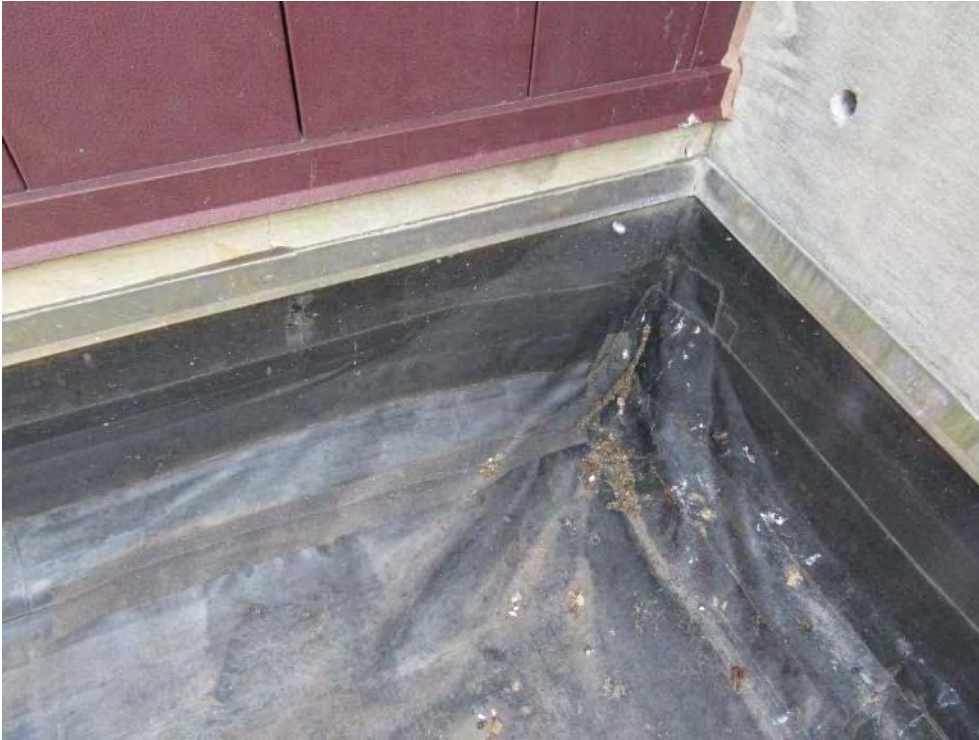
**Photograph No. R-02**

Flashing Upstand and  
Detailing of Roof (Q  
Building)

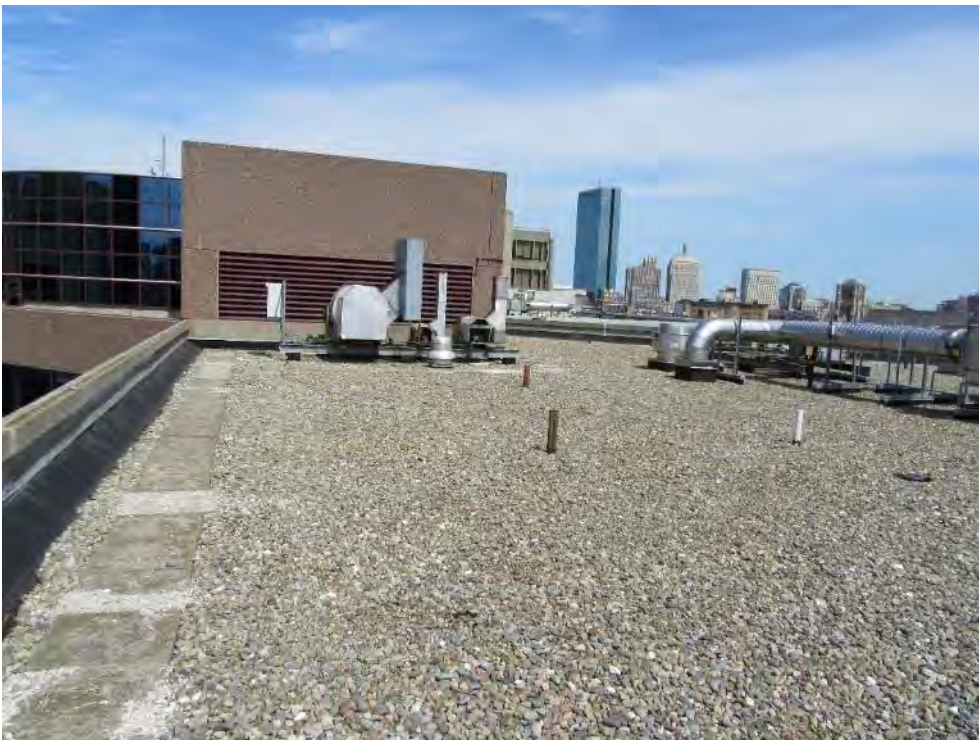
**Photograph No. R-05**

Roof Membrane  
Upstand (BUR Roof to  
Q Building)

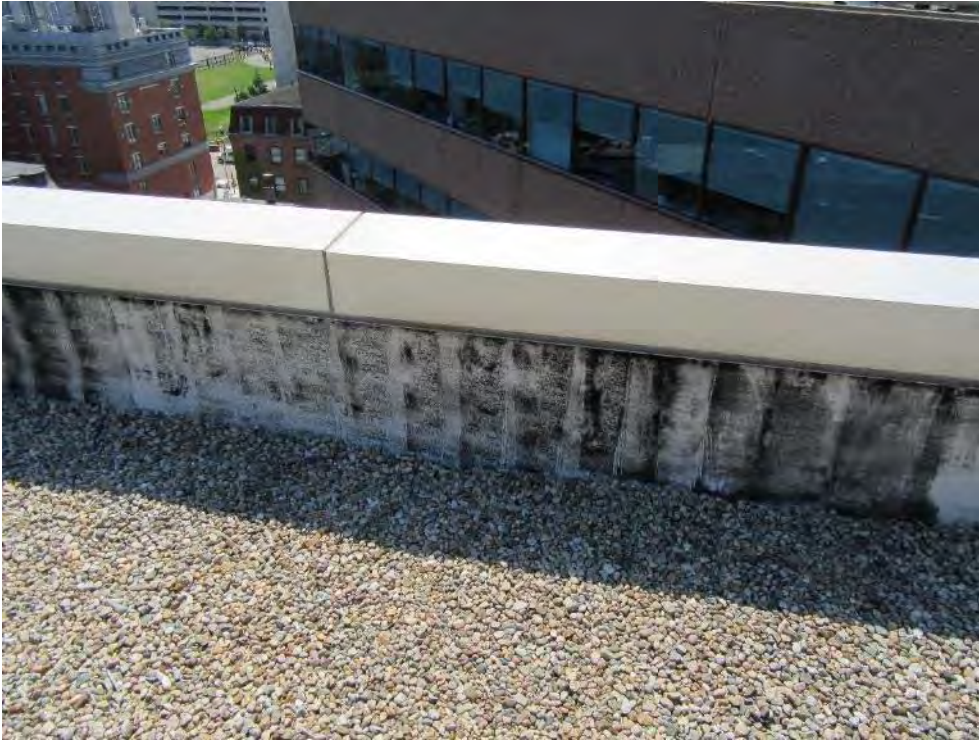
**Photograph No. R-06**

Areas of Exposed  
EPDM Membrane with  
Insulation, Filter Fabric  
and Ballast Removed

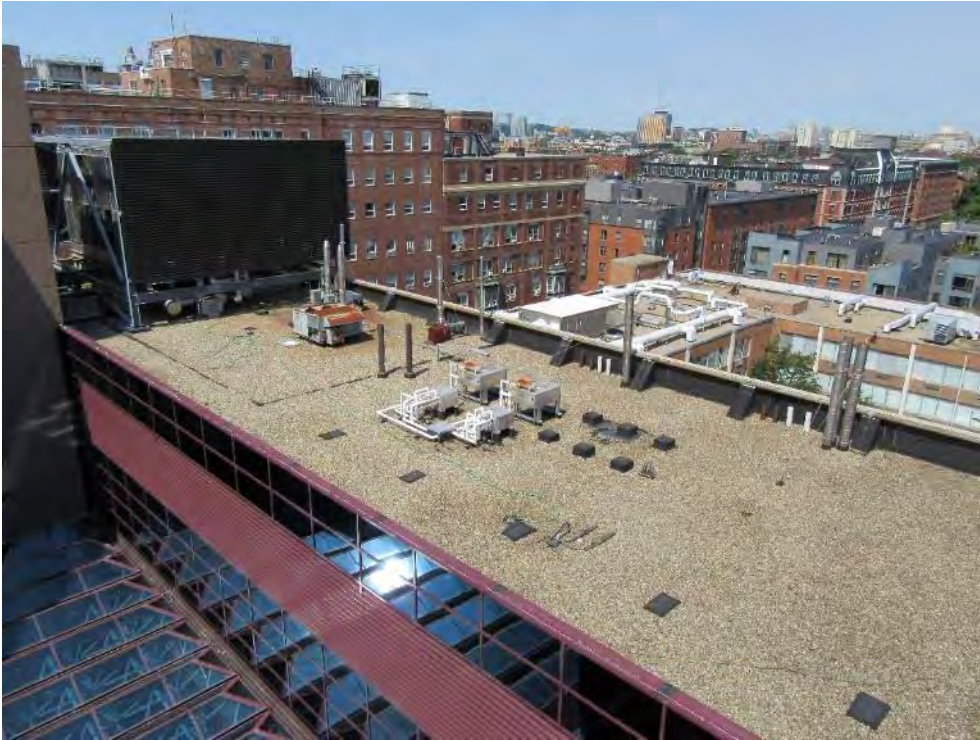
**Photograph No. R-07**

H Building Roof,  
Viewed from Q Building  
Roof

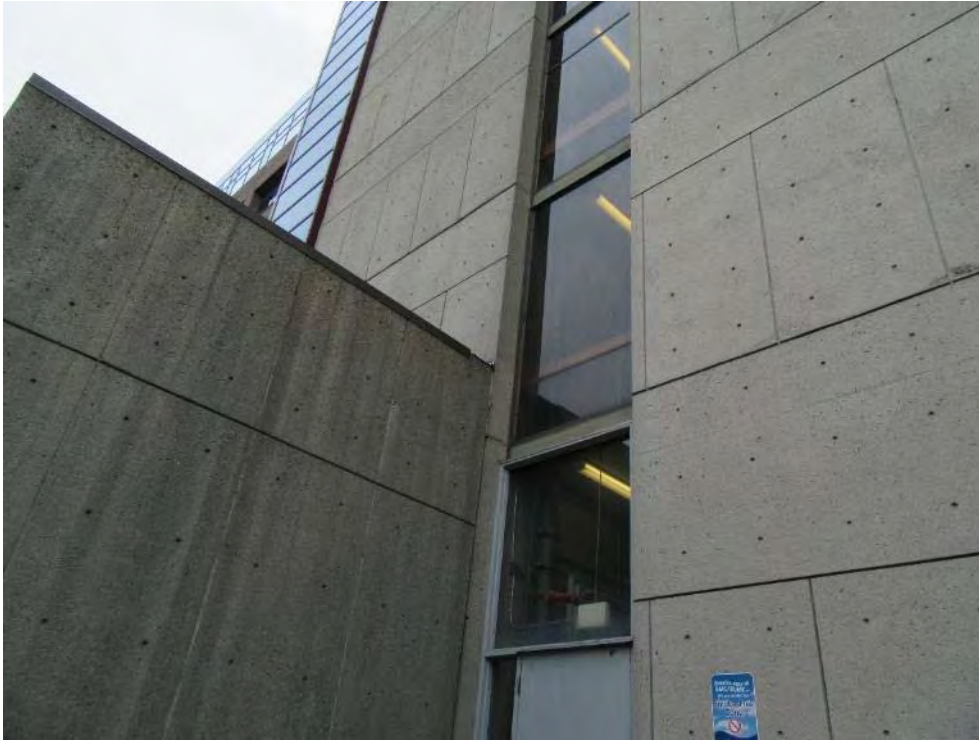
**Photograph No. EXT-08**

Infill CMU Blocks at H Building

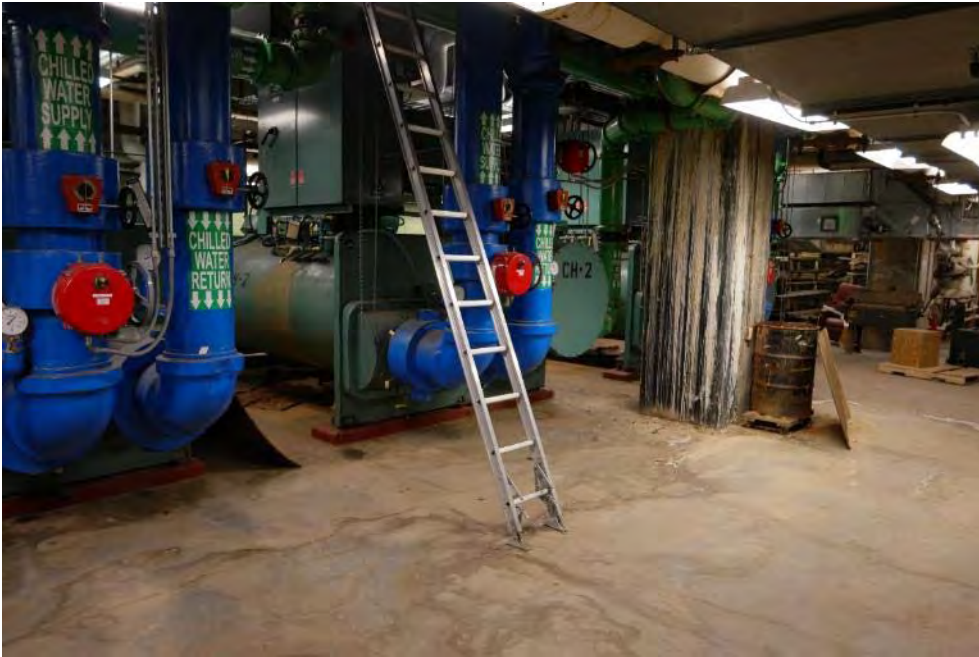
**Photograph No. M-02**

Chilled Water Pumps

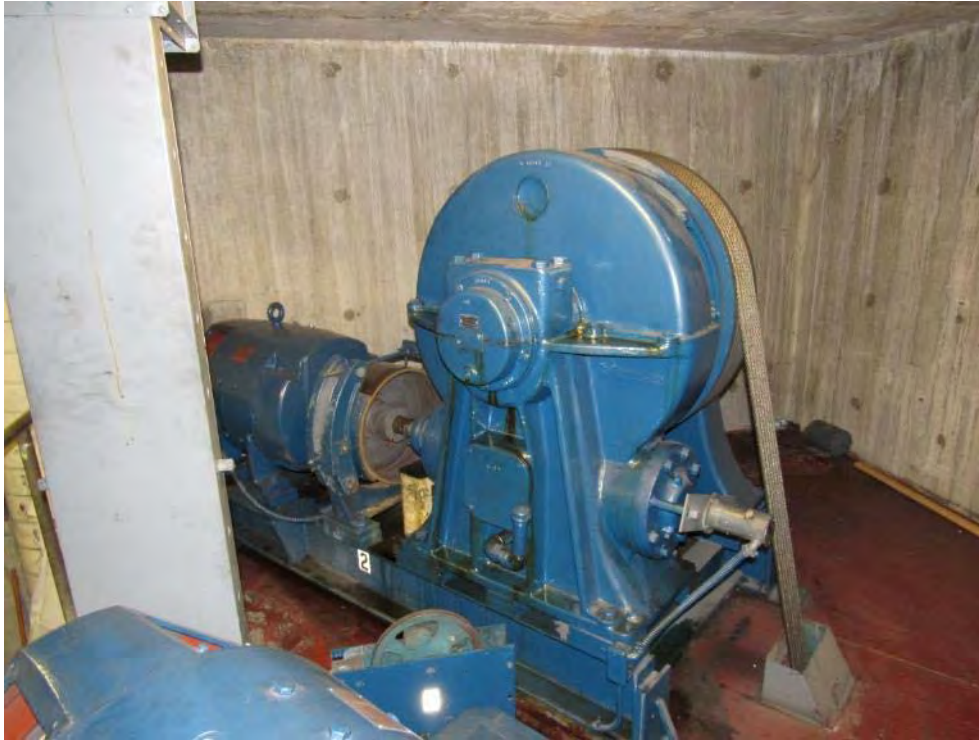
**Photograph No. ELV-02**

H Building – Older  
Controllers for Cars 1 and  
2

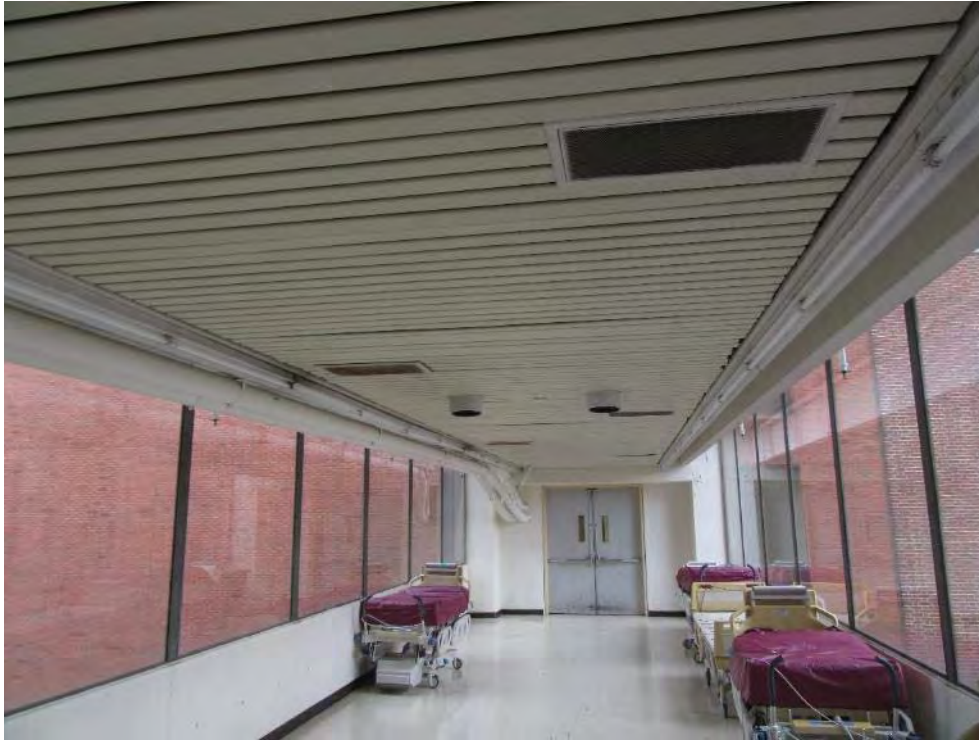
**Photograph No. INT-08**

Corridor in H Building
