PREPARATORY SURVEY REPORT
ON
THE PROJECT FOR
REHABILITATION OF METEOROLOGICAL RADAR SYSTEM
IN
GUIUAN
IN
THE REPUBLIC OF THE PHILIPPINES

May 2014

JAPAN INTERNATIONAL COOPERATION AGENCY

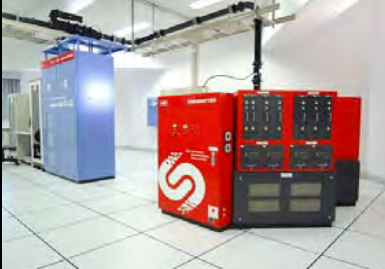
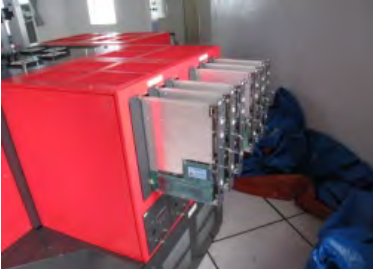
Digital Receiver and Signal Processor (DRSP)	Damaged	Replacement	Equivalent to the existing one (Replaced one to be utilized as spare parts)

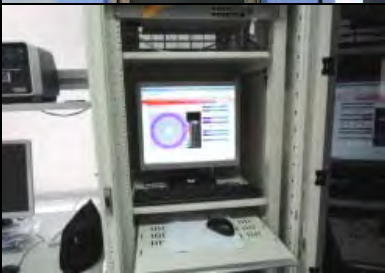
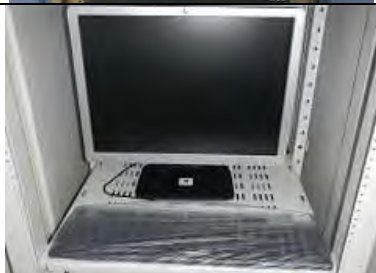
Data & Protocol Converter	Reuse (Confirmed that this is still operational)

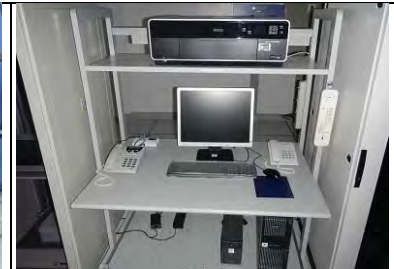
Radar Task Controller	Reuse (Confirmed that this is still operational)

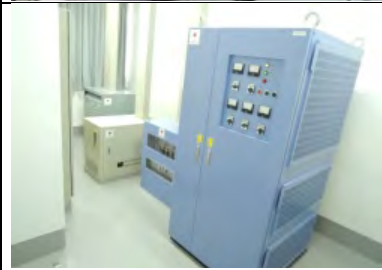
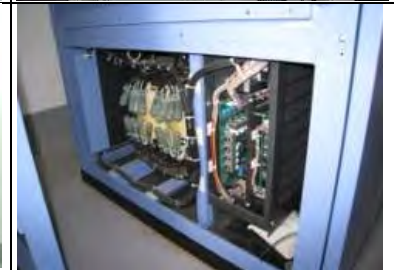
Isolation Transformer and Automatic Voltage Regulator (AVR) for Radar Equipment	Reuse (Confirmed that this is still operational)

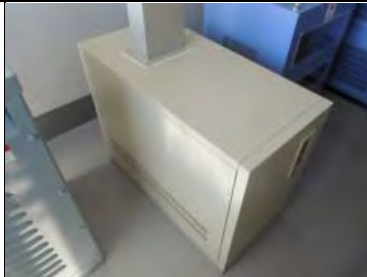
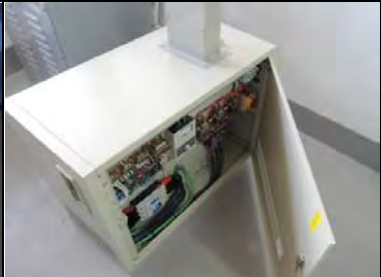
Isolation Transformer (1F Electricity Room)	Reuse (Confirmed that this is still operational)

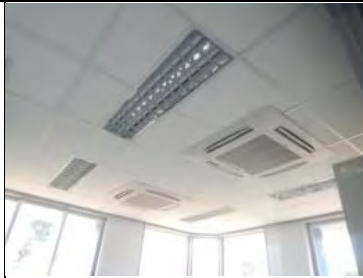
Air Conditioning Indoor Unit (1F Observation Room and Data Analysis Room)	Destroyed/ Damaged	Replacement	Equivalent to the existing one

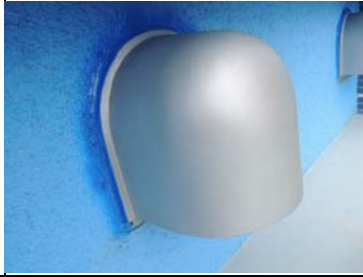
Bent Cap for Exhaust of Fan (1F and M4F)	Missing/Destroyed	Replacement/ Reinforcement	<ul style="list-style-type: none"> ■ Missing and destroyed bent cap will be replaced with a new one. ■ Reinforcement fixing with bolt.

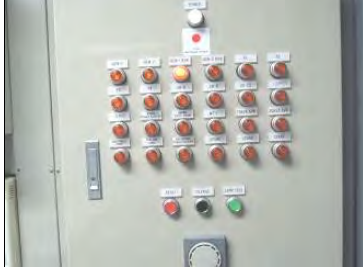
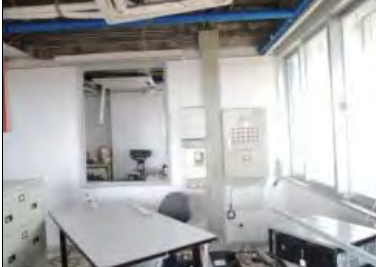
Alarm Panel (1F)	Destroyed/ Damaged	Replacement	Equivalent to the existing one

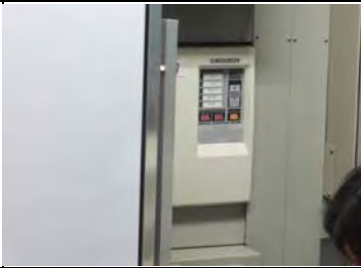
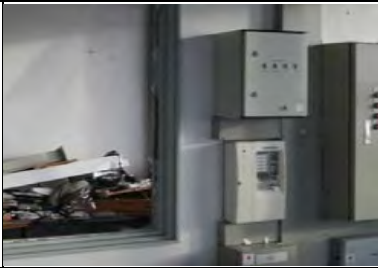
Fire Alarm Panel (1F)	Destroyed/ Damaged	Replacement	Equivalent to the existing one

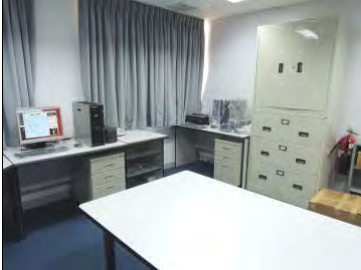
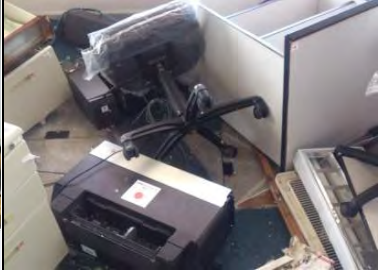
Furniture (1F)	Destroyed/ Damaged	Replacement	Equivalent to the existing one

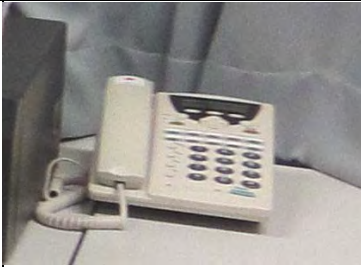
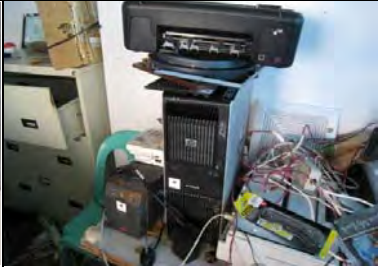
Telephone (1F)	Destroyed/ Damaged	Replacement/ Reinforcement	Equivalent to the existing one

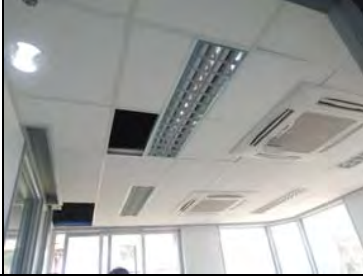
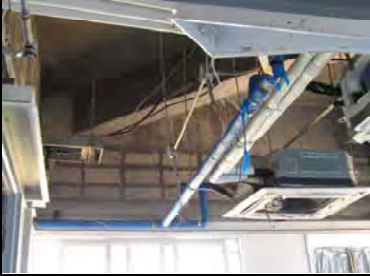
<p>Interior Lighting Fixtures (1F Observation Room, Data Analysis Room, Maintenance Room, Entrance Hall, M4F Radar Equipment Room, 6F Radome Room and Staircase from 4F to 6F)</p>	<p>Missing/Destroyed</p>	<p>Replacement</p>	<p>Equivalent to the existing one</p>

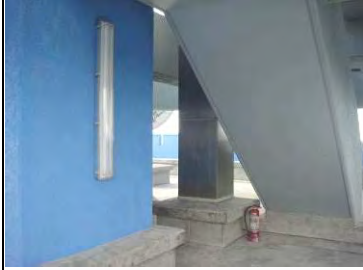
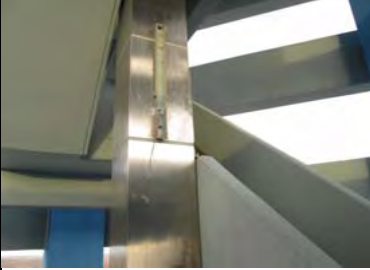
<p>Exterior Lighting Fixtures (from 2F to 4F and 5F Observation Deck)</p>	<p>Missing/Destroyed</p>	<p>Replacement/ Reinforcement</p>	<ul style="list-style-type: none"> ■ Missing and destroyed exterior lighting fixtures will be replaced with new ones ■ Reinforcement fixing with a metal strap

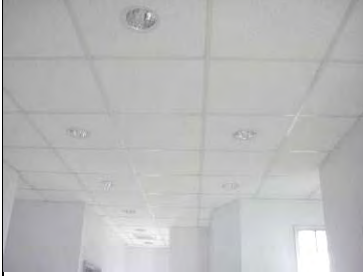
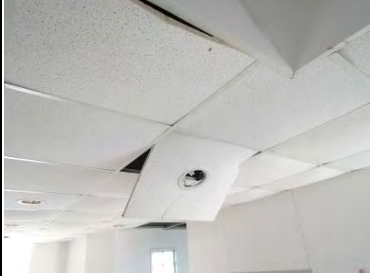
<p>Interior Finishing (1F Observation Room, Data Analysis Room, Maintenance Room, Entrance Hall, M4F Radar Equipment Room and staircase from 4F to 6F)</p>	<p>Destroyed/ Damaged</p>	<p>Replacement</p>	<p>Equivalent to the existing one</p>

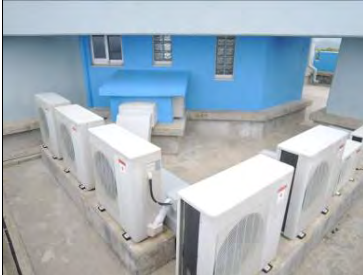
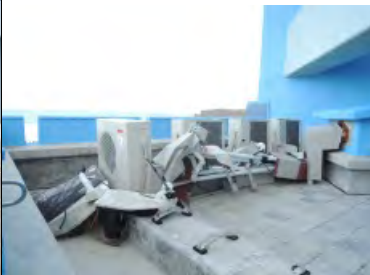
<p>Air Conditioning Outdoor Unit (2F)</p>	<p>Missing/Destroyed</p>	<p>Replacement/ Reinforcement</p>	<ul style="list-style-type: none"> ■ Missing and destroyed air conditioning outdoor unit will be replaced with a new one. ■ Air conditioning outdoor unit will be firmly fixed with reinforced steel bars made by stainless angle to the concrete base.

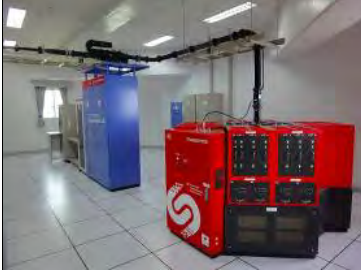
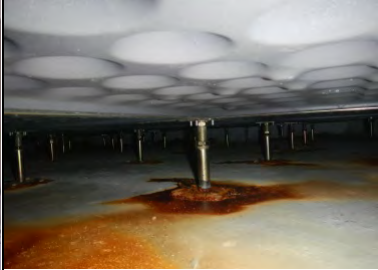
Access Floor in Radar Equipment Room (M4F)	Damaged	Replacement	Equivalent to the existing one

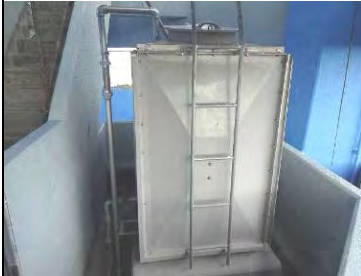
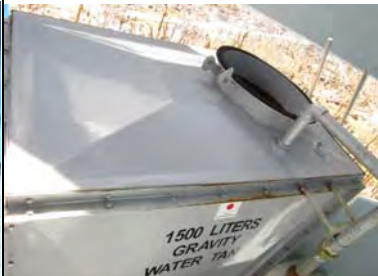
Elevated Water Tank Cover (M2F)	Missing	Replacement/ Reinforcement	<ul style="list-style-type: none"> ■ Missing cover will be replaced with a new one ■ Reinforcement fixing with bolt

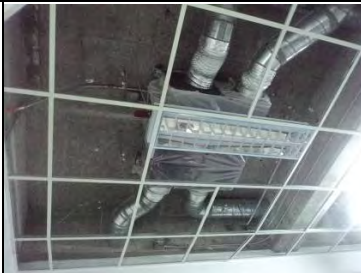
Heat Exchanger (M4F)	Destroyed/ Damaged	Replacement	Equivalent to the existing one
