# STORMWATER BEST MANAGEMENT PRACTICES GREATER BALTIMORE SURVEY 2016

Prepared By Richard Klein  
Community & Environmental Defense Services  
410-654-3021 [Rklein@ceds.org](mailto:Rklein@ceds.org) [ceds.org/gbs](http://ceds.org/gbs)  
July 22, 2016

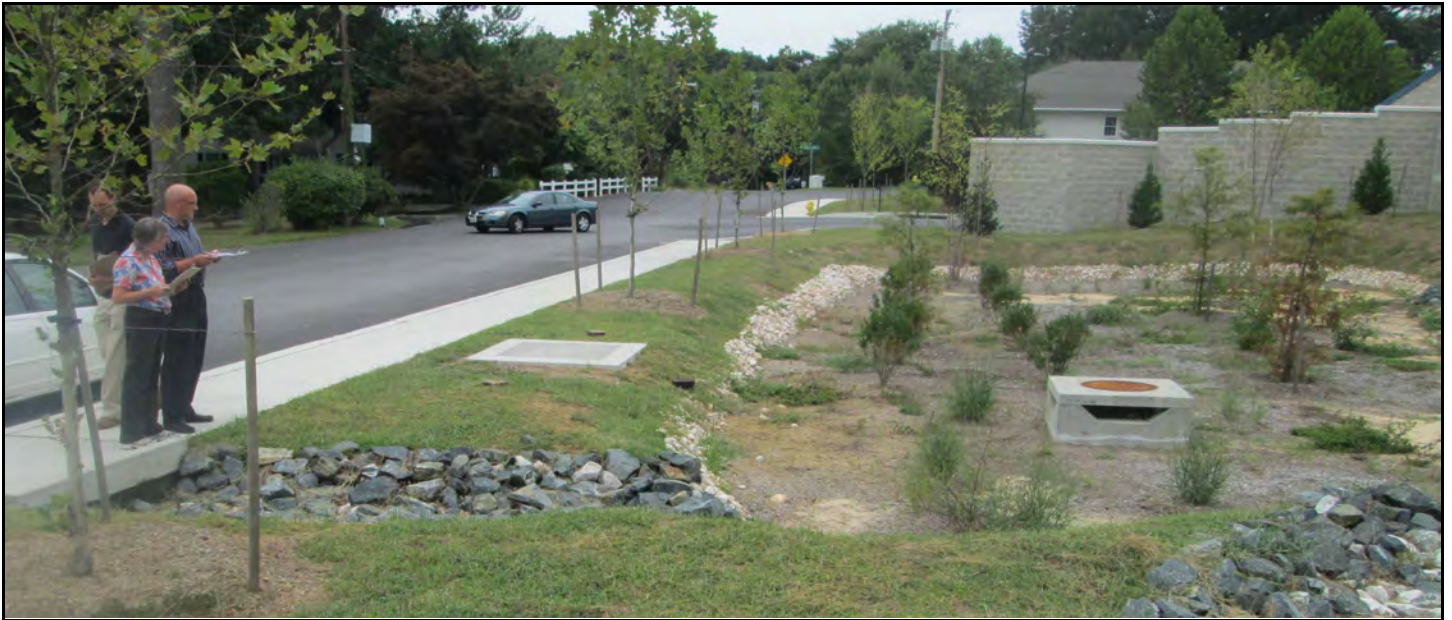
Matthew Henjum, Evan Isaacson and Lynne Rockenbauch assessing a Micro-Bioretenion BMP

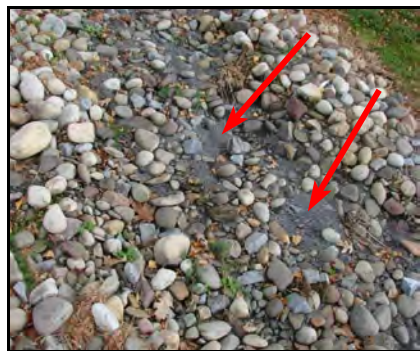
Spaces between gravel clogged with sediment

benefits. If you find that the spaces between gravel is filled with sediment then the diaphragm likely requires cleaning. If there's vegetation growing from the gravel in the middle of the diaphragm then this may mean

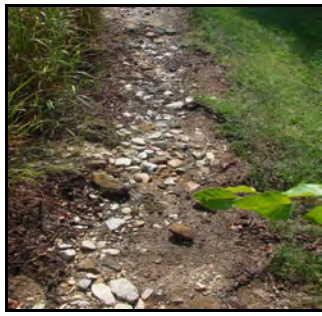
**Clogged diaphragm**

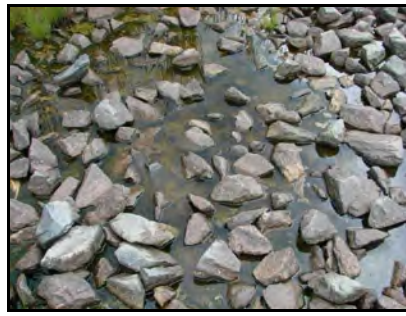
**Standing water**

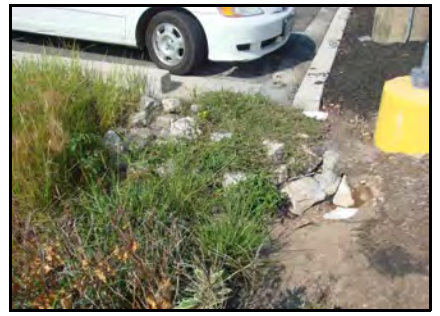
**Clogged Diaphragm**

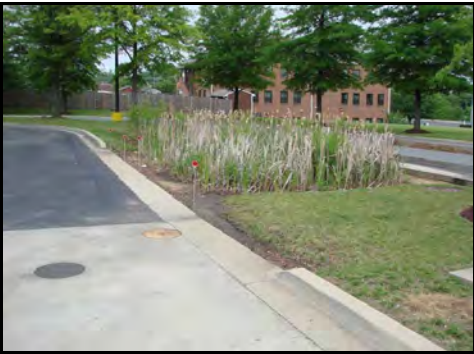
**Cattails or other wetland plants**

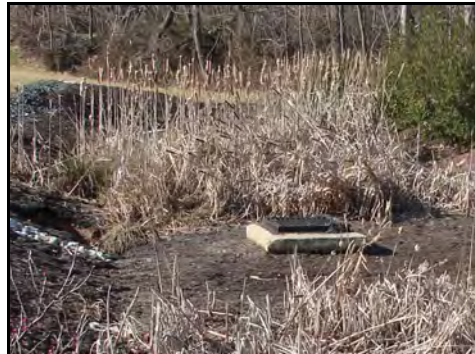
**Winter view of cattails**

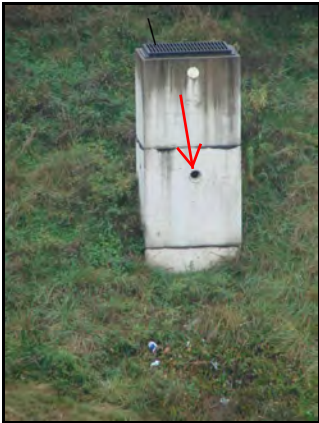
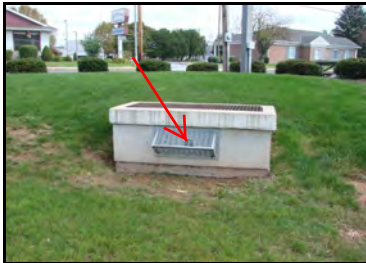
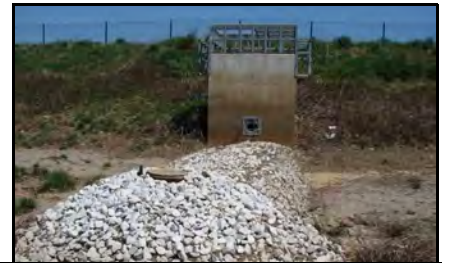
Of the four outlets, only the left two serve infiltration basins. Note that the lowest opening on both of these spillways is at least a foot or two above the basin floor, which forces most runoff to infiltrate through the basin flood. Opening at bottom of the second from right outlet prevents ponding and infiltration. A perforated pipe buried in the stone drains runoff entering far right pond.

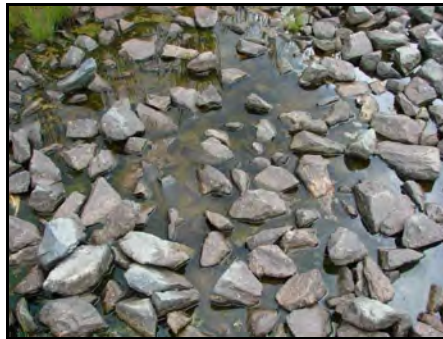
Spaces between stone full of water

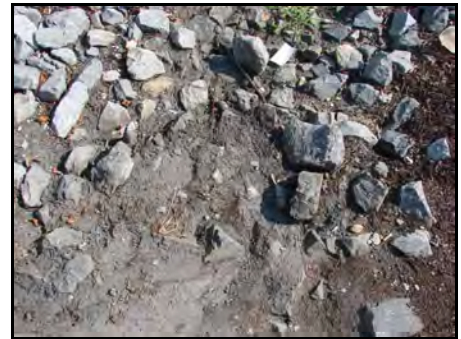
Spaces between stone full of sediment

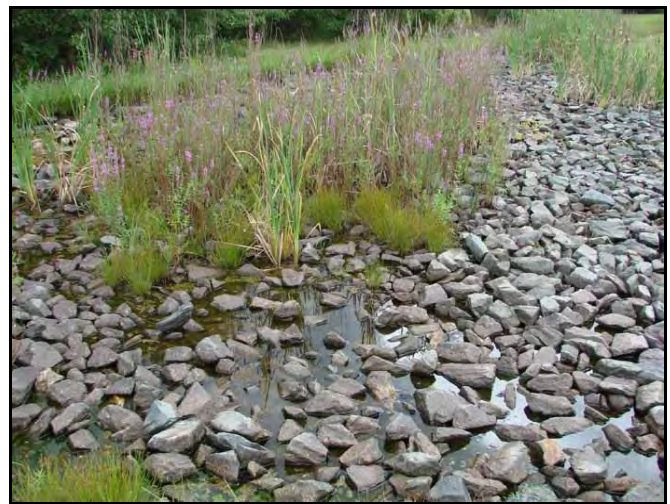
Cattails growing from saturated trench - summer view

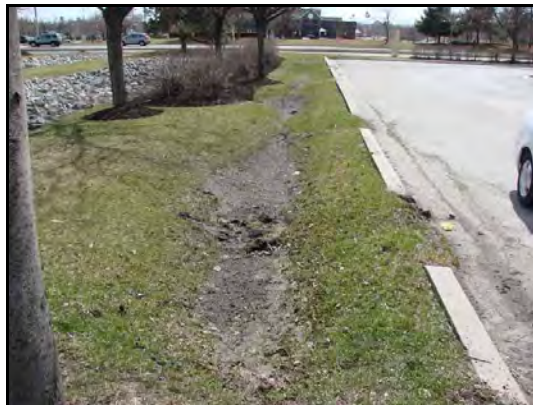
Grass filter strip full of sediment

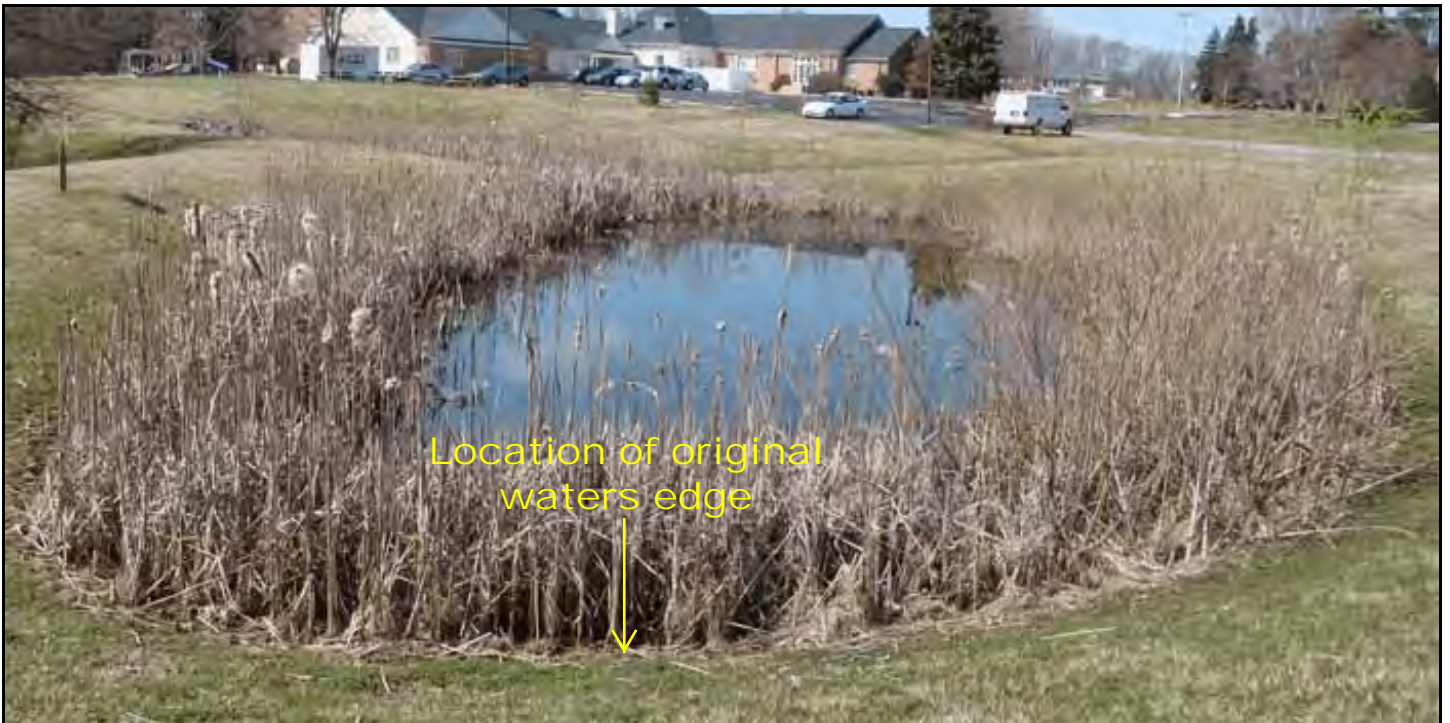
Location of original  
waters edge

**When looking at a pond like this you can easily guess where the original shoreline was - where the mown grass meets the cattails. Over time sediment will accumulate within a pond which will then be colonized with wetland vegetation. If this process has significantly reduced the water surface area then the pond should be cleaned. Vegetation is not an asset; it lowers pollutant removal.**
